CROOKS HOLLOW DAM
INTEGRITY ASSESSMENT
CROOKS HOLLOW ROAD
TOWN OF FLAMBOROUGH, ONTARIO
FOR
HAMILTON REGION
CONSERVATION AUTHORITY

Job No. 92HF137

February, 1993

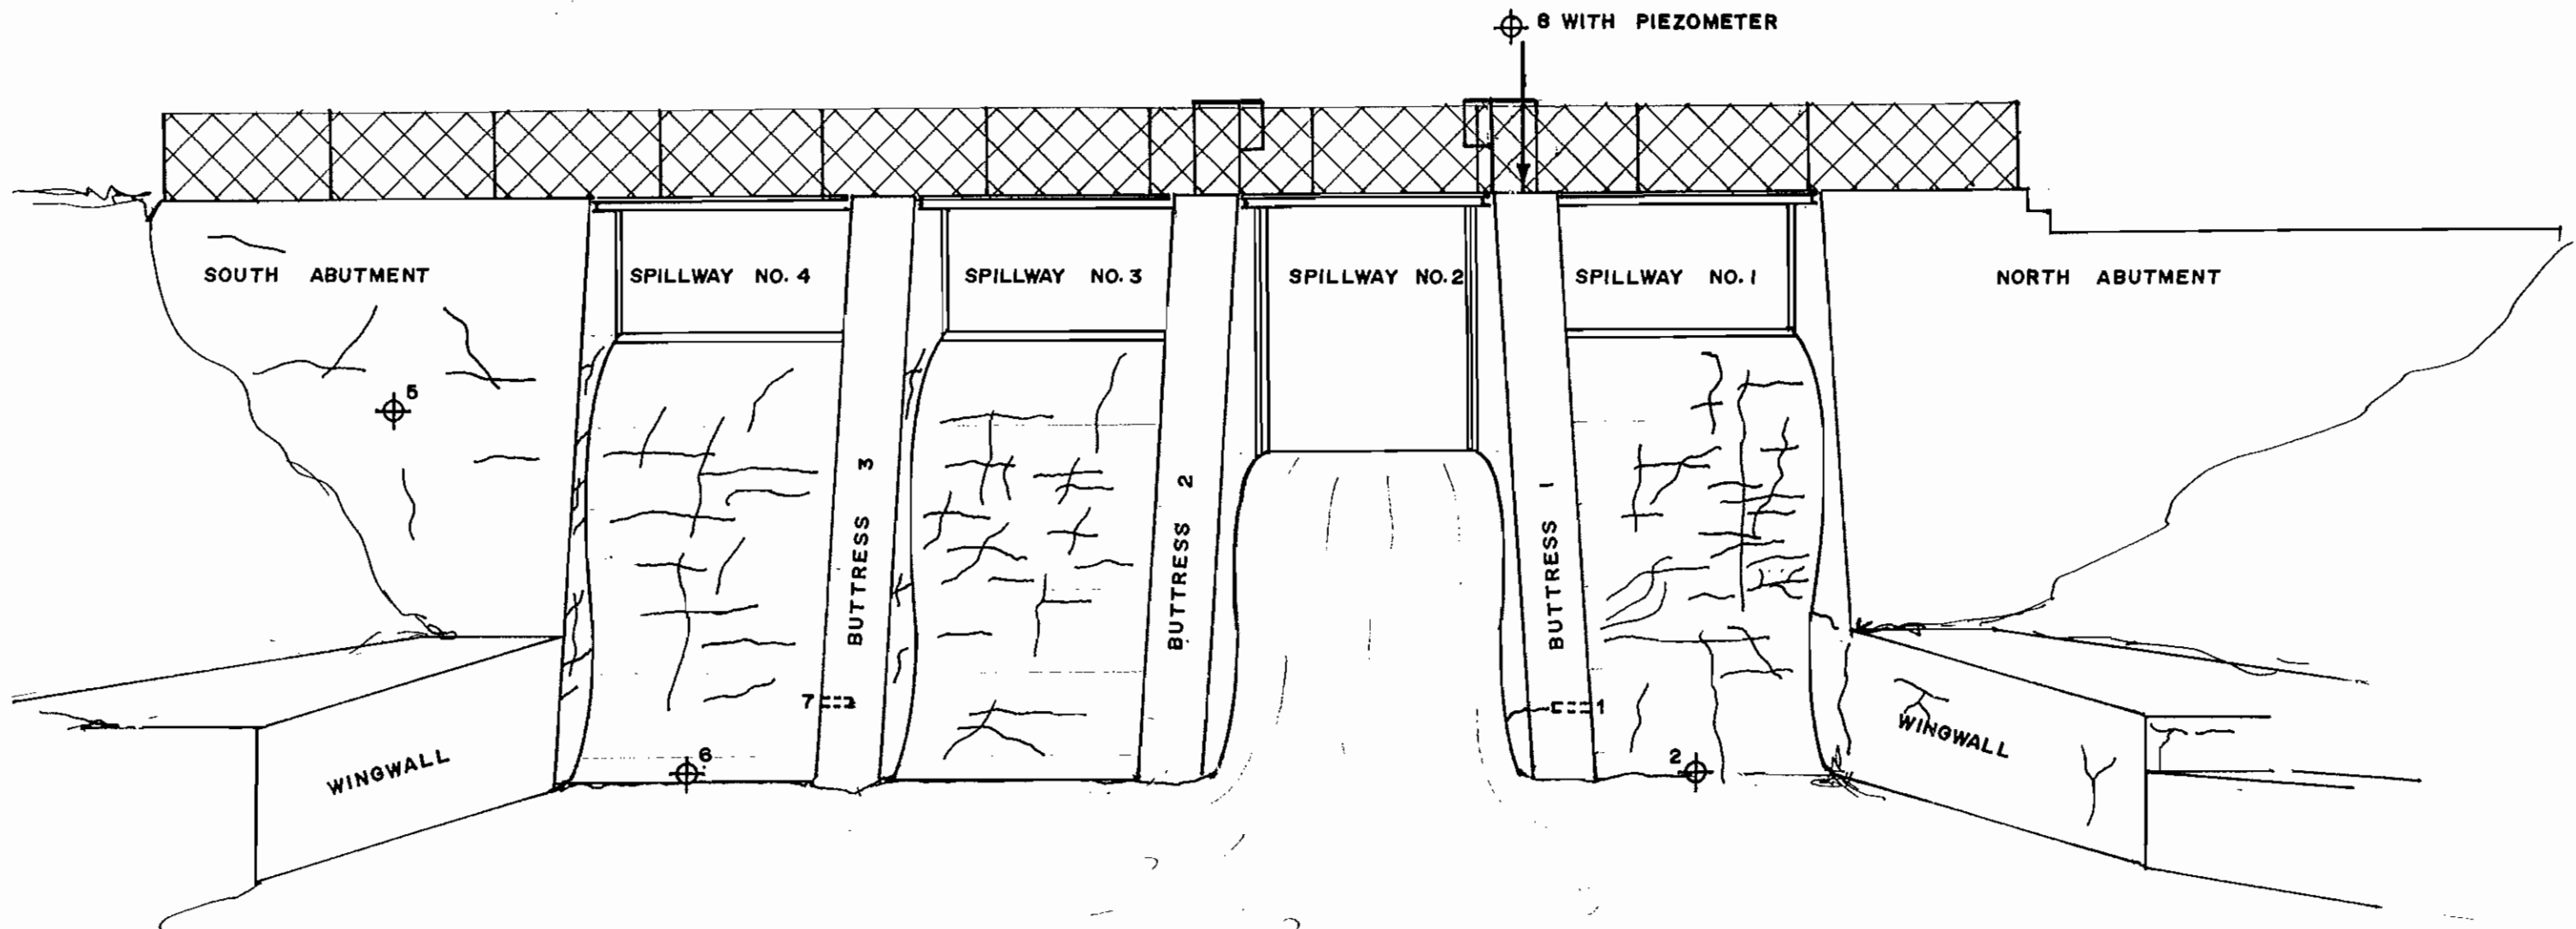
Drawings 1 and 2 show the location where the core was retrieved. Core No.'s 1 through 7 are 100 mm in diameter and range in length from 0.26 m to 1.0 m. Core No. 8, located in the north buttress was drilled vertically 7.62 m into the bedrock. The core from this hole was less than 50 mm in diameter.

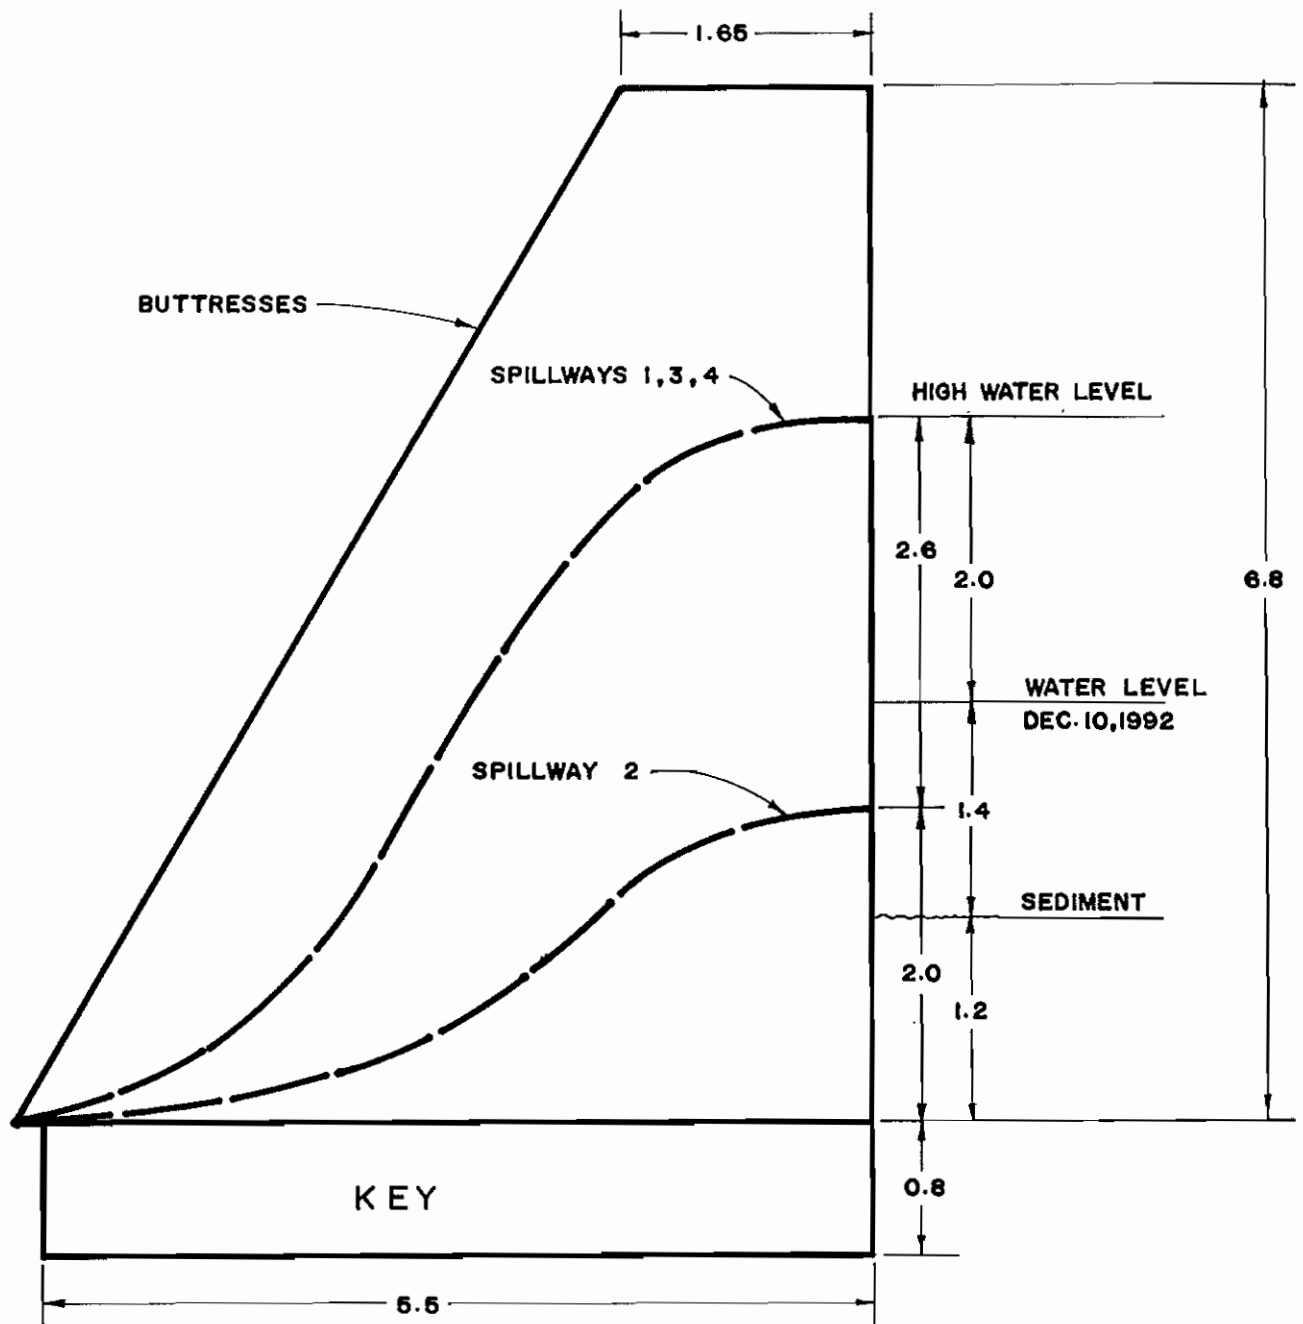
HAMILTON REGION CONSERVATION AUTHORITY
 CROOKS HOLLOW DAM INTEGRITY ASSESSMENT
 CROOKS HOLLOW ROAD
 FLAMBOROUGH, ONTARIO
 DAM CROSS-SECTION

<u>Parameter</u>	<u>Discussion</u>
Dam Profile	The dam profile shown on Drawing 1 and the cross-section shown on Drawing 3 prepared from site measurements, was used for stability computations.
Abutments	The effect of the abutments was not considered in the analysis. The portion of the dam between the outside edges of spillways 1 and 4 was considered. This assumption is considered to be conservative.

The computed factor of safety against overturning under present operating conditions is about 1.9, which is considered to be satisfactory for the existing dam. The safety factor decreases to 1.3 when the weight of the buttresses is omitted.

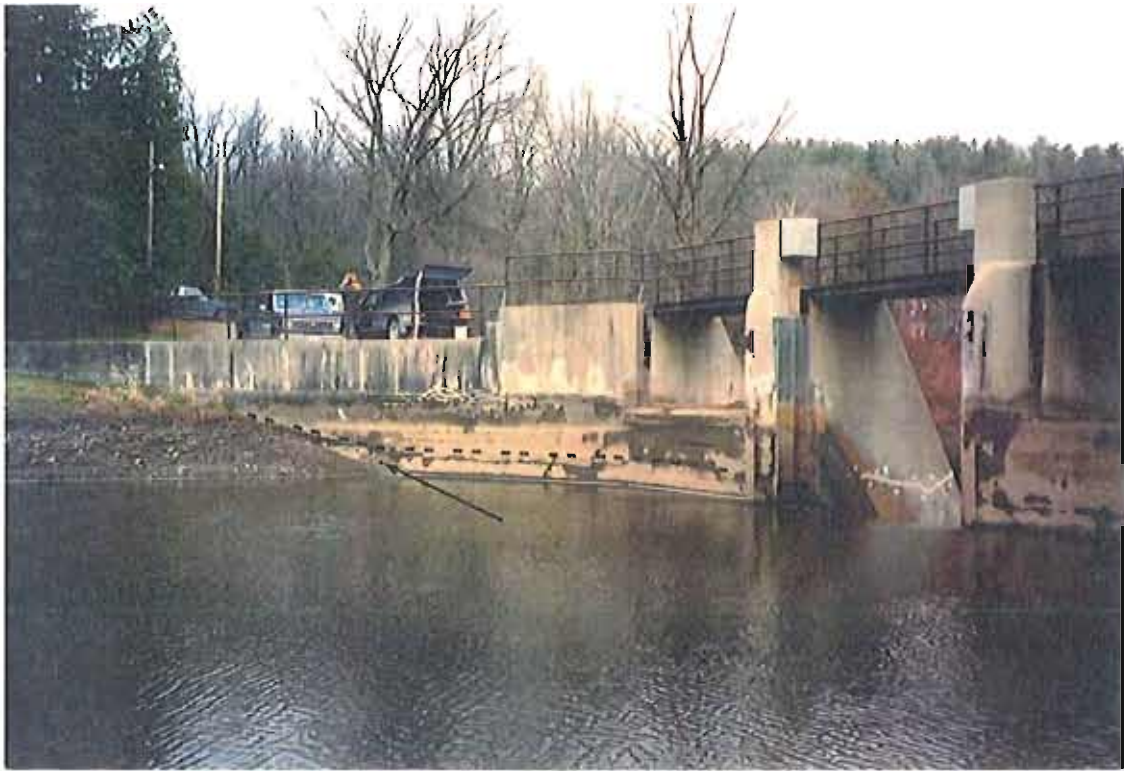
Photograph No. 1 - Upstream face of North Abutment and wing wall show extensive horizontal and vertical cracking with white CaCO_3 deposits along the length. Core No. 3 (arrow) was extracted below the level of shotcrete repairs (dashed line). Note the epoxy injection into buttress 1 as seen through spillway No. 2.

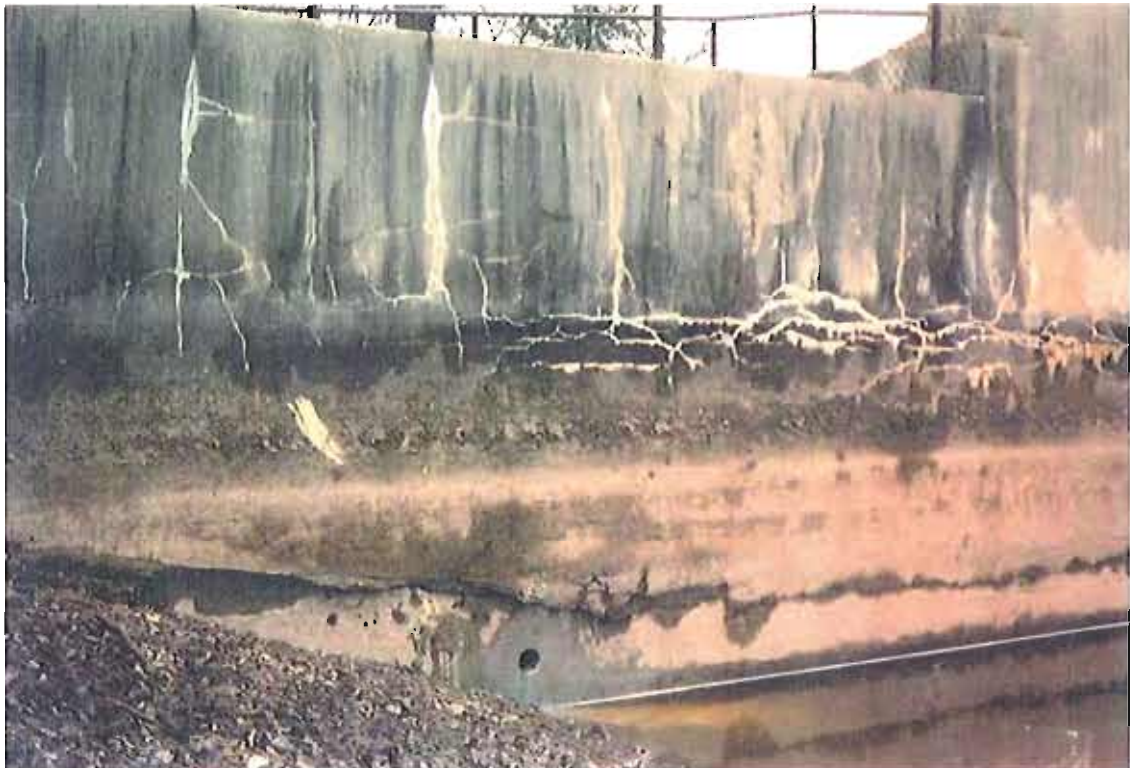
These photographs show that the cracking is primarily horizontal and vertical with some secondary diagonal cracks. The cracks commonly are lined with a deposit of white calcium carbonate (CaCO_3) (Photograph No.'s 2, 6, 7 and 8). These deposits indicate fluid movement along the cracks is leaching calcium (Ca^{+2}) from the cement paste and redepositing it at the crack surface as CaCO_3 . We believe these cracks reflect the condition of the concrete beneath the shotcrete skin. The nature of the cracking suggests the deterioration is a result of freeze-thaw and wetting-drying.

As shown in Photograph No.'s 2, 7, and 9 the most extensive cracking is present in spillways 1, 3 and 4, the south face of the north abutment wall, and the upstream face of the north abutment and wingwall. These areas also show the most intense leaching/re-precipitation along the cracks. Water seepage through these cracks was noted along a portion of a crack in the south face of the north abutment at the same elevation as the top of the downstream wingwall (Photograph No. 9). Near the top of the spillway 4 water seepage was also noted along a portion of a horizontal crack (Photograph No. 6). Although other sections of the dam also show cracking and leaching/re-precipitation, the intensity of these features is considerably less.

Photograph No. 2 - Upstream face of North Abutment.

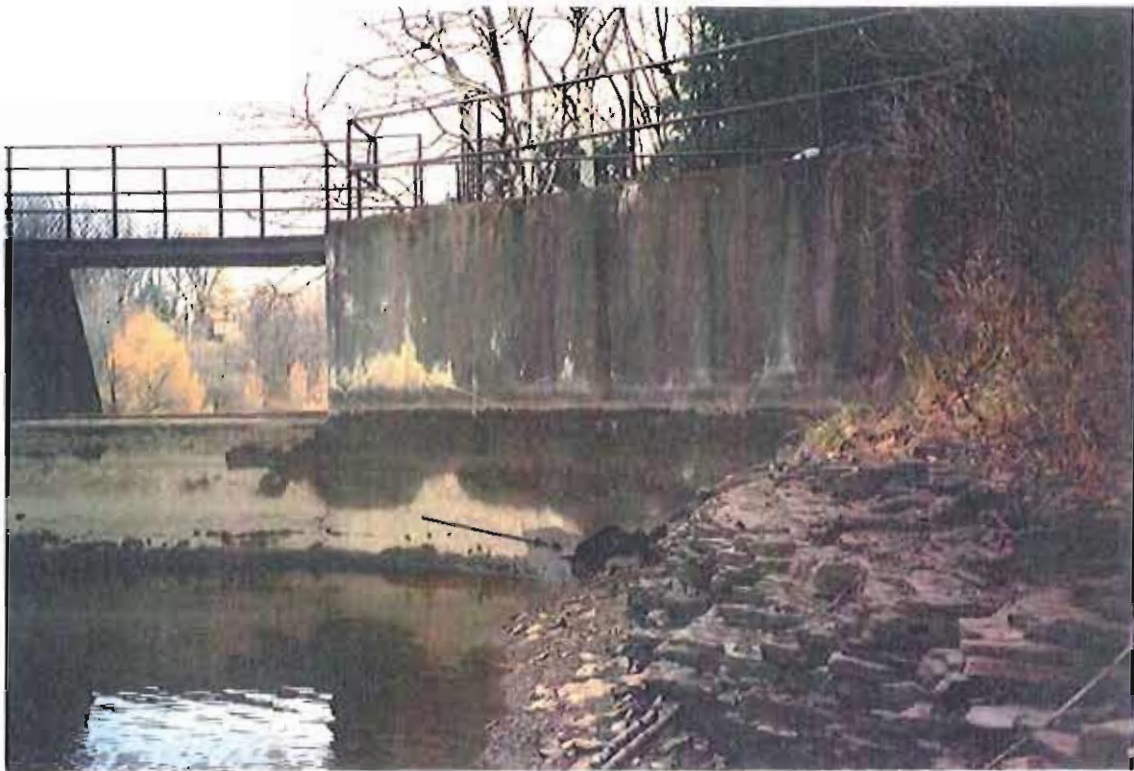
Core No.'s 3 and 4 were taken from the upstream faces of the north and south abutments below shotcrete repair patches, just above the present water level. Core No. 3 reveals good quality sound concrete in the north abutment. Core No. 4 fractured upon extraction from the south abutment, the cracking occurring along the paste-aggregate contact of two cobble-sized particles in the core. The fracture surfaces show extensive leaching and CaCO₃ re-precipitation.

Photograph No.3 - Upstream face of South Abutment at right and spillway No. 4 at left. Note that the intensity of cracking and leaching is less on this face than on the North Abutment. The arrow indicates the location of core No. 4.

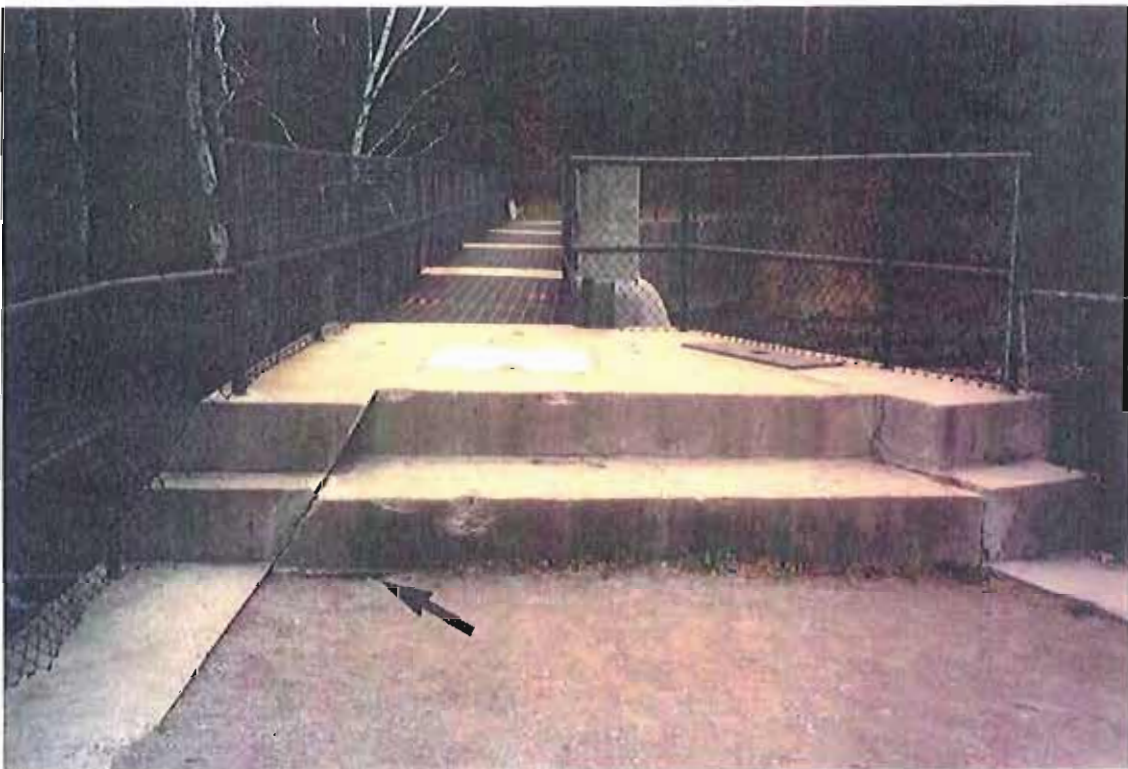
The location of the settlement is shown on photograph No. 4.

Two possible causes of the settlement consistent with the observed occurrences after major rainfalls are postulated:

- i) Erosion of materials from within the abutment , by rainwater infiltration and seepage.
- ii) Poor compaction of the abutment backfill material.

Photograph No.4 - Looking south from the north shore across the walkway over the dam. Note the slight undercutting of the steps at the lower left (arrow).

The impact of the loss of ground on dam stability is difficult to assess without determination of the cause. Considering the upstream concrete wall and the minor nature of the problem, we do not believe the problem is significant at this time. However, it is recommended that further exploratory work including boreholes within the backfill and examination within the maintenance chamber (following removal of the contained water) be carried out to define the cause.

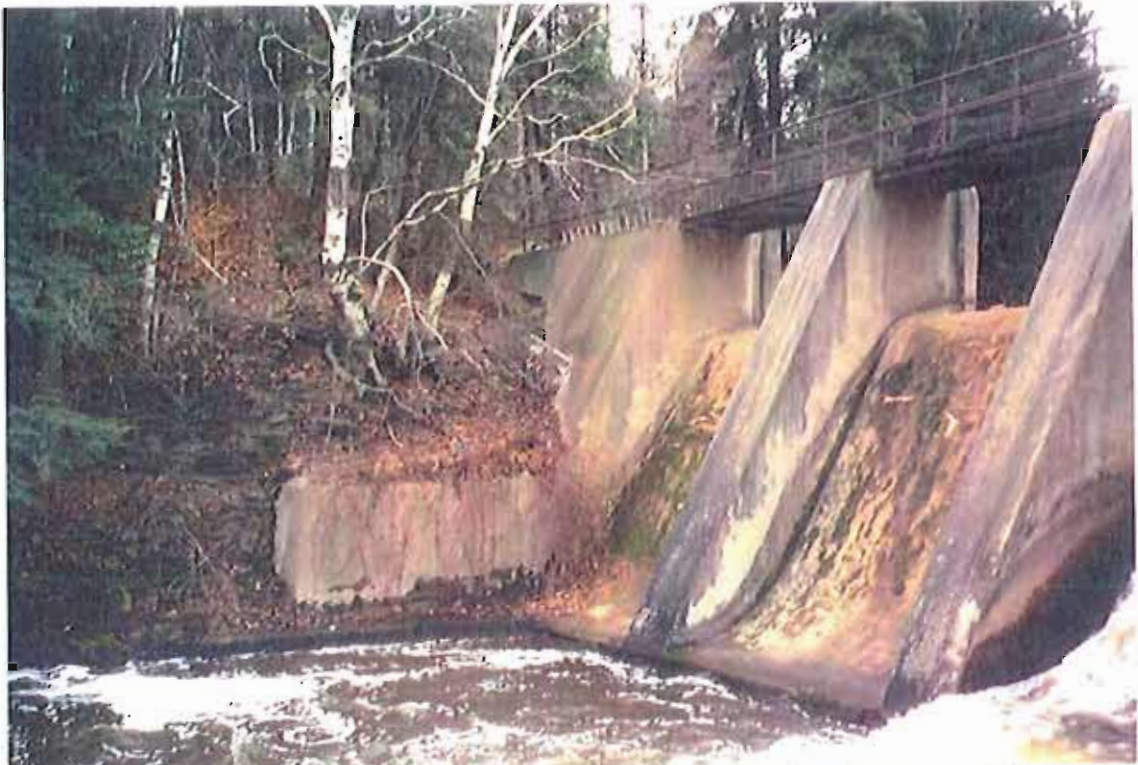
Photograph No. 5 - Downstream face. South shore. Note the cracking and leaching of the south abutment as well as spillway 4 and 3 (fore ground).

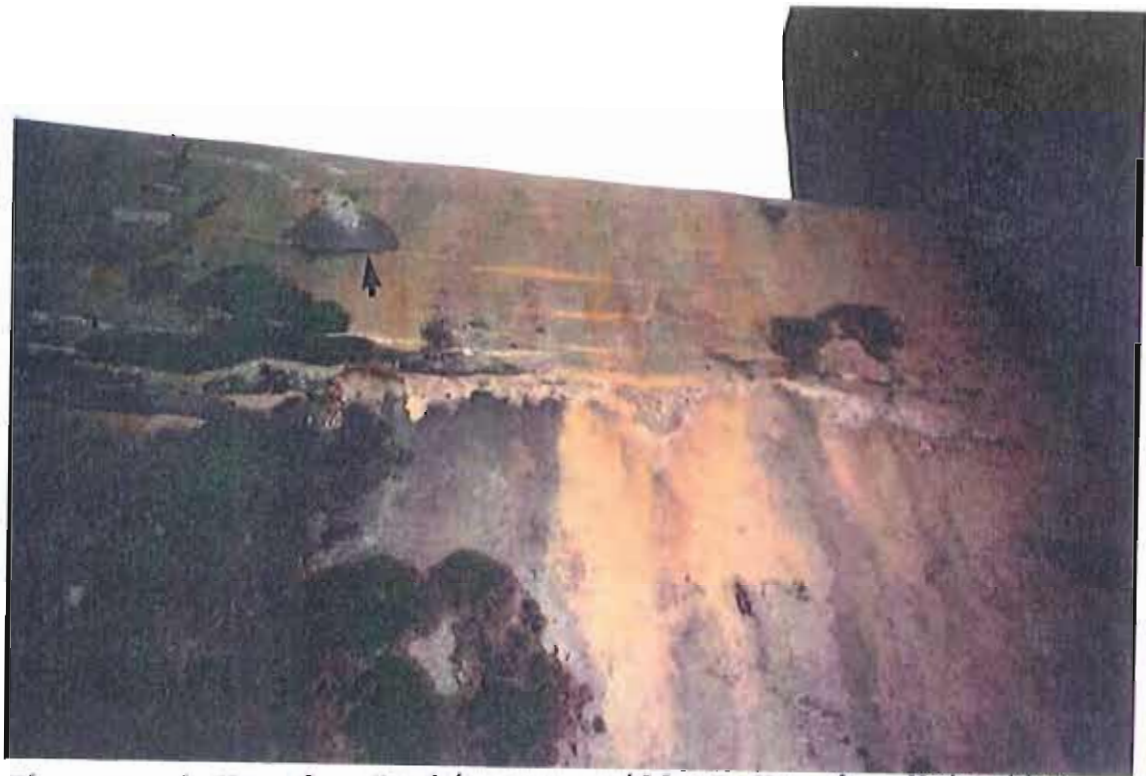
Photograph No. 6 - Looking up spillway No. 4. Note the horizontal and vertical cracking with calcite deposits. Also, the arrows indicate cracks with water seepage.

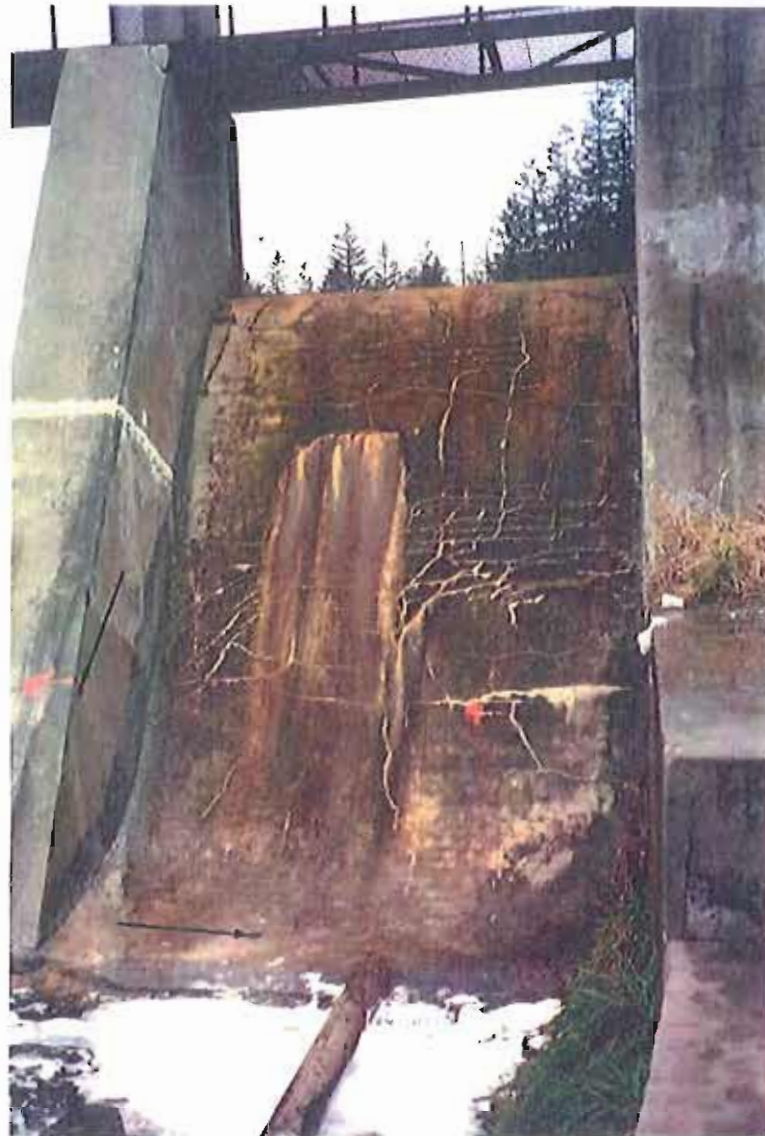
Erosion of materials below the problem area may occur due to washing out of material through cracks in/under the abutment walls. However, no eroded material is evident at the base of the abutment (Photograph No.'s 7 and 9) and the exit location is not apparent. It is noteworthy that the maintenance chamber was flooded; sediment may be accumulating on the base of this room.

Photograph No. 7 - Downstream face of spillway No. 1. The arrows show the locations of core No. 1 in the buttress and core No. 2 in the toe of the spillway. Core No. 8 was drilled vertically into the top of the buttress. Note the intensity of cracking on the spillway face as the result of freeze-thaw and wetting-drying effects.

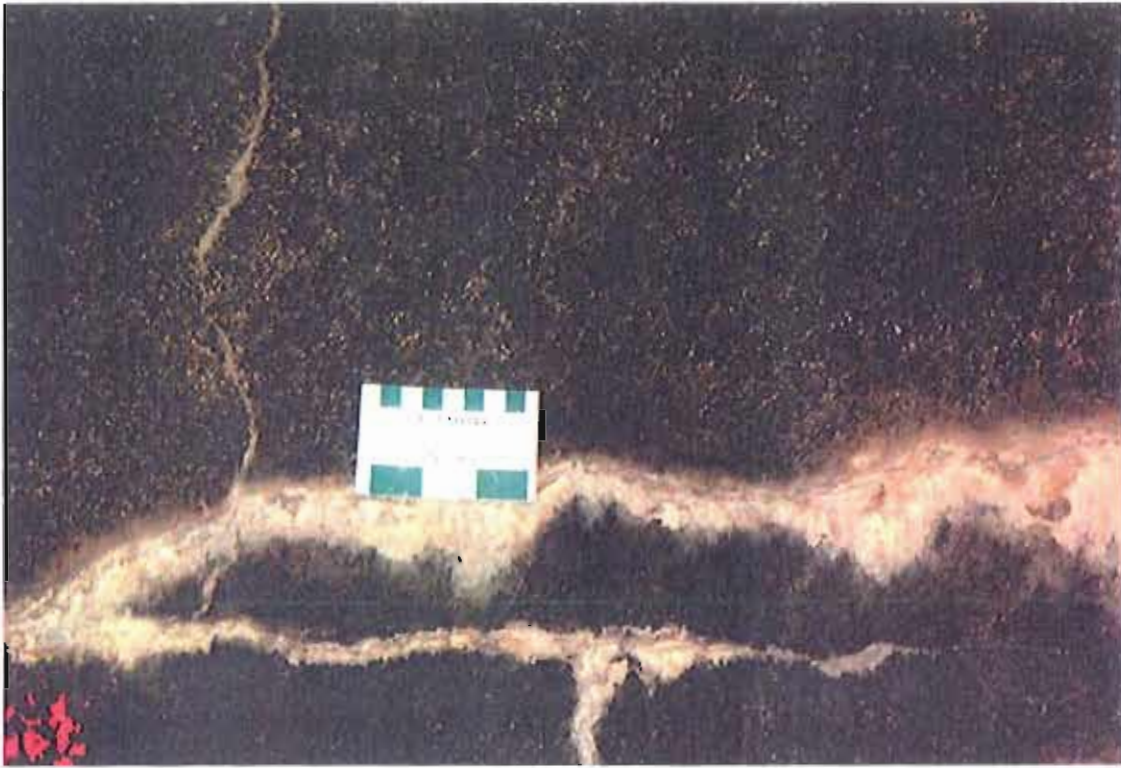
Photograph No. 8 - A close-up of freeze-thaw cracking of the shotcrete repairs with a crust of white calcite. The crust is the result of water migrating along the cracks and leaching Ca^{2+} from the cement paste. As the fluids are exposed to the surface Ca^{2+} is deposited as CaCO_3 .

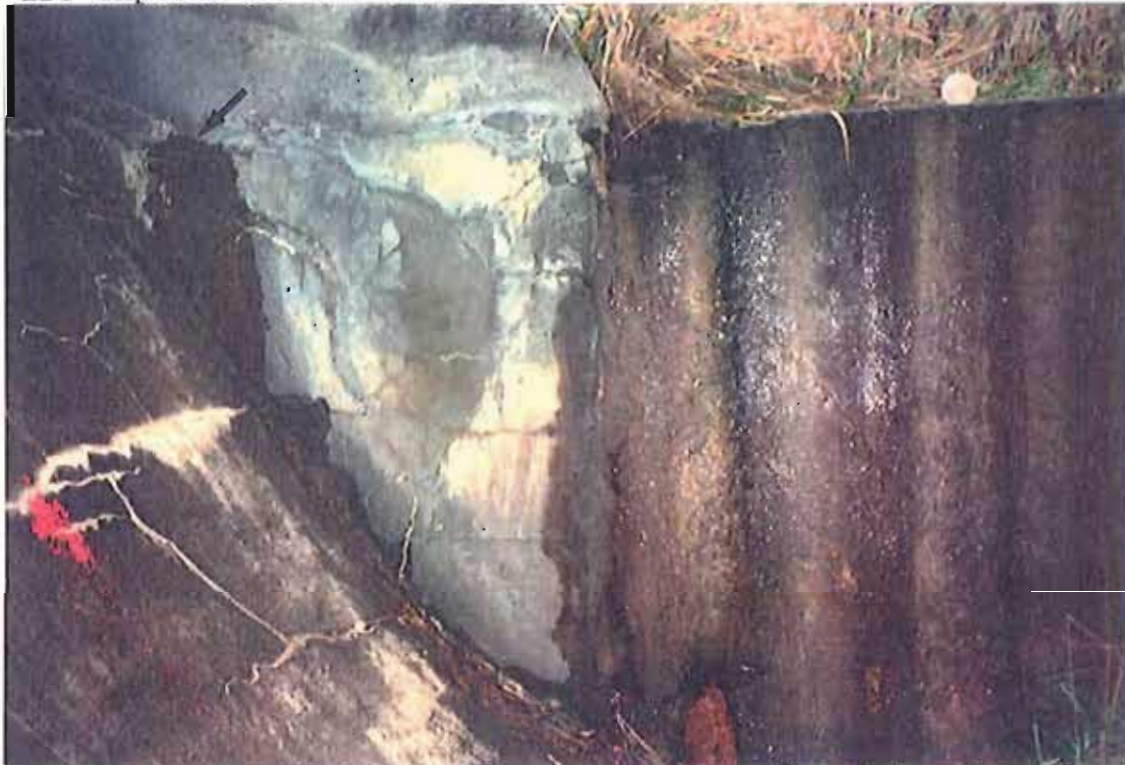
It should be noted that visual observation on site as well as in the core samples reveals that leakage of water through that dam is occurring during the summer months. The degree of ongoing remedial work required to maintain the structure could be reduced significantly by implementing measures to prevent seepage of water through the dam.

Photograph No. 9 - South face of north abutment and wingwall on the downstream side. Note the water seepage (arrows) through cracks in the abutment. Extensive water seepage also occurs over the face of the wingwall (at right).

We believe the application of a durable waterproofing membrane on the upstream face of the dam will be most cost effective. Epoxy injection of the cracks could also be considered. However, due to the large number of cracks throughout the dam, this procedure will be expensive and may not be successful unless provision is made to conduct a secondary injection program to fill any cracks that may have not been sealed during the initial application.

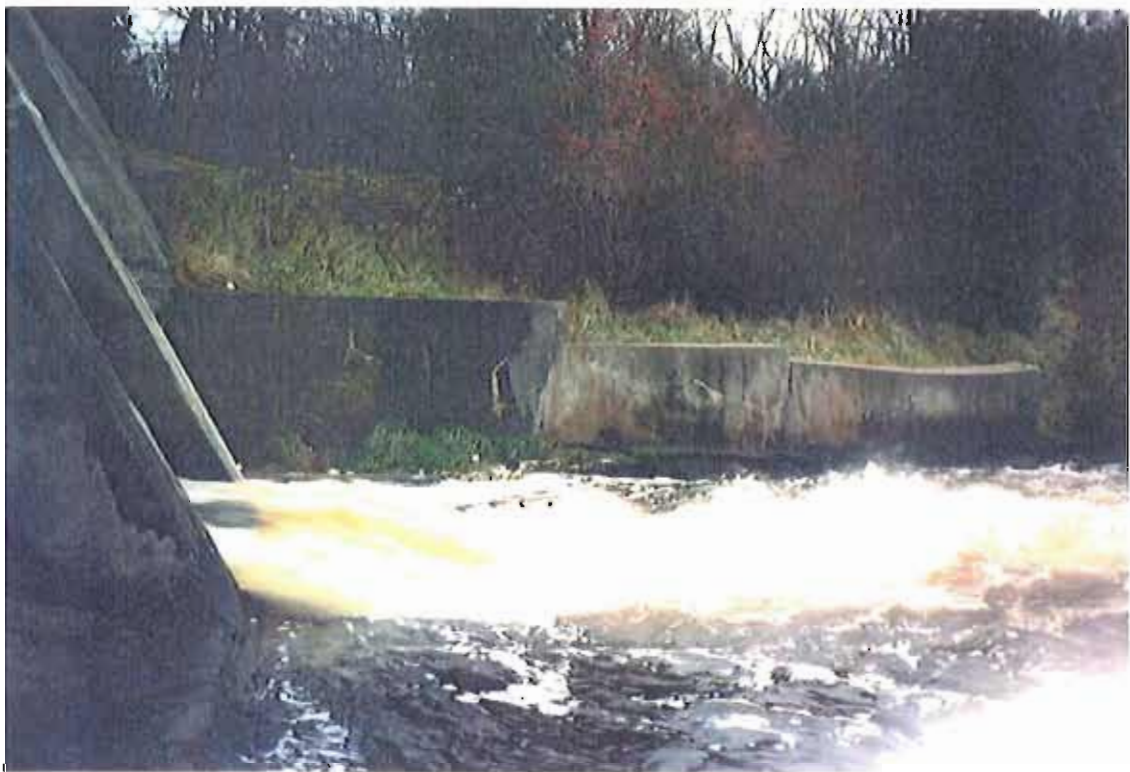
Photograph No. 10 - Downstream side of wingwalls on north shore.

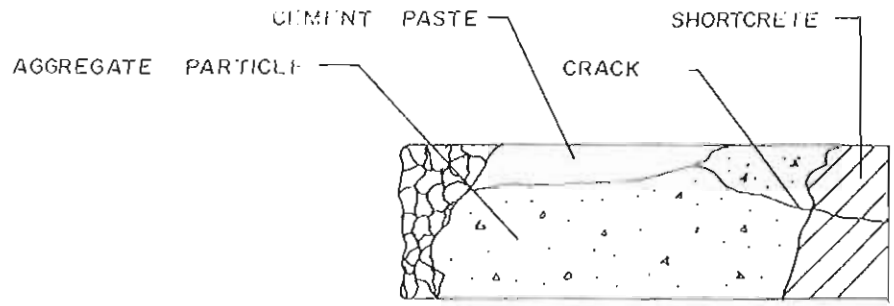
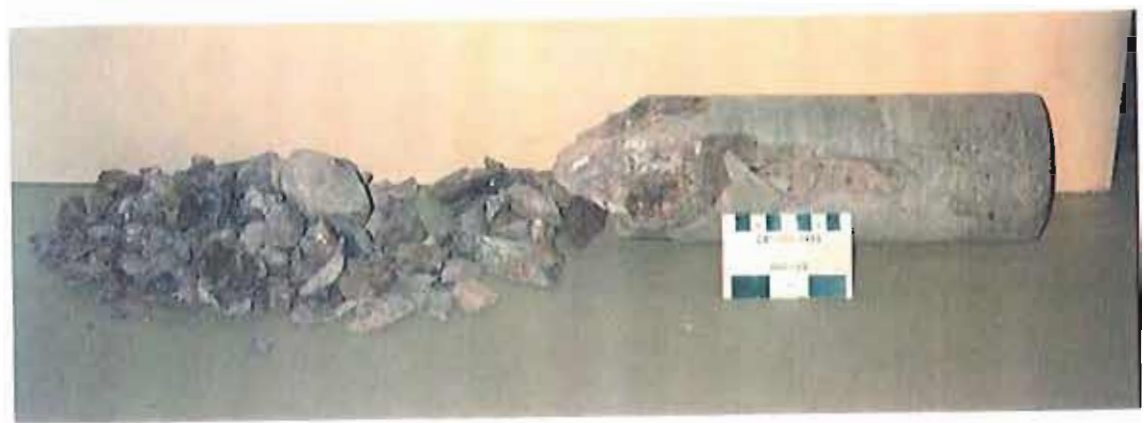
CORE NO. 1

Core No.'s 1 and 7 were drilled horizontally into the north and south buttresses, respectively. The concrete underlying the shotcrete layer in both buttresses is severely distressed such that the drilling operation reduced the cores to rubble. The poor condition of the concrete restricted drilling in both buttresses to less than 0.5 m.

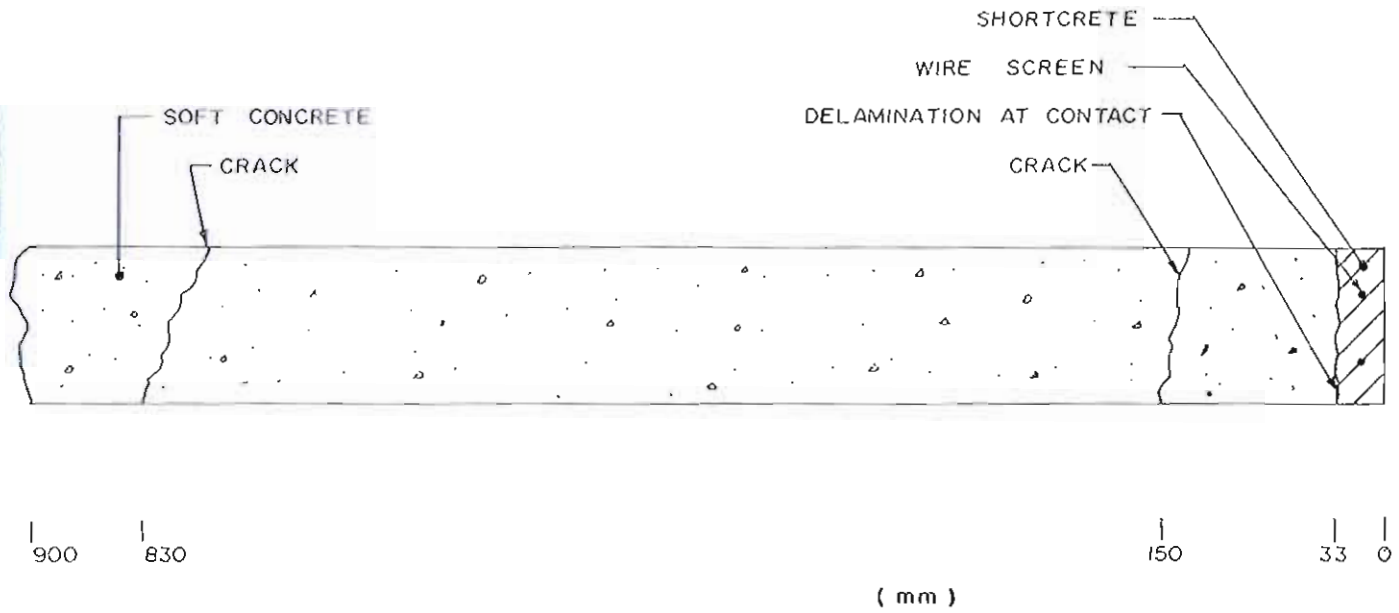
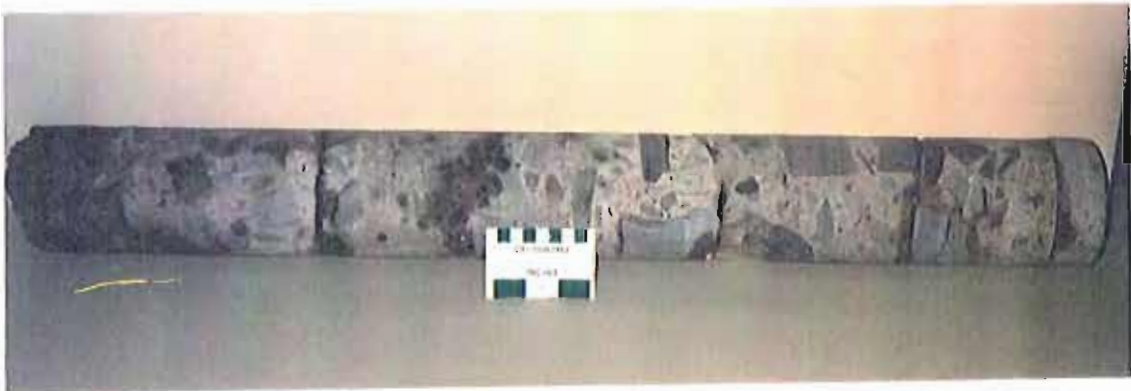
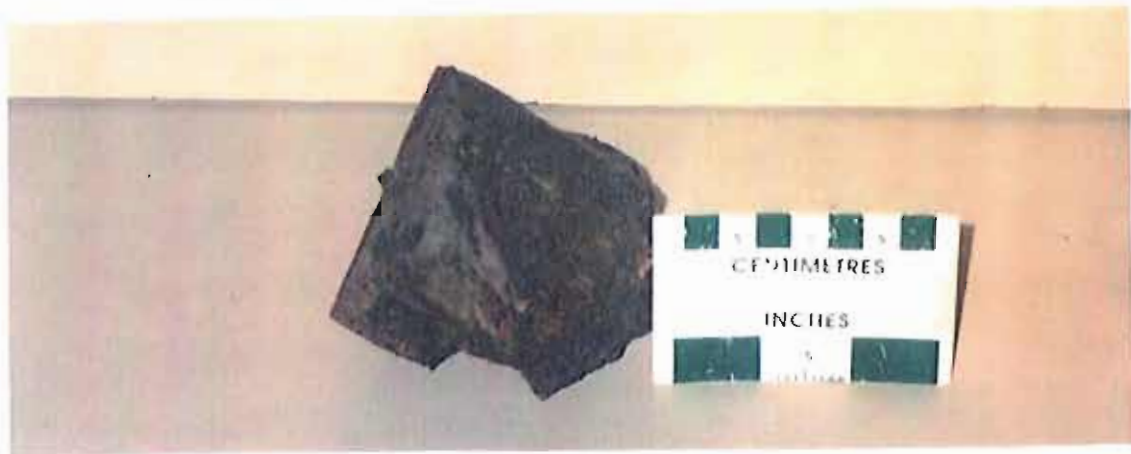
CORE NO. 2

With the exception of Core No.'s 3 and 4, all of the cores intersected the outer layer of shotcrete. This layer ranges in thickness from 33 mm to 105 mm and typically is well bonded to the underlying concrete. In core No.'s 2 and 6 which were drilled at the toe of spillways 1 and 4, respectively, the shotcrete appears to have debonded from the underlying concrete. In core No. 2 a thin layer of CaCO₃ covers the surface of the delamination. It should be noted however that the shotcrete at the bottom of the spillways is still intact.

Good quality concrete was intersected below the surficial layer of concrete in spillways 1 and 4. Occasional horizontal cracking was intersected in both cores with CaCO₃ deposits present along all of the crack surfaces. The lower 0.1 m of core No. 2 intersected a very soft section of concrete in which the cement paste and fine sieve sized fractions of the sand have been removed. This material is weakly cemented.

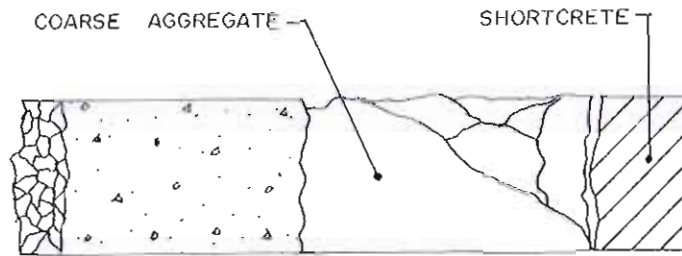
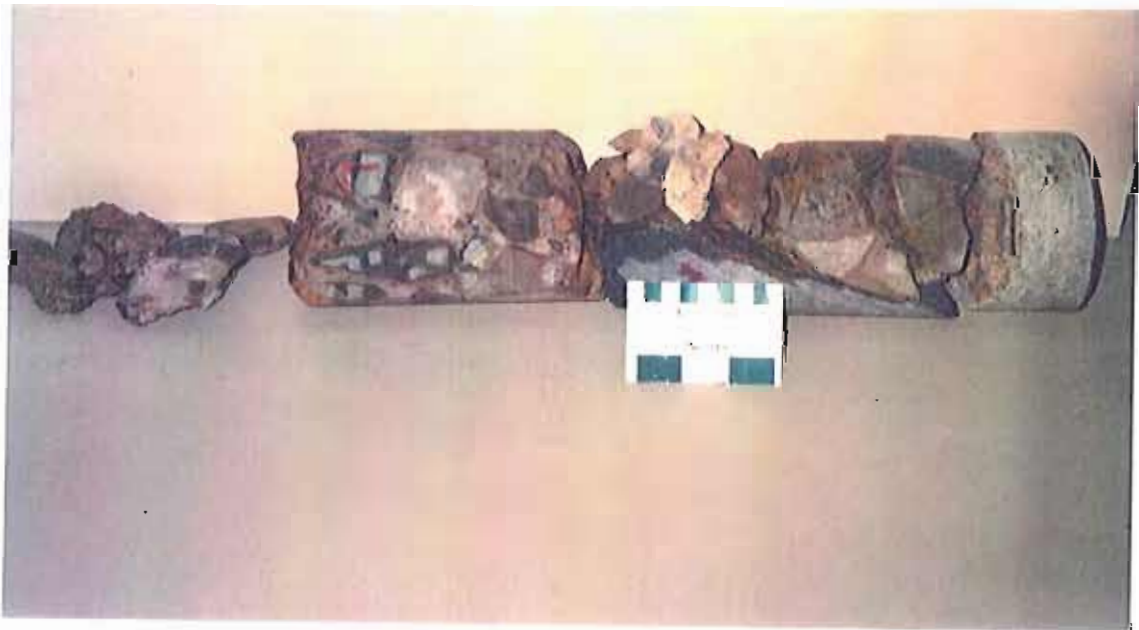
CORE NO. 5

Core No. 5 was drilled into the downstream face of the south abutment. The concrete underlying the shotcrete repairs is intensely cracked such that over half of the extracted core is rubble.

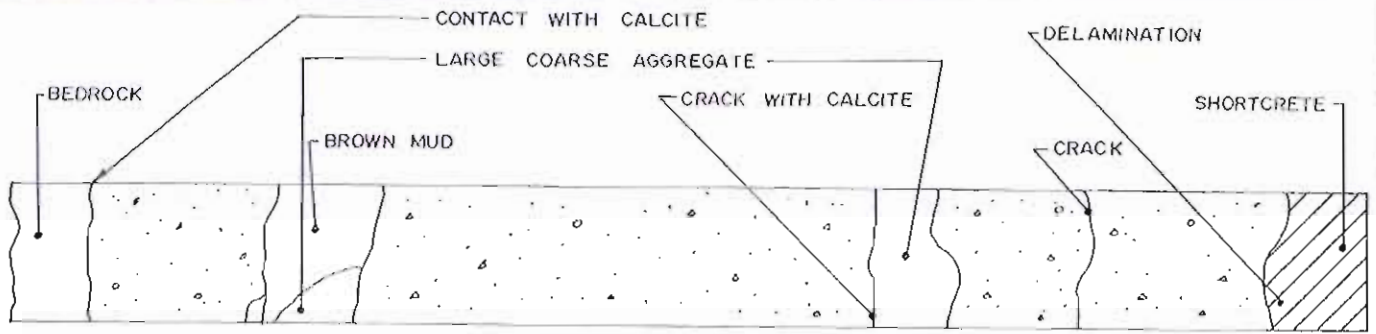
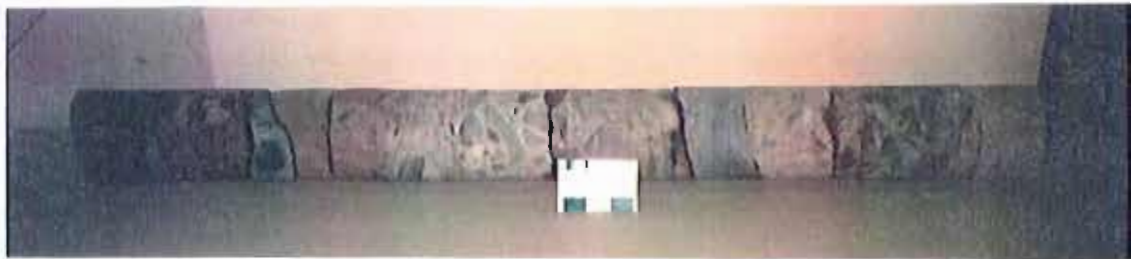
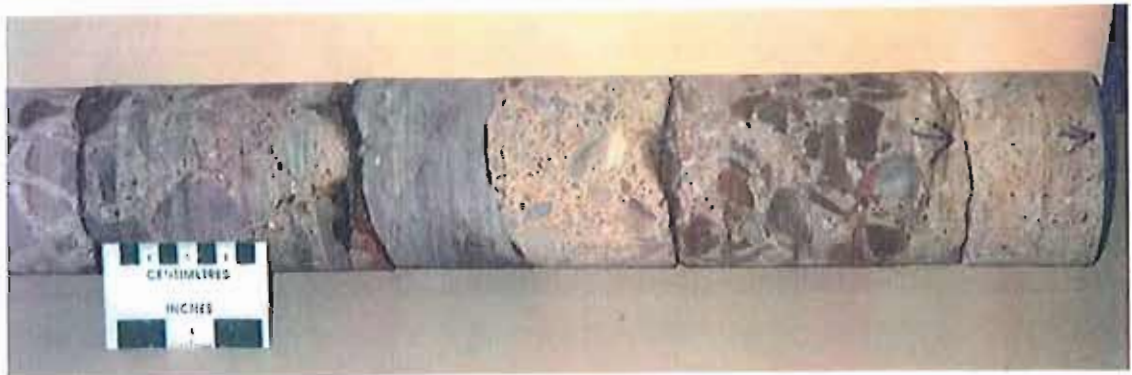
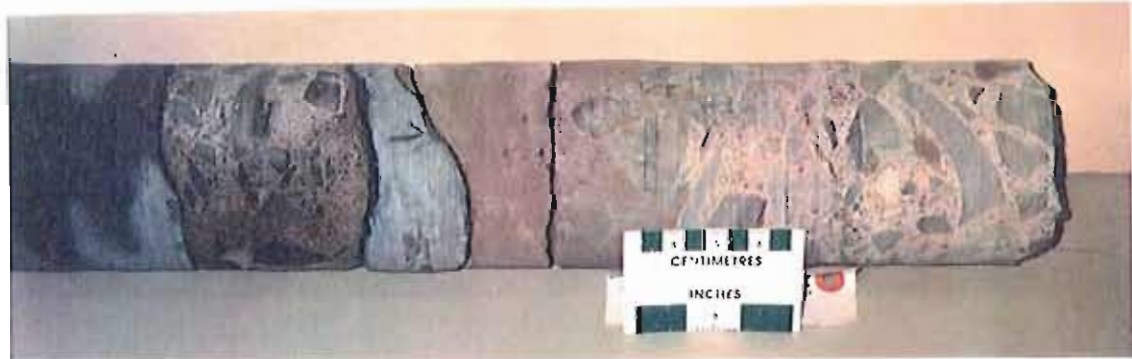
CORE NO. 6

From 0.75 to 0.82 m in core No. 6 a layer of reddish brown mud was intersected. This layer is intimately mixed with the concrete suggesting the mud had contaminated the concrete during its initial placement.

Core No. 6, which was advanced to a depth of approximately 1 m intersected bedrock at 0.9 m. The bedrock-concrete contact was weakly bonded and broke during extraction of the core. The contact surface shows minor CaCO₃ deposits. Bedrock was not contacted in core No. 2 at a depth of 0.9 m.
