CROOKS HOLLOW DAM
INTEGRITY ASSESSMENT
CROOKS HOLLOW ROAD
TOWN OF FLAMBOROUGH, ONTARIO
FOR
HAMILTON REGION
CONSERVATION AUTHORITY

Job No. 92HF137

February, 1993

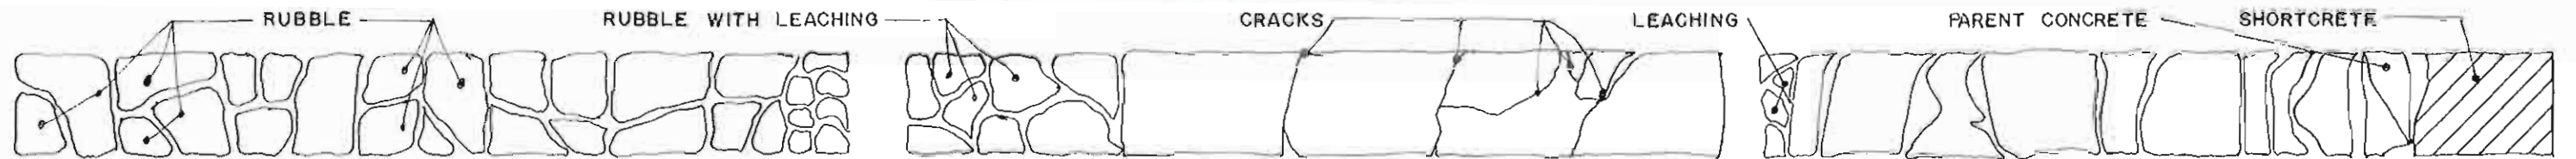
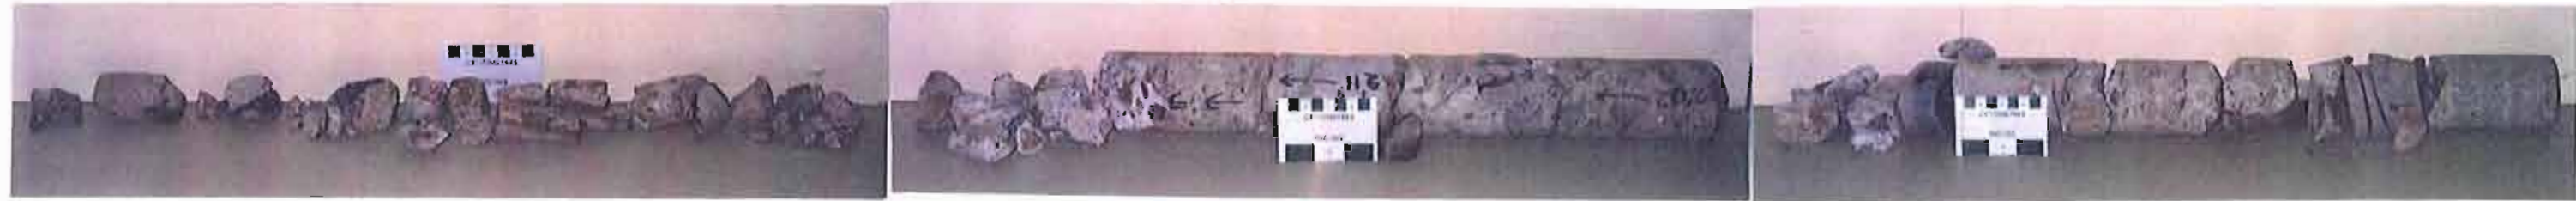
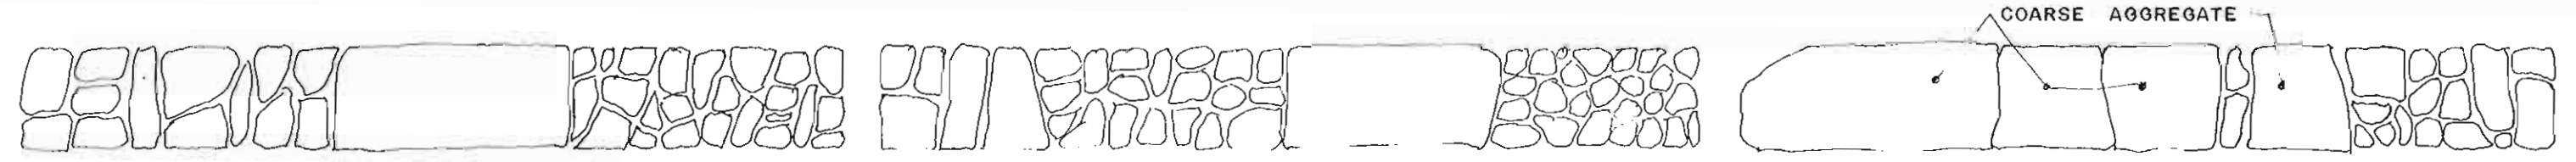
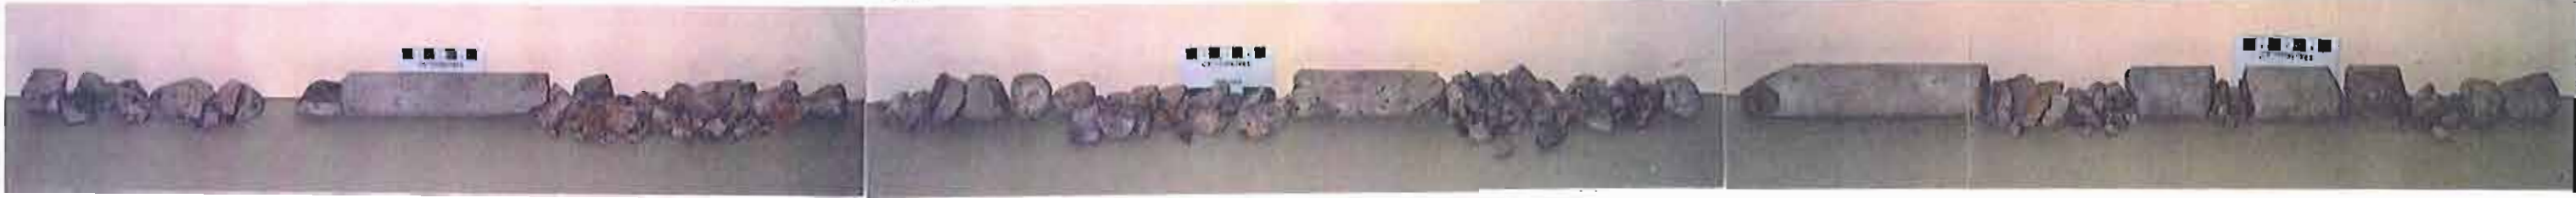
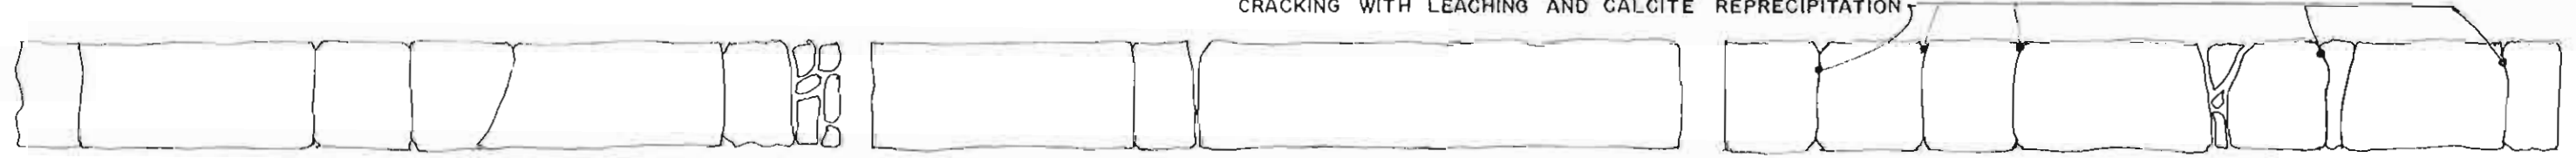
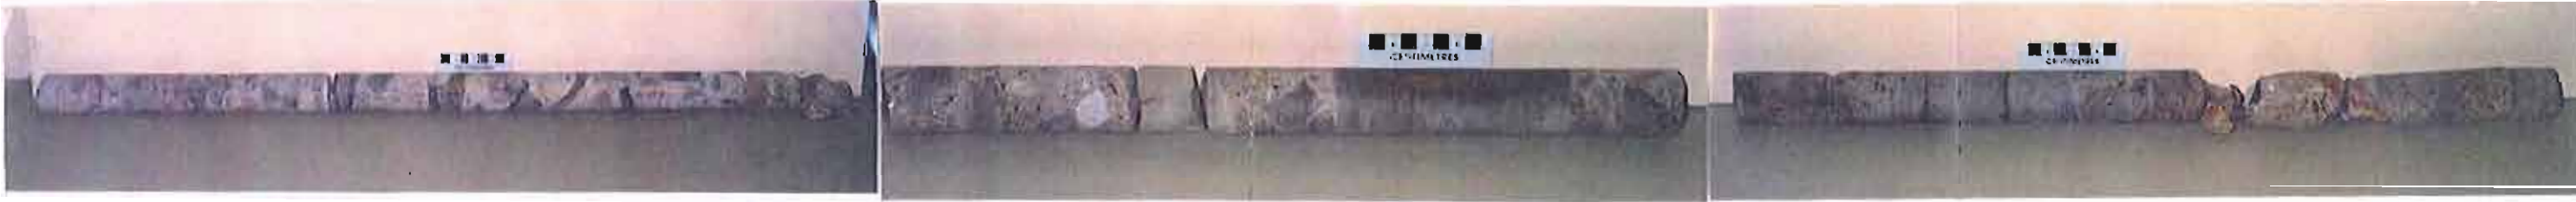
CORE NO. 8

This condition is most obvious in the log of core No's 1, 7 and 8. Core No. 8 shows that the upper 4 to 5 meters of the buttress is badly delaminated. It should be noted that the north side of this

CRACKING WITH LEACHING AND CALCITE REPRECIPITATION
