Hamilton Conservation Authority
Ancaster, Ontario

Dam Stability and Condition Assessment

Crooks' Hollow Dam

Final Report
July 2007

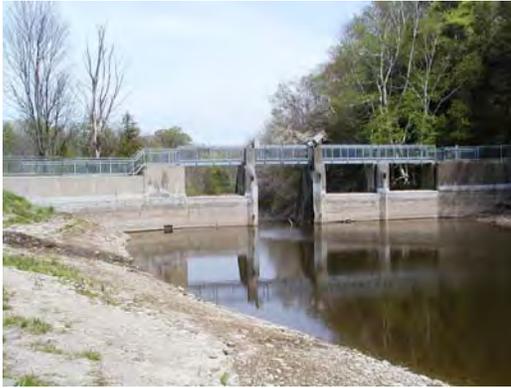
Upstream Face of Dam

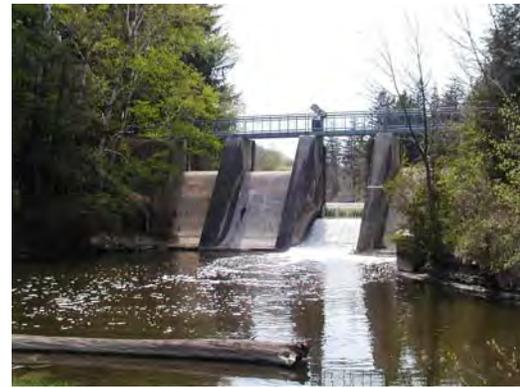
Downstream Face of Dam
