Hamilton Conservation Authority

Completion Report

Crooks' Hollow Dam Removal and  
Restoration of Spencer Creek

June 7, 2013

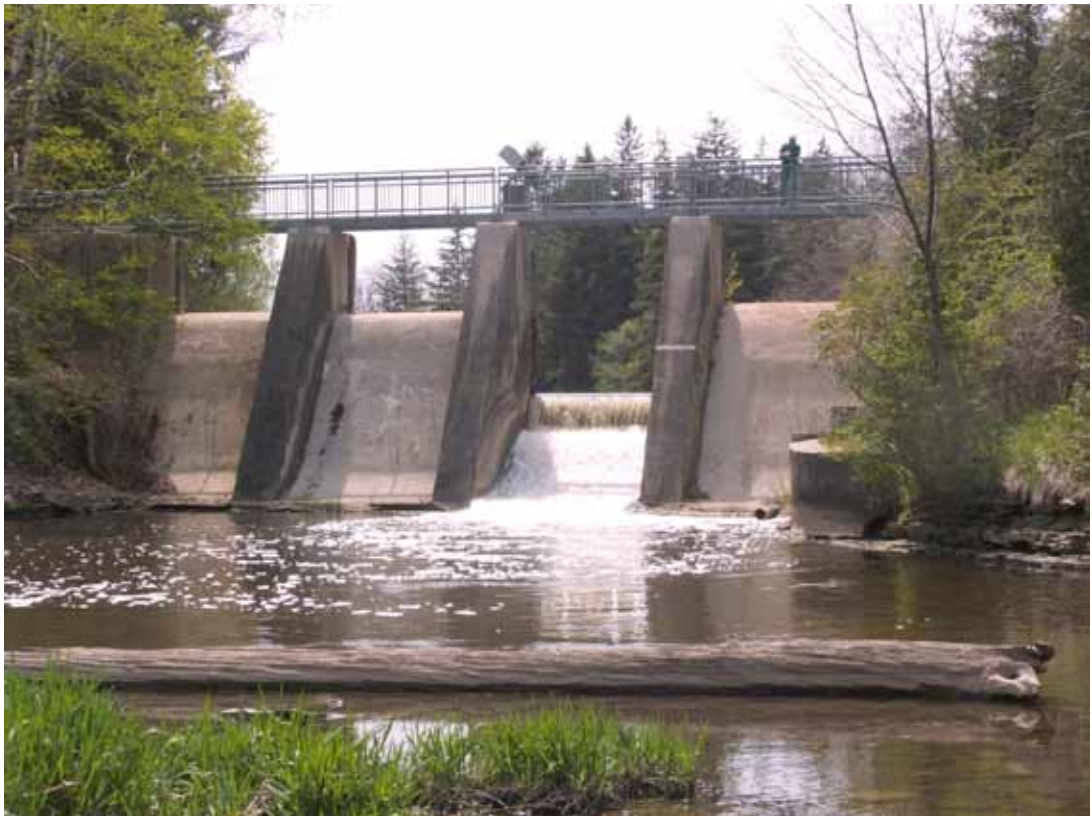
**Figure 1-1 A View of Crooks' Hollow Dam from Downstream Side Prior to Decommissioning**

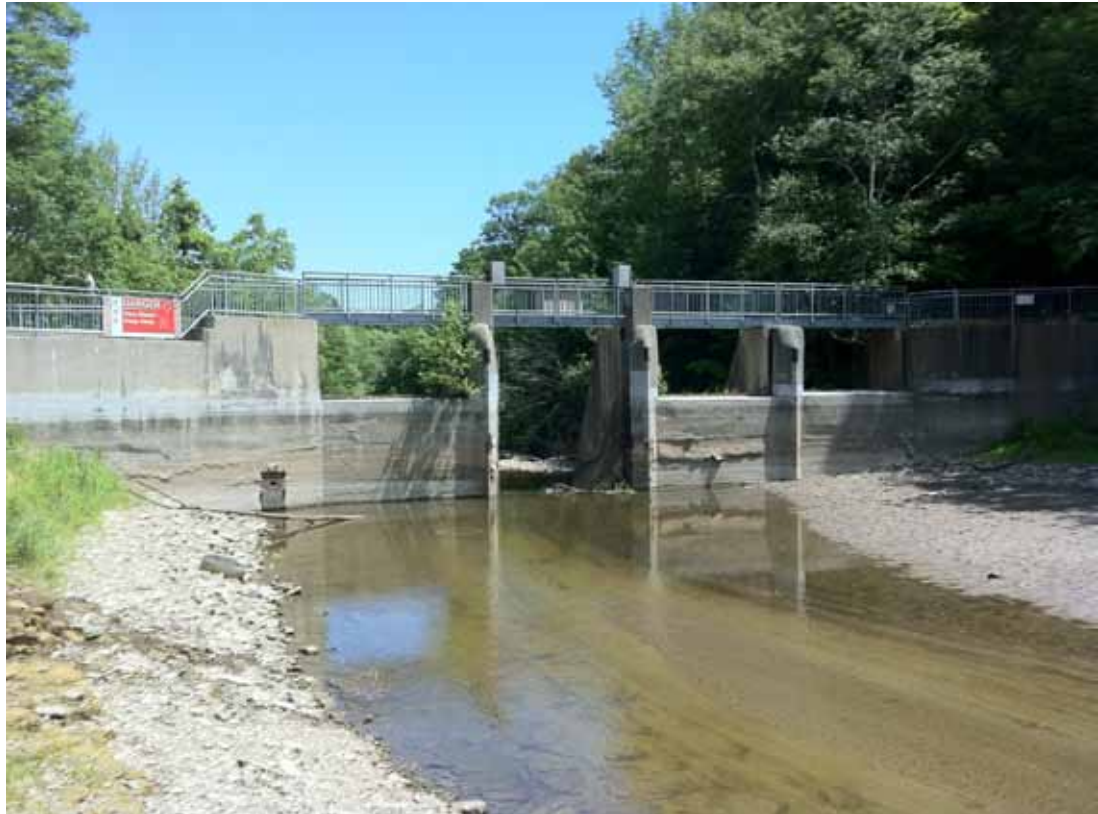
Condition assessments of the dam carried out in 1968 and 1976 (William L. Sears) identified enough concern about the integrity/stability of the dam that the normal operating water level was lowered to reduce the loads on the structure during major storm events. Subsequent assessments in 1993 (Peto MacCallum Ltd.) identified the poor condition of the concrete and notably, the spillway piers, which exhibited severe concrete delamination and cracking (see Figure 2-1). The dam was considered to be stable under current operating conditions, and for short-term increases in water levels up to 1.5 m above spillway Numbers 1, 3 and 4 (elev.  $\pm 218.82$  m) in the event of a major storm event. However, the dam was not considered to be able to withstand the force of a major storm event if the normal operating water level was maintained at its original design operating level of 1.8 m above the top of spillways Numbers 1, 3 and 4 (elev.  $\pm 219.12$  m).

**Figure 2-1 A View of the Upstream Face of Crooks' Hollow Dam Showing Concrete Wear and Cracking**

In 2011, the Crooks' Hollow Dam was over 95 years old and although minor repairs were periodically carried out over the years, no significant rehabilitation work had been done. The dam was nearing its useful life expectancy and was in substandard condition. Recent engineering studies confirmed that the dam would require corrective rehabilitation to ensure its safe operation under major storm events or it should be decommissioned and either removed or modified into an overflow weir.

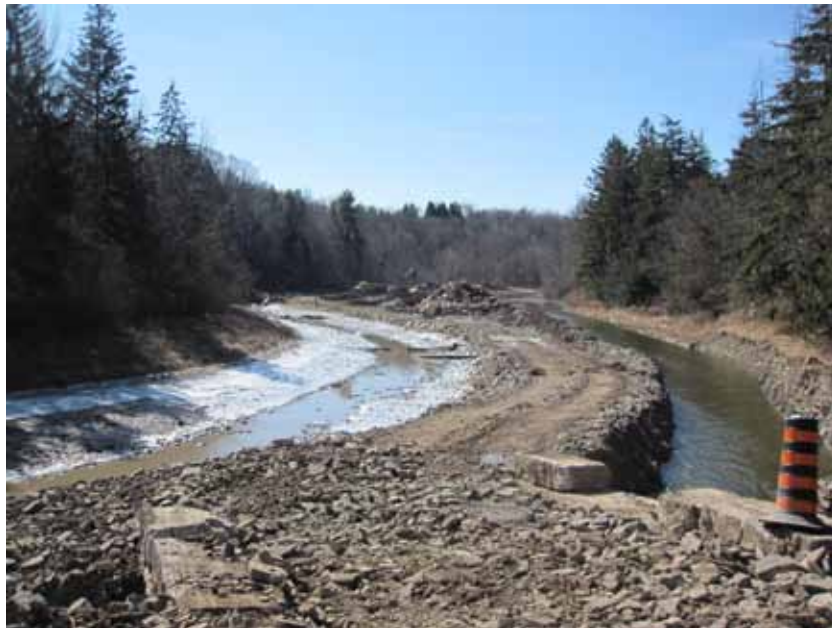
The first stage of the diversion channel passed flowing water in front of the dam and through the dam spillway, to allow for (i) upstream excavation work, (ii) riffle construction and (iii) creek bank restoration. A later second stage of the diversion channel re-routed the creek flow around the north side of the dam once the northern wing-wall was removed, allowing for (i) dam demolition, (ii) downstream excavations, riffle construction and bank restoration activities to ensue (see Figure 5-1).

**Figure 5-1 Diversion Channel (Right Side) Created to Facilitate Construction and Dam Decommissioning Activities**

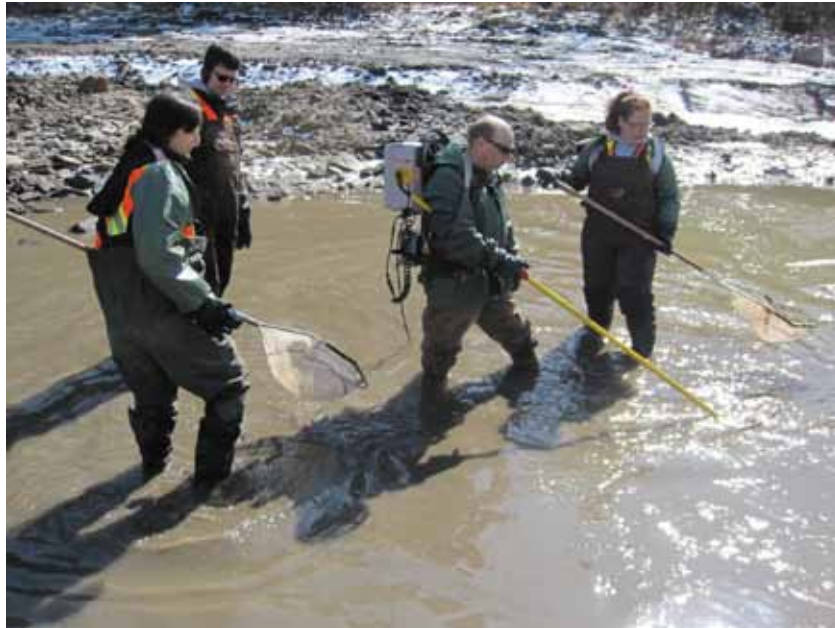
The fish rescues were conducted with a backpack electrofishing unit (see Figure 5-2). The electrofishing unit was set on pulse power to the requirements of the decommissioning site (between 250 to 350 volts, frequency 60hz.). A seine net was used to collect fish where a backpack electrofishing unit could not be used due to low conductivity levels and depth. A seine net was utilized to collect fish from the plunge pool downstream of the dam.

**Figure 5-2 HCA and MNR Biologists Conducting a Fish Rescue Upstream of the Dam Site**

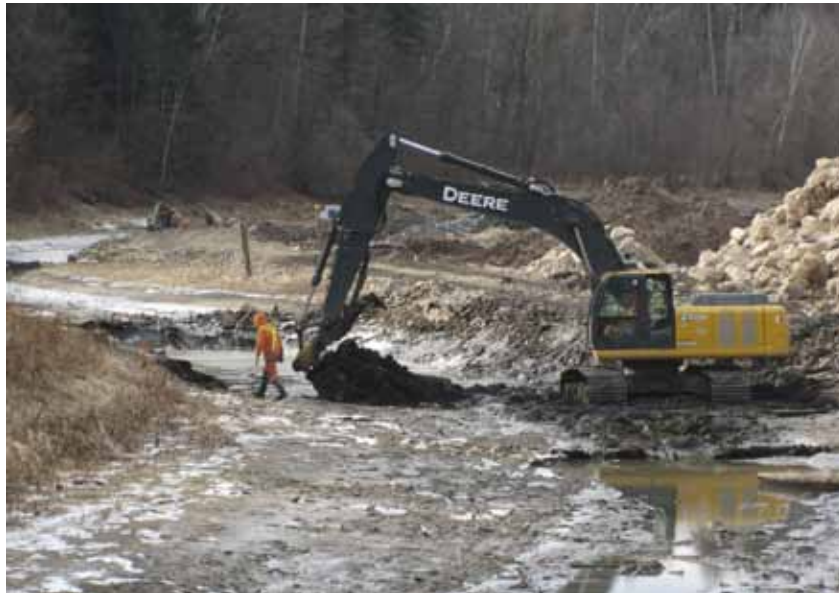
**Figure 5-3 Sediment Being Excavated from the Creek Bed During Construction Activities**

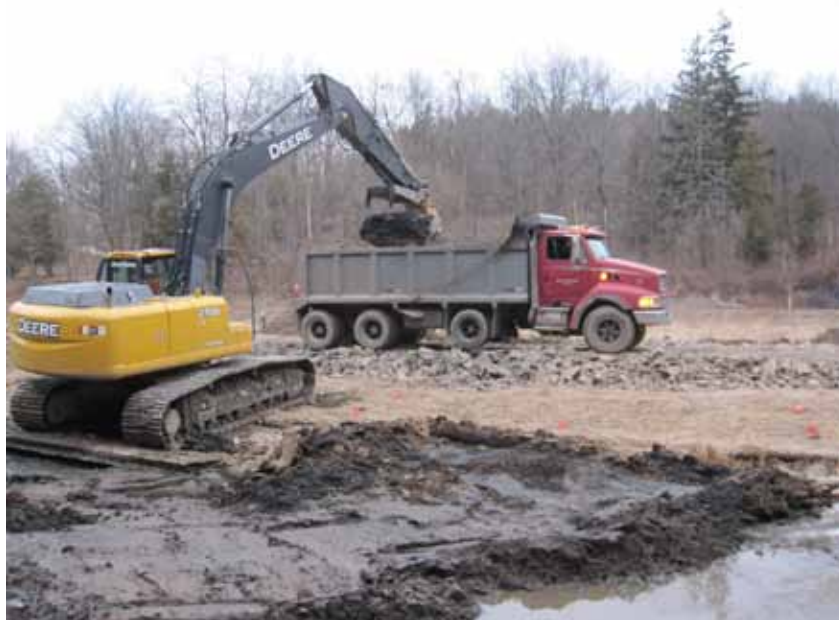
Excavation and removal of the Hg-impacted sediment commenced on Tuesday, February 28, 2012 and was finalized on Wednesday February 29, 2012. Prior to any excavations, the Hg-impacted area on site was carefully delineated by the construction workforce, with guidance from detailed Hatch drawings and an onsite, Hatch environmental representative. Several Panda Environmental, tri-axel dump trucks were retained by the contractor for transport of the Hg-impacted sediment off-site, for final disposal at Newalta Landfill in Stoney Creek, Ontario (see Figure 5-5). Trucks were kept in rotation until all Hg-impacted sediment was removed from the site.

**Figure 5-5 Mercury-Impacted Sediment Being Excavated from Creek Bed and Taken Offsite for Safe Disposal**

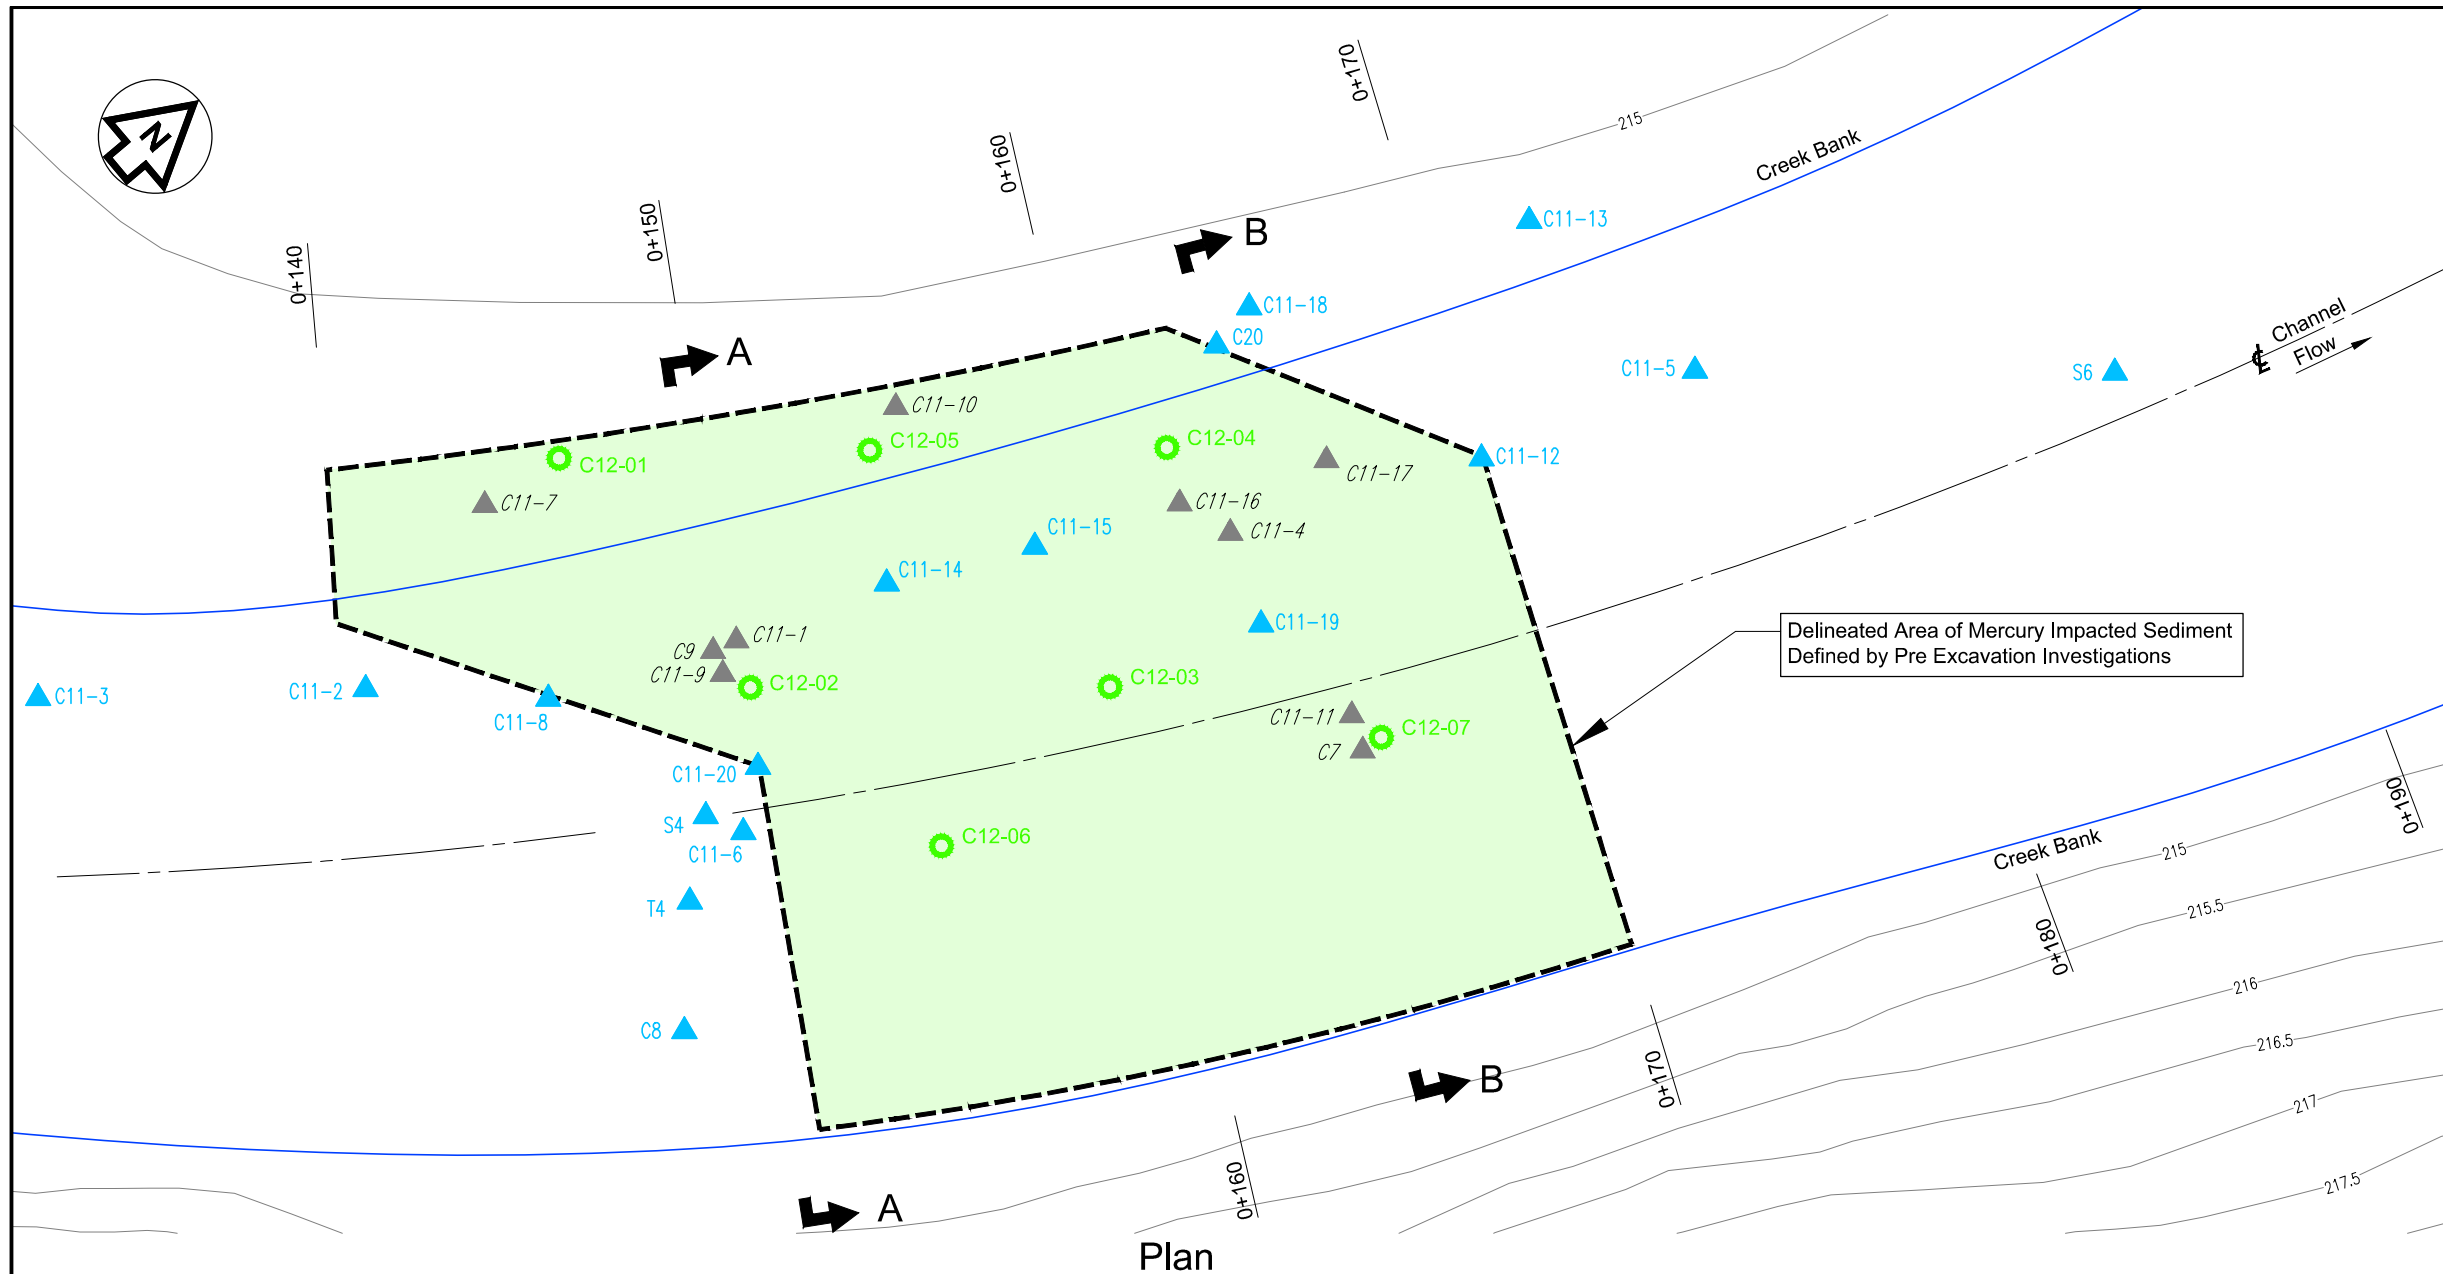
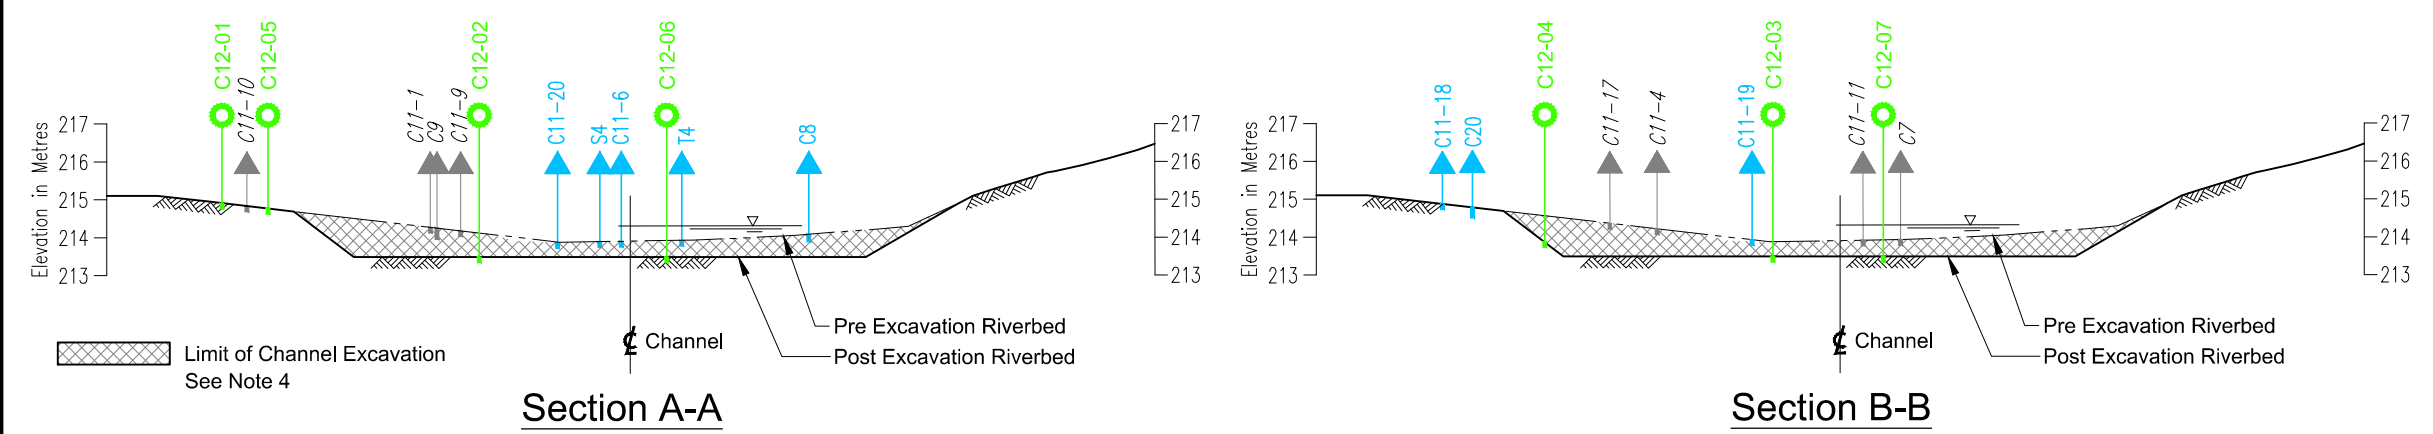
Figure 5-6 includes a detailed drawing and cross-section of the Hg-impacted sediment area that was excavated at the site. Pre and post excavation sampling locations with associated mercury concentrations are included in the drawing.

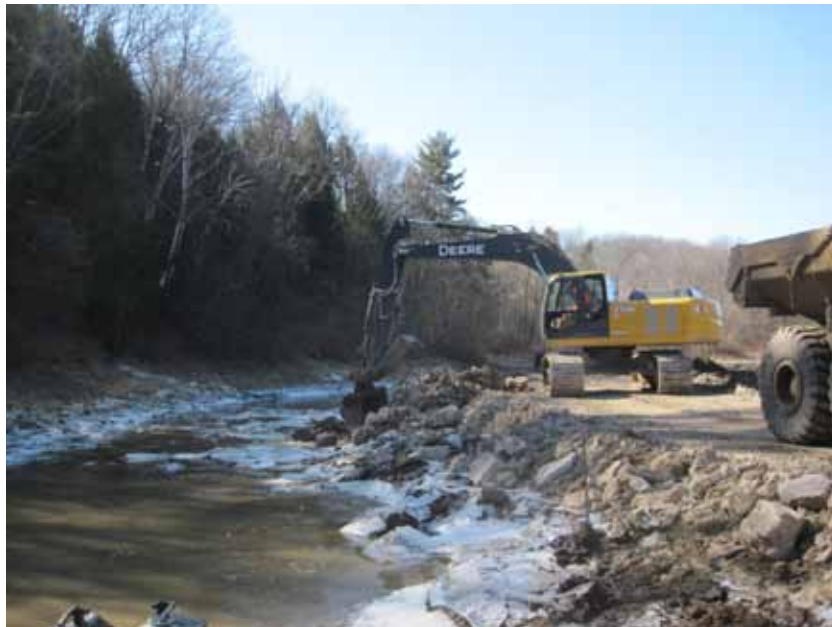
The construction of the respective riffle sections using armour stone was carried out in a southwest to northeast direction (i.e., upstream to downstream) between weeks three and five. For each riffle section, armour stone was placed within the excavated creek bed via an articulated dump truck, or tri-axle dump truck where/when appropriate. Excavators were used to compact the boulders, and spread them along the creek bed and banks, per the construction drawings and Parish Geomorphics instruction. The boulders were orientated so as to provide appropriate riffle habitat while preserving the desired gradient/fall of the creek bed (see Figure 5-7).

**Figure 5-7 Construction of a Riffle Area Upstream of Former Dam Site**

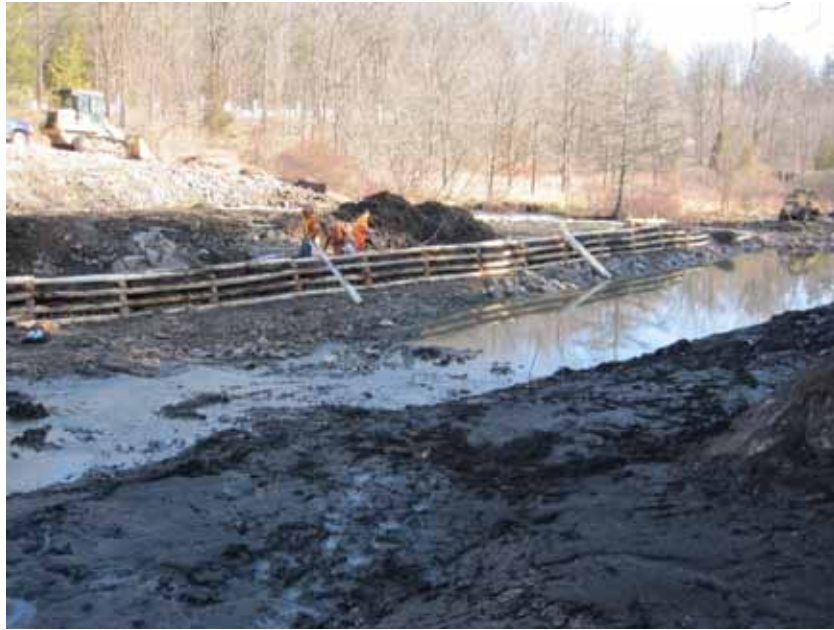
The crib wall was constructed along the northern creek bank (immediately downstream of the dam) as an erosion protection measure that would help withstand higher flows in the absence of the dam structure. The assembly of the crib wall took place during week five of construction (March, 2012), following the demolition of the dam. Wooden poles approximately 6 feet long, with a six inch diameter were hammered together by the construction workforce with 12 inch-long nails to form a long, rectangular prism frame. Soil, filter cloth and natively-harvested live willow stakes were piled in-between the lattice structure to promote vegetative growth, and ensure stability (see Figure 5-8).

**Figure 5-8 Construction of Crib Wall Downstream of Former Dam Site**

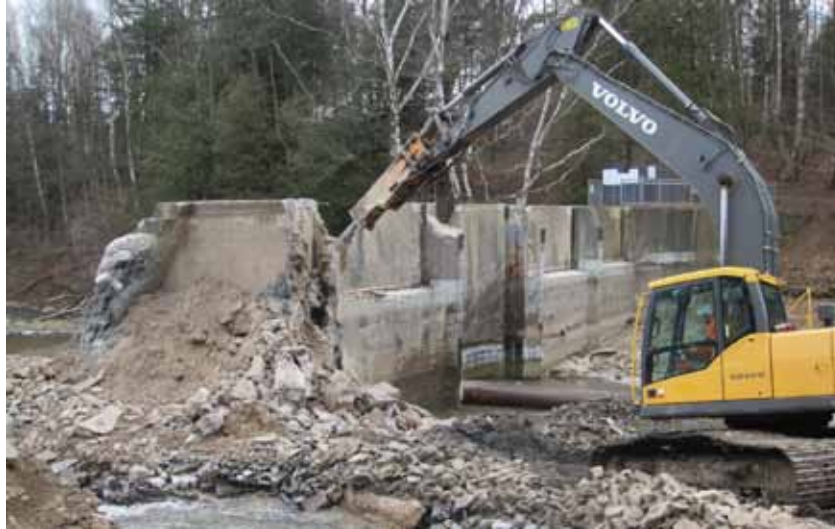
hoe-ram, with the exception of the rebar-reinforced valve chamber on the north end, which required some additional care to dismantle (see Figure 5-9).

**Figure 5-9 Excavator Breaking Up Dam Structure with Hoe-Ram**

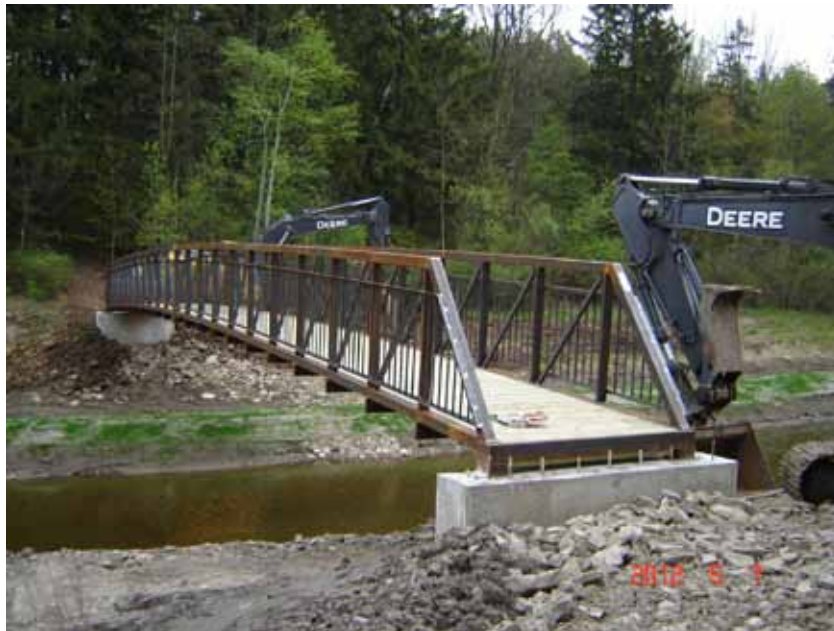
**Figure 5-10 Construction Workforce Finalizing Pedestrian Bridge Installation**

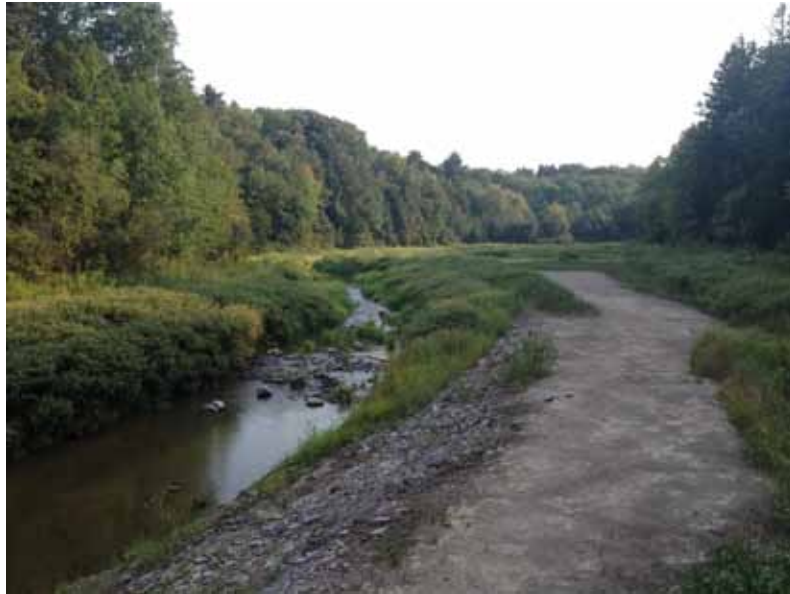
The restoration and naturalization of the site occurred during various stages throughout construction. As creek banks were restored and finalized, they were reseeded with native grass species, and covered with jute fabric to promote growth. Upon construction completion, the entire site was re-seeded with native vegetation. In addition, trees and shrubs were purchased and planted throughout the site per the Tree Preservation and Planting Plan (see Appendix C), to restore the creek area to a naturalized condition (see Figure 5-11).

**Figure 5-11 A View of the Restored / Naturalized Site Following Construction Activities**

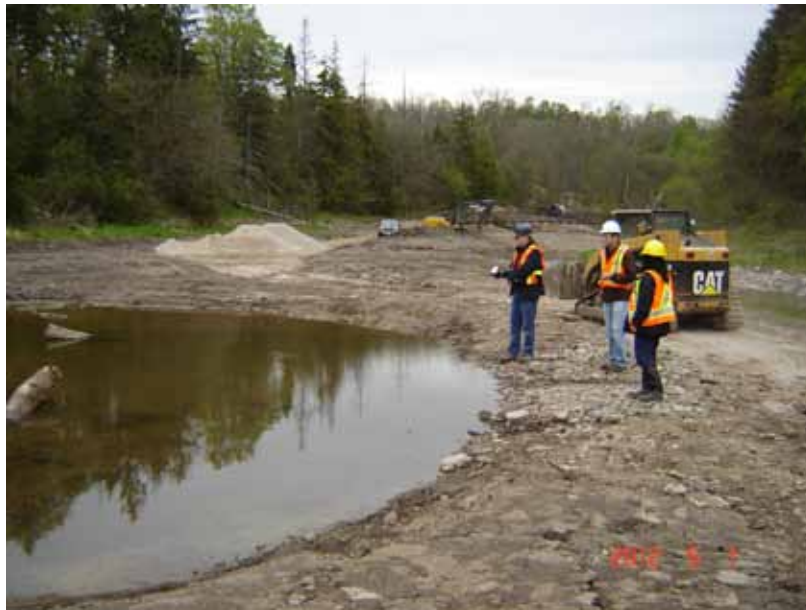
Three wetland areas, located on the southwest, north-central and northeast portions of the site, respectively, were excavated as part of construction activities. These wetland areas were replanted with native vegetation once construction activities were completed. Logs from felled trees on site were recycled by depositing them into these wetland areas, so as to enhance their habitat characteristics (Figure 5-12).

**Figure 5-12 Constructed Wetland Feature Opposite Northern Creek Bank, Upstream of Former Dam Site**

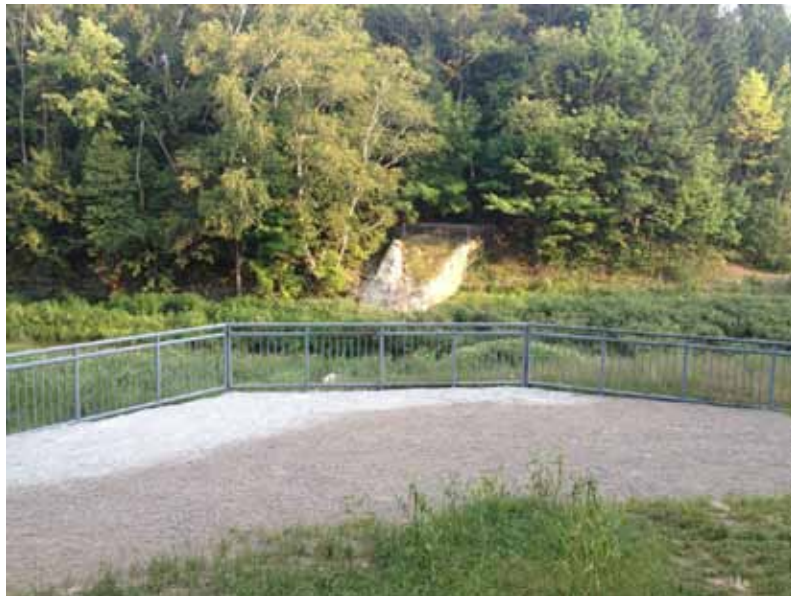
**Figure 5-13 Remaining Dam Abutment and Lookout Areas Created to Preserve Cultural Heritage (View from Northern Bank, Opposite Crooks' Hollow Road)**

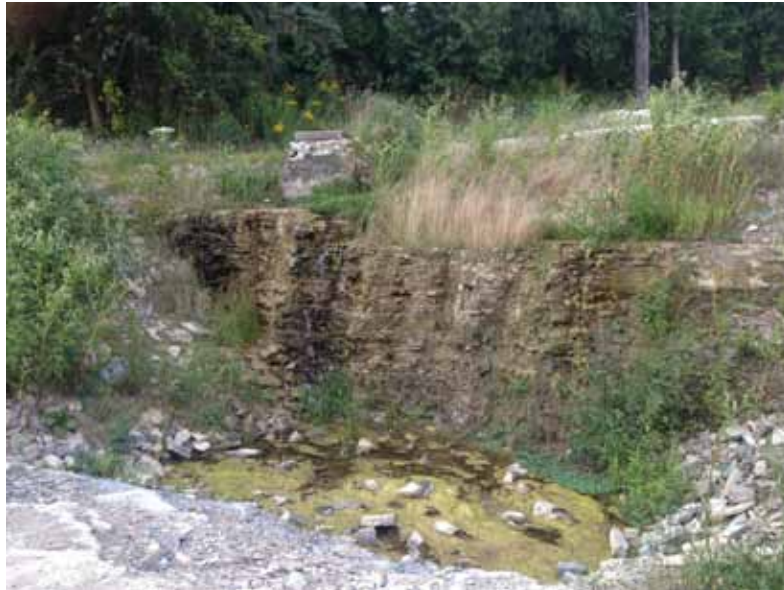
- An old, sealed well on the northern bank of the creek (adjacent to the dam site) was left in place, in its original condition (see Figure 5-15).
- A small waterfall feature consisting of groundwater seeping along the surface bedrock and discharging at a vertical bedrock face was created as a result of diversion channel excavation near the north lookout area. This aesthetic feature was left in place following construction activities (see Figure 5-15).

**Figure 5-14 Small Waterfall Feature Left in Place Adjacent to North Lookout Area, with Sealed Well in the Background**
