HERITAGE IMPACT ASSESSMENT

**Crooks Hollow Dam at Spencer Creek
Community of Greensville, Town of Flamborough
Regional Municipality of Hamilton
Wentworth County, Ontario**

Report Number: 11-1136-0029-R01

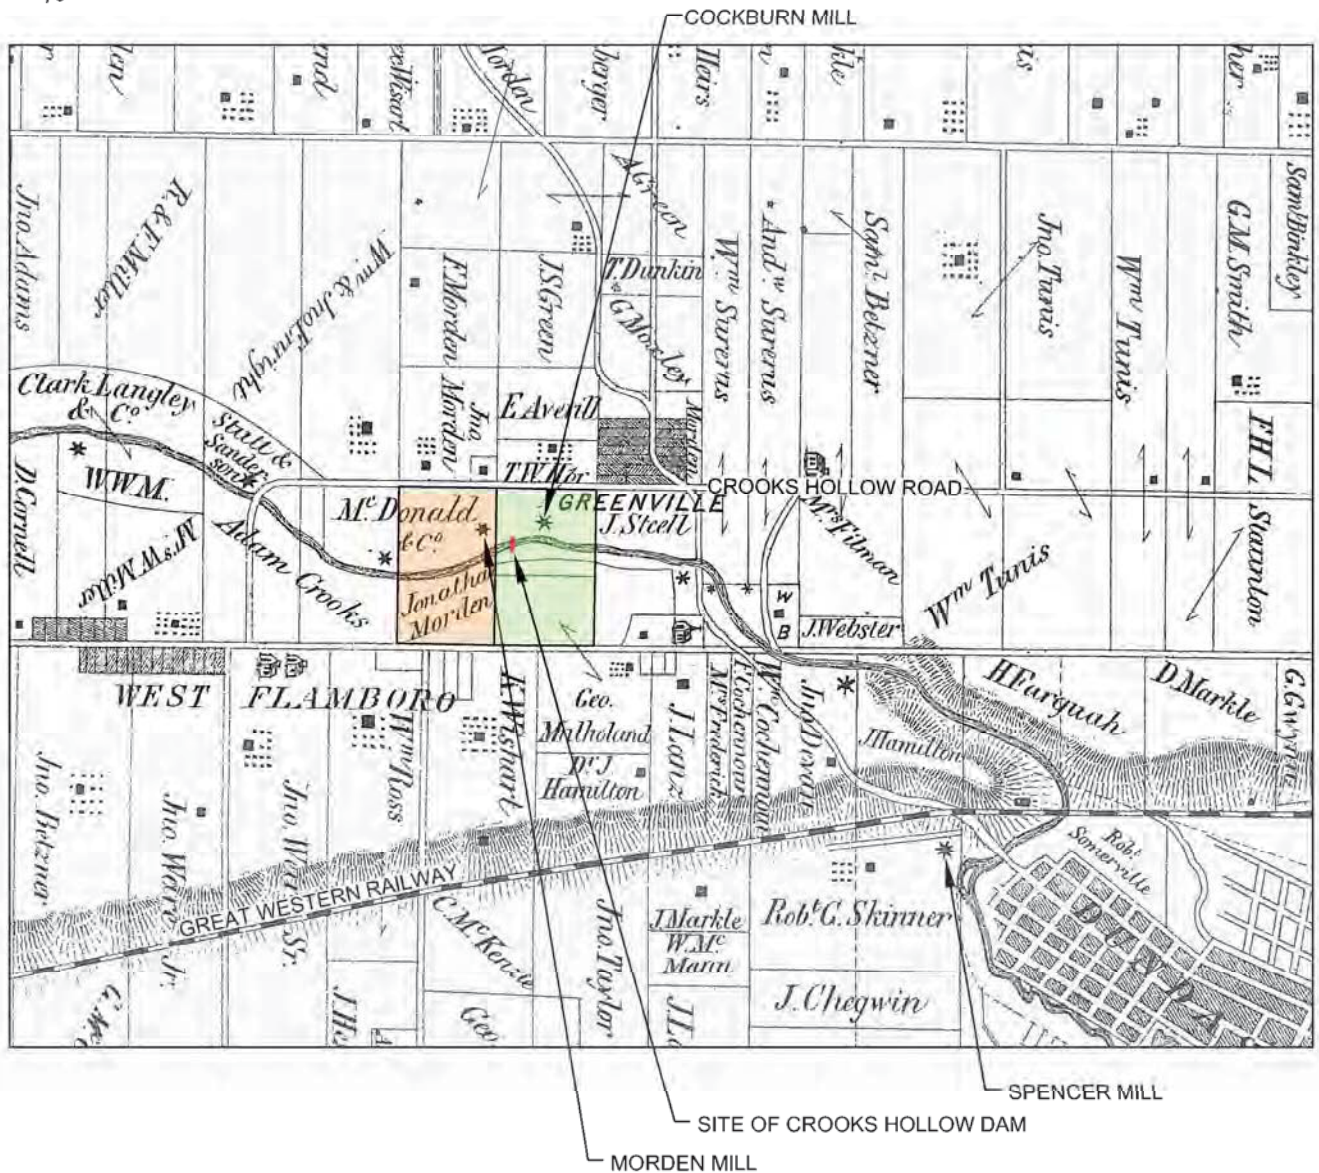
PROJECT	HERITAGE IMPACT ASSESSMENT CROOKS HOLLOW DAM GREENSVILLE, WENTWORTH COUNTY, ONTARIO		
TITLE	SPENCER CREEK IN CROOKS HOLLOW WENTWORTH ATLAS, 1875		
PROJECT No.	11-1136-0029	FILE No.	1111360029-R01001
CADD	DCH	SCALE	NTS
CHECK	May 30/11	REV.	
		FIGURE 2

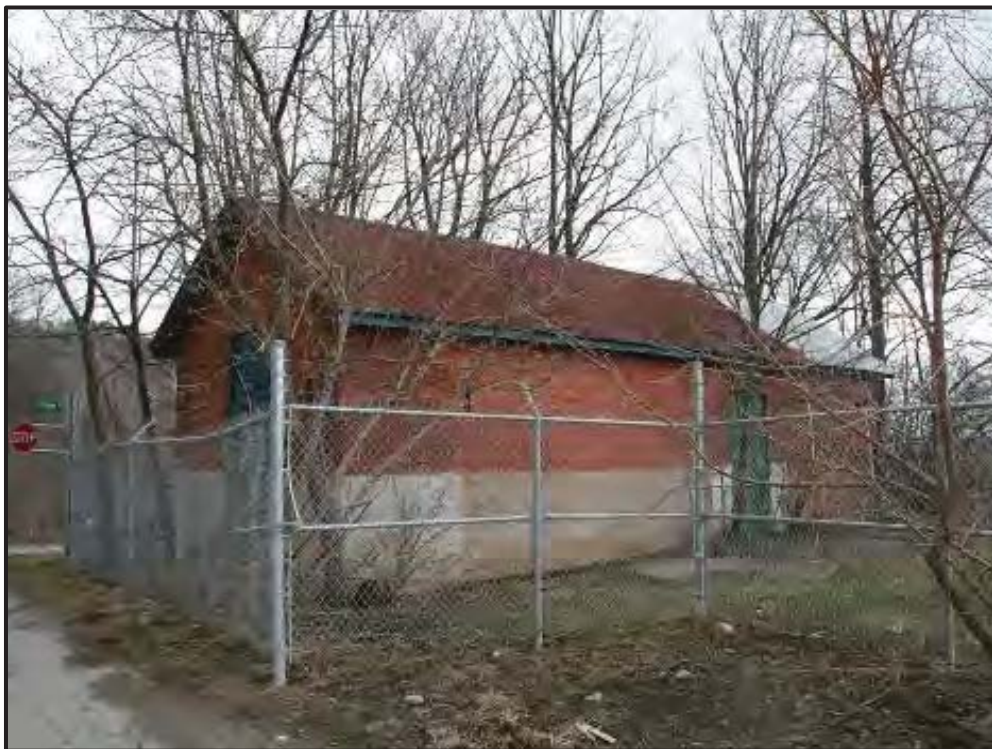
Plate 2: Pump house at the Dundas reservoir in 2011

Until the 1880s the citizens of Dundas seem to have relied on private wells and possibly the streams flowing through the town as their source of water. In 1871, Dundas had a population of 3,135 and had grown to 3,509 ten years later. This growth required a more reliable source of water and in 1884 the municipality completed a public waterworks. The supply of water was distributed by gravity from springs on the Niagara Escarpment, about four kilometres away from the town. The springs fed a one million gallon reservoir constructed adjacent to the Grand Trunk Railway on the slope of the escarpment. (Plates 1, 2) From this elevated position water was distributed into the town at a pressure of 75 psi.

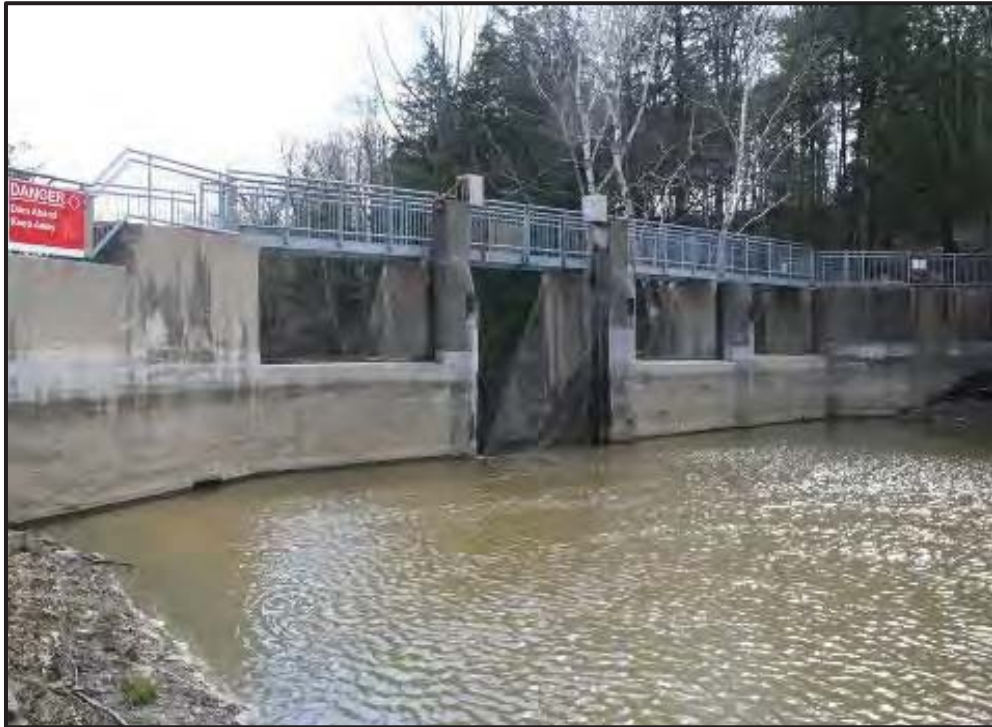
Plate 7: Upstream View of Dam looking to east abutment. The low #2 spillway is evident as are the buttresses that could increase the depth of the reservoir if needed. The metal footbridge provides a public crossing of the stream.

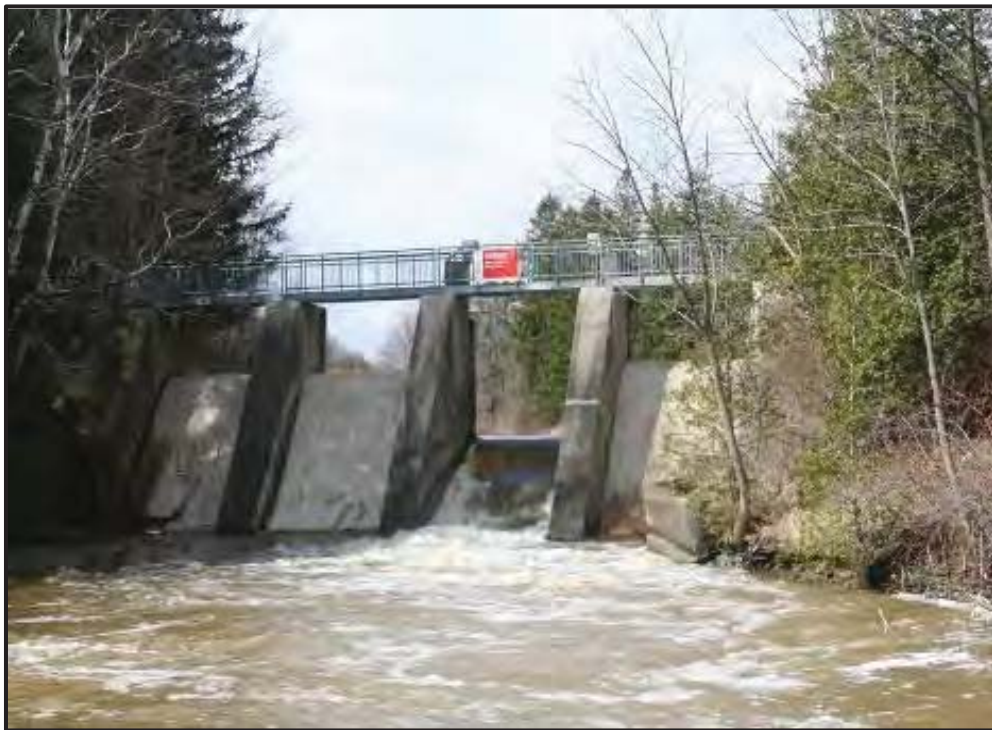
Plate 8: Looking upstream to Dam showing lower level of Spillway 2 crest

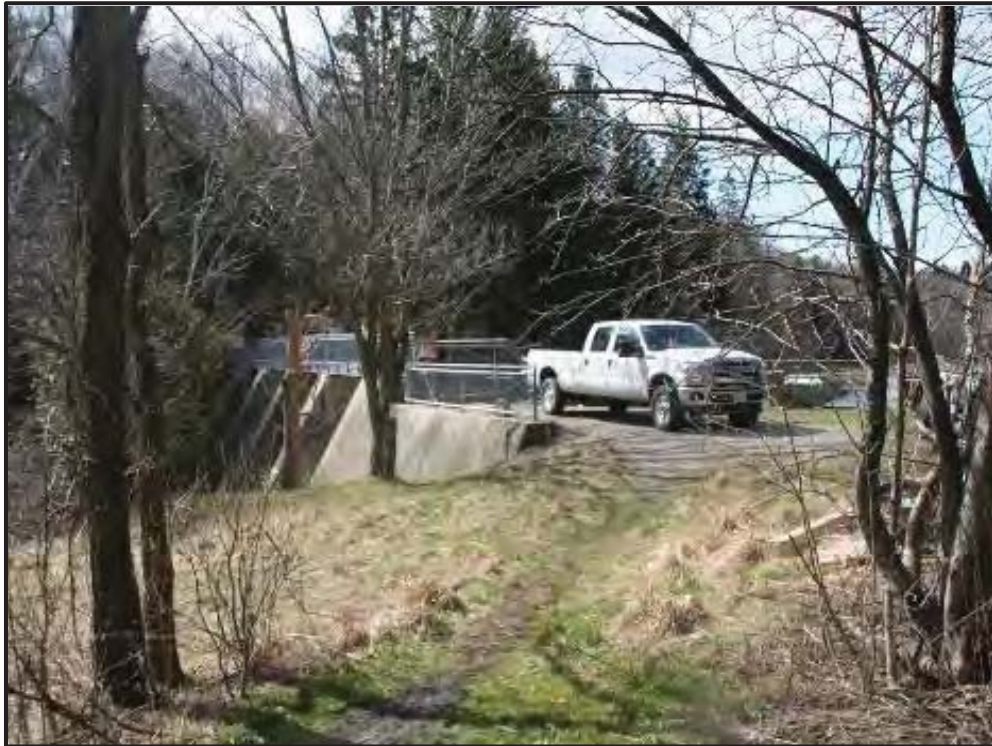
Plate 9: Concrete and earth abutment on west side of dam

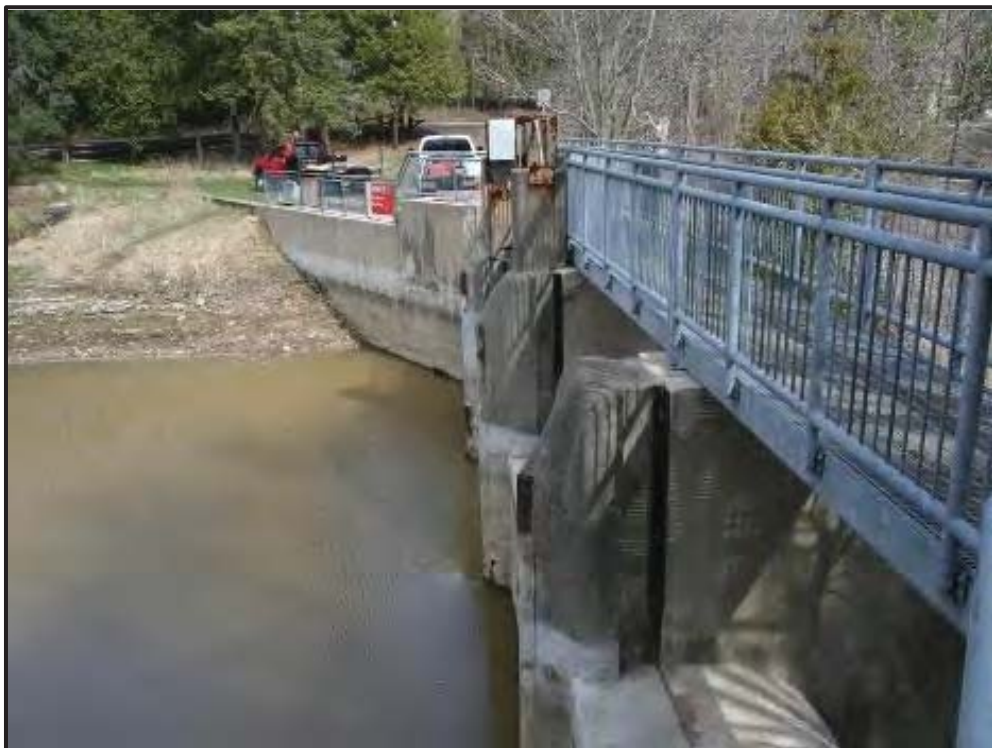
Plate 10: Dam crest, and stop log slot, earth berm and bridge looking to west bank

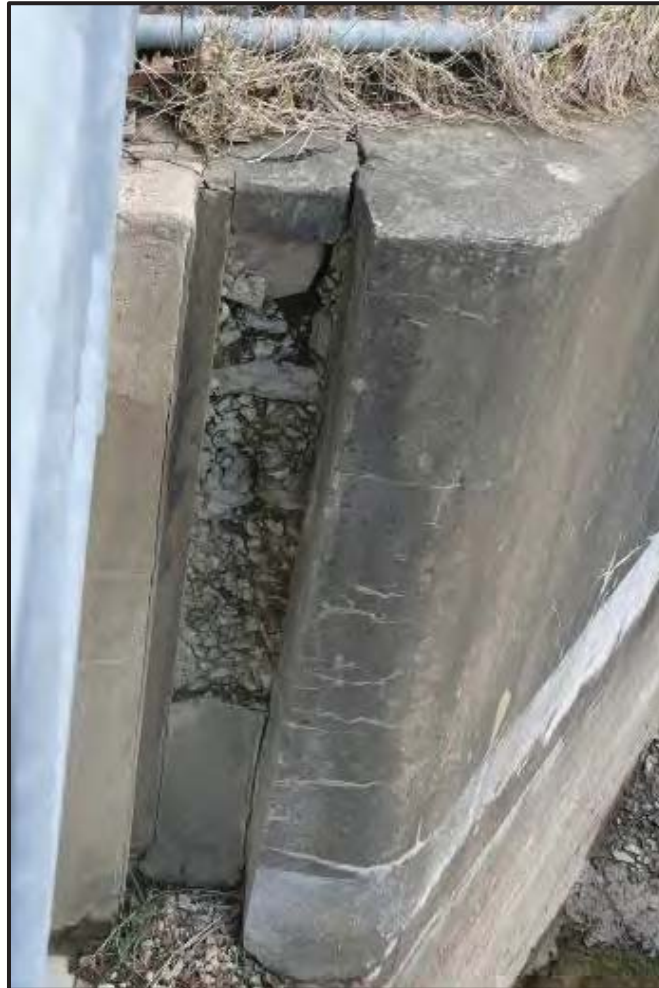
The quality of the concrete in the dam was consistent with early 20th century practice. The spillway concrete consisted of large gravel, probably from river bed; intermixed with smaller crushed stone. By the 1920s concrete was made only from crushed stone. Core drilling in 1992 found that the buttress concrete was in poorer condition than the spillway, possibly due to numerous freeze-thaw cycles. The core samples also indicated evidence of pockets of contamination in the concrete due to the inclusion of clay.²⁰ By the time of construction of this dam, concrete technology had advanced to a point where substantial and durable dams, bridges and other structures had been built that still function today. The somewhat coarse concrete and clay inclusions found in the Crooks Hollow dam may be indications of the difficulty of finding skilled trades during the War.

Plate 11: Large gravel evident in concrete visible in stop log slot of Spillway 4

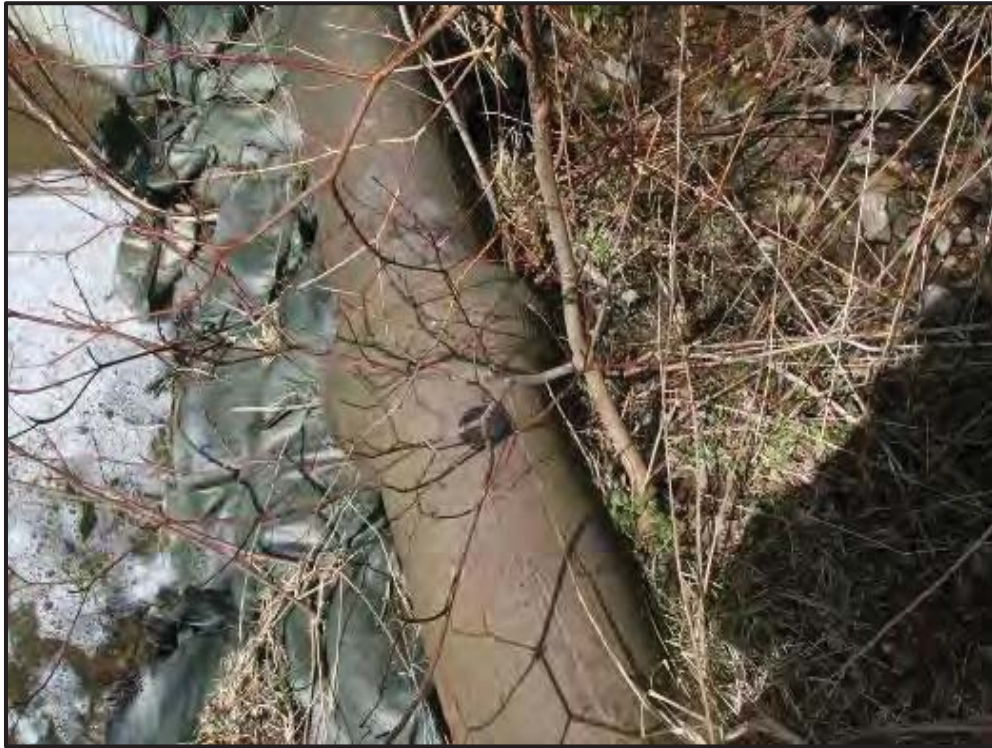
Plate 12: The cast iron water conduit was laid on the ground adjacent to the creek rather than buried

- **Retain Dam Ruins:** As much as possible of the Crooks Hollow waterworks dam should be retained, and specifically the cast iron water conduit; a portion of the south abutment, and as much as possible of the north earth and concrete dam. If possible the valve chamber (if it exists) should be retained.

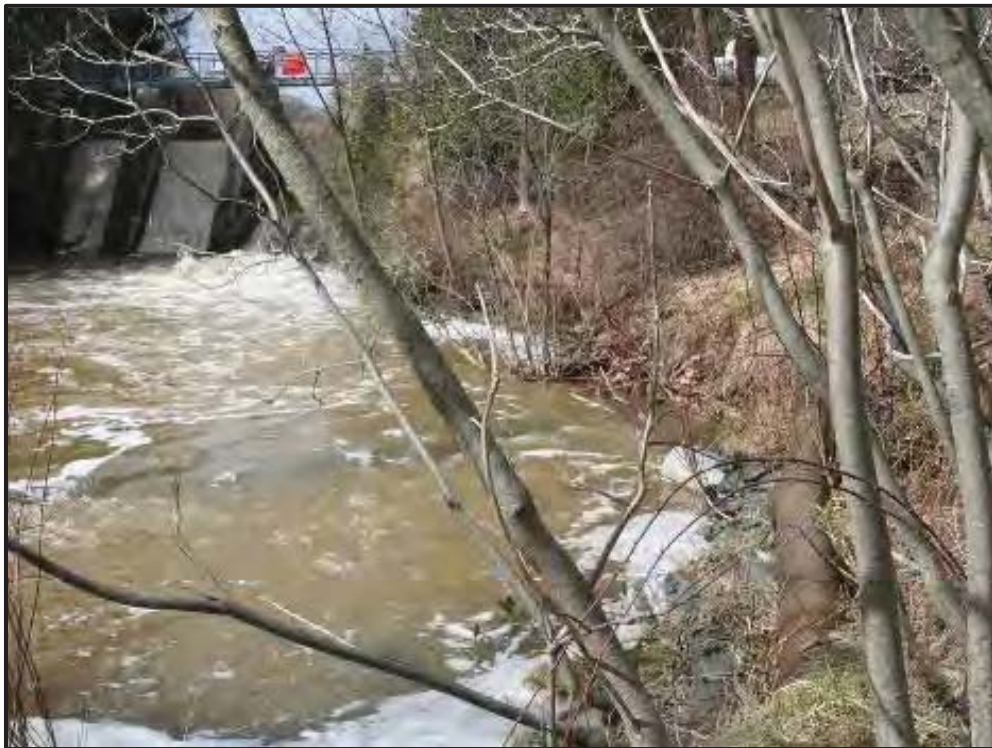
Plate 13: Iron conduit along bank of Spencer Creek with dam in rear

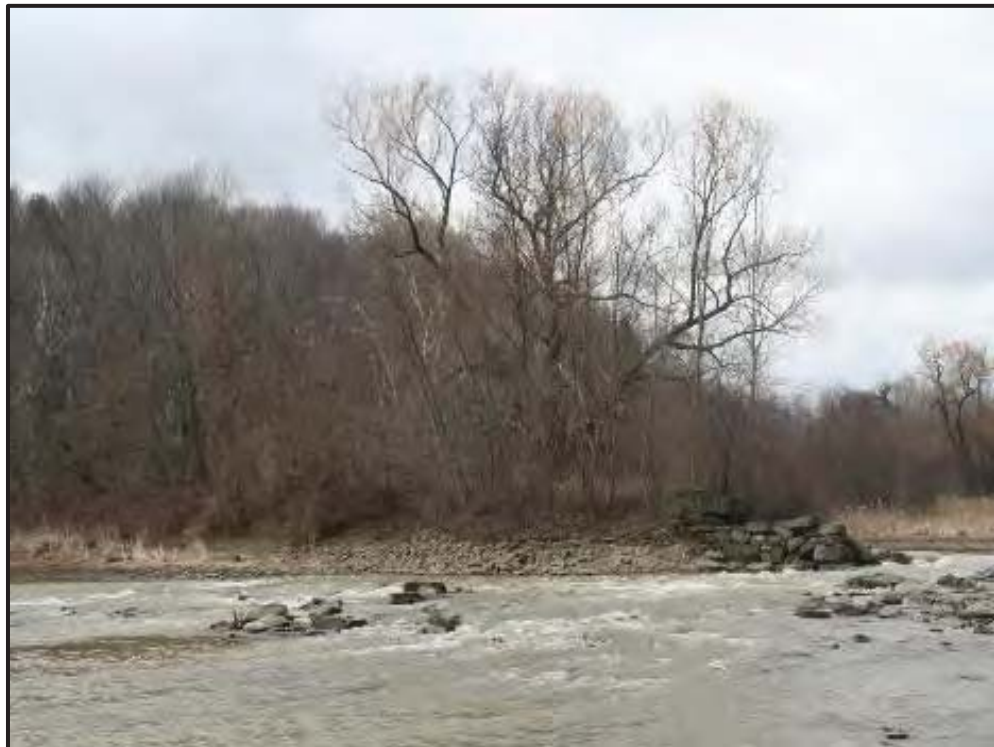
The Morden Mill Dam was originally constructed in 1810 and depicted in c.1900 in Plate 6. Today it consists of a long earth and stone dyke extended from the south bank almost across the creek valley. (Figure 6) The dyke appears to be the original length and has been stabilized from flooding by natural regeneration of trees. The remains of a stone weir lie between the dyke and the north bank. (Plate 14)

Plate 14: Looking upstream to the dam at Morden Mill

The Cockburn Mill building foundations and dam ruins as well as the Morden Mill earth dyke and stone weir should be stabilized to prevent further deterioration. The selective removal of vegetation should be considered for the Cockburn Mill ruins and the Morden Mill earth dyke to assist in the conservation of these resources and to aid in visual appreciation of their historic character.

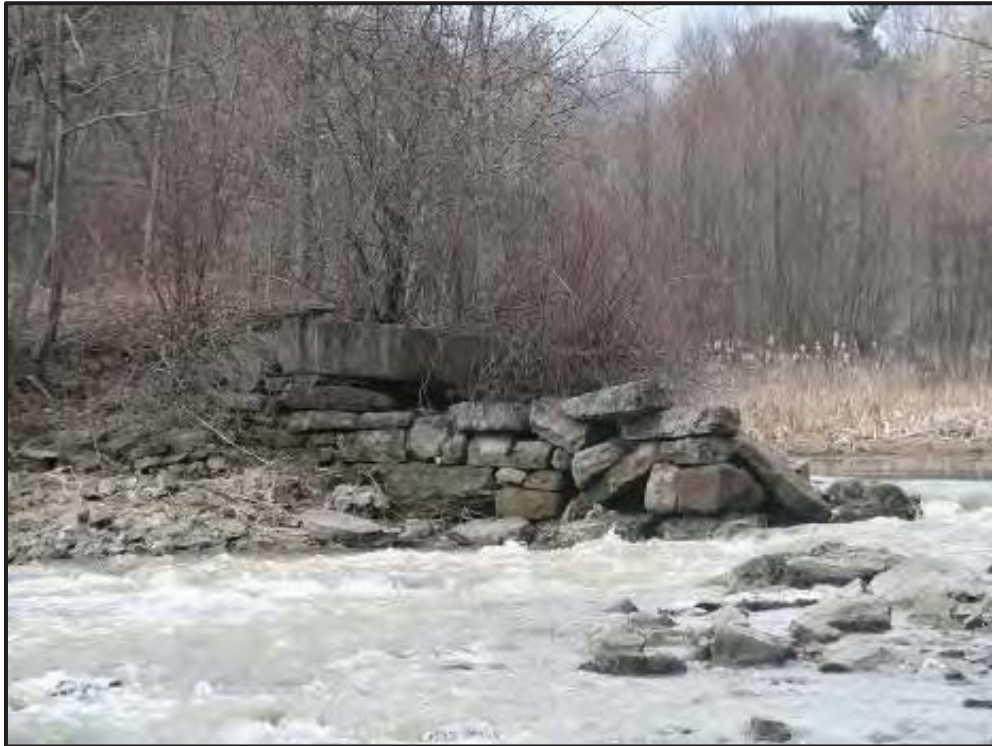
The unusual aspect of the weir is the use of large stone blocks. (Plate 15) More typically mill dams were rock-filled timber cribs, such as used at the Cockburn Mill.

Plate 15: Detail of stone blocks in the weir as it is attached to the dyke on the south bank.

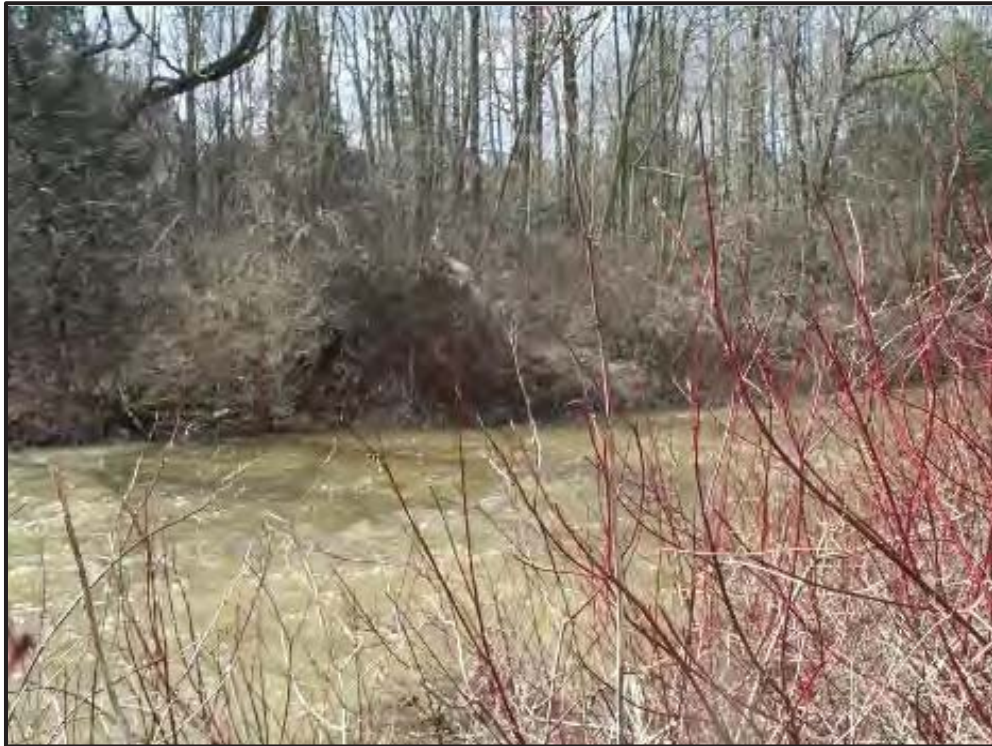
The Cockburn mill consists of an extensive complex of ruins located on the north bank of the Creek. (Figure 5) The mill and dam as it appeared in the early 20th century is illustrated in Plates 3 and 4. The dam across Spencer Creek was probably breached in 1915 before construction of the Crook Hollow Dam commenced. The earth abutment of the dam still exists on the south bank. (Plate 16)

Plate 16: Remnant of breached Cockburn Mill earth abutment on south bank of Spencer Creek

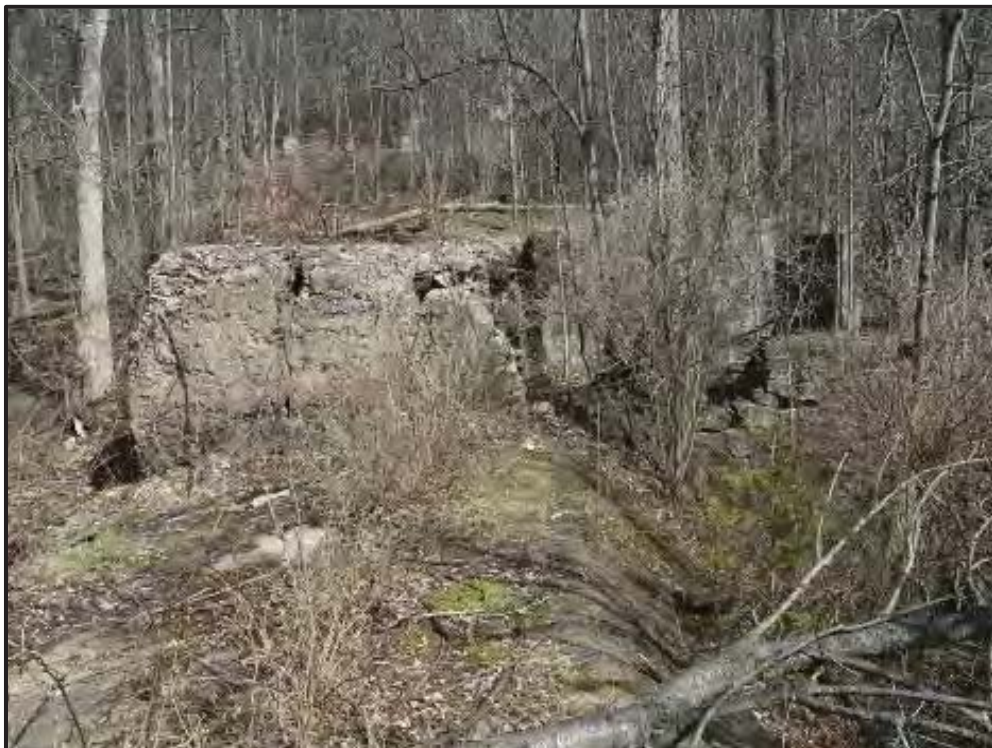
The concrete spillway weir depicted in Plate 4 still exists today. (Plate 17) The stone-filled, timber crib design is still evident today. (Plate 18) This weir possibly dates from the rebuilding of the dam in c.1912.

Plate 17: Cockburn Mill concrete weir, looking west with mill ruins in rear

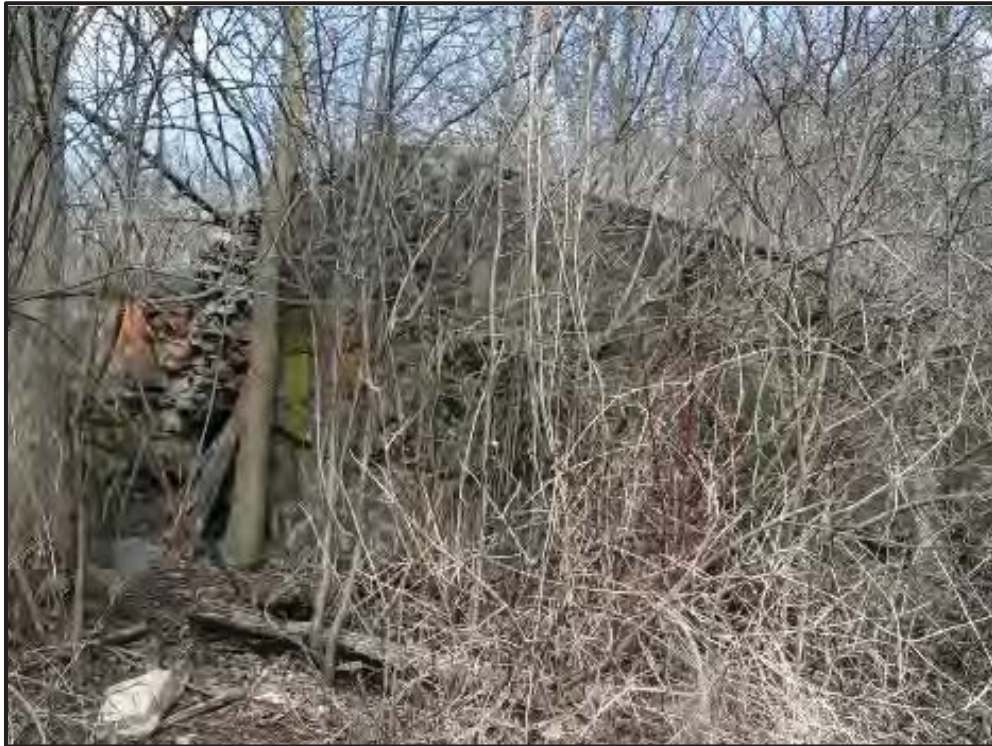
Plate 18: South end of Cockburn Mill dam concrete weir. The earth dam across Spencer Creek would have extended to the left of this structure. The rock filled crib construction is visible in the end of the weir.

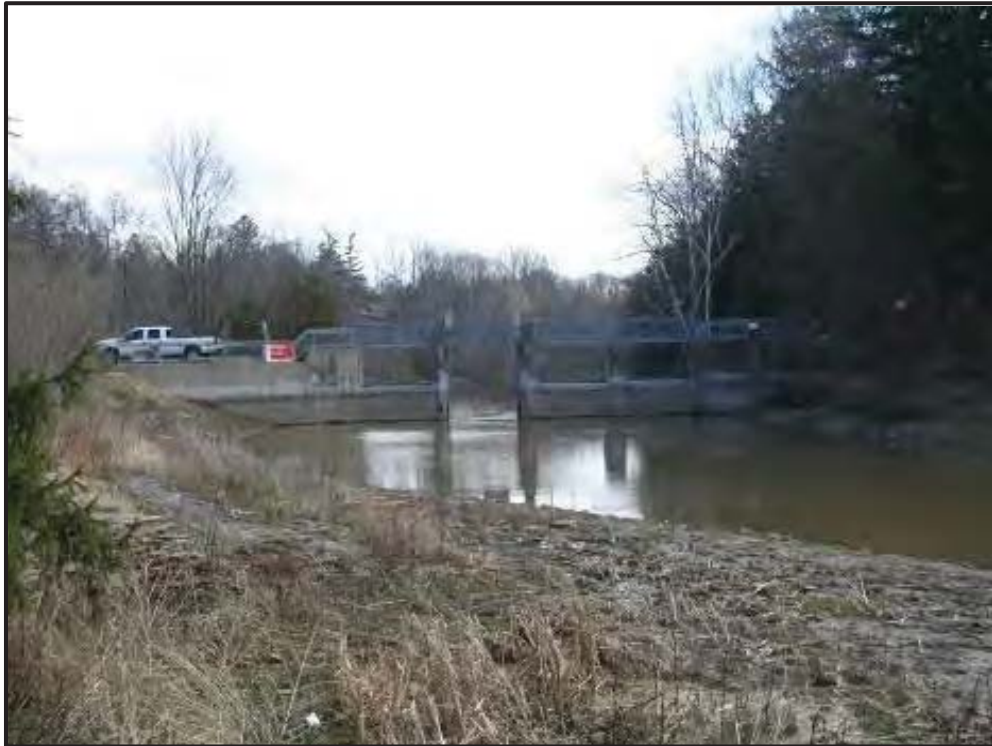
Almost a century of flooding of the reservoir has created a silt layer on the bottom of the Crooks Hollow Reservoir. The tree line defines the edge of the reservoir when spillway #2 was closed. (Plates 19-21) Given the size of the evergreens, the reservoir had not been filled to the maximum height of stop logs for many years.

Plate 19: Drained reservoir above dam

- **Landscaping:** A landscaping plan should be developed that considered the silt deposits in the reservoir as part of the historic character of the Spencer Creek Valley. The headpond landscape above the Cockburn dam site and the Morden Mill dam should be used as models on which to base the landscape design of the former reservoir.

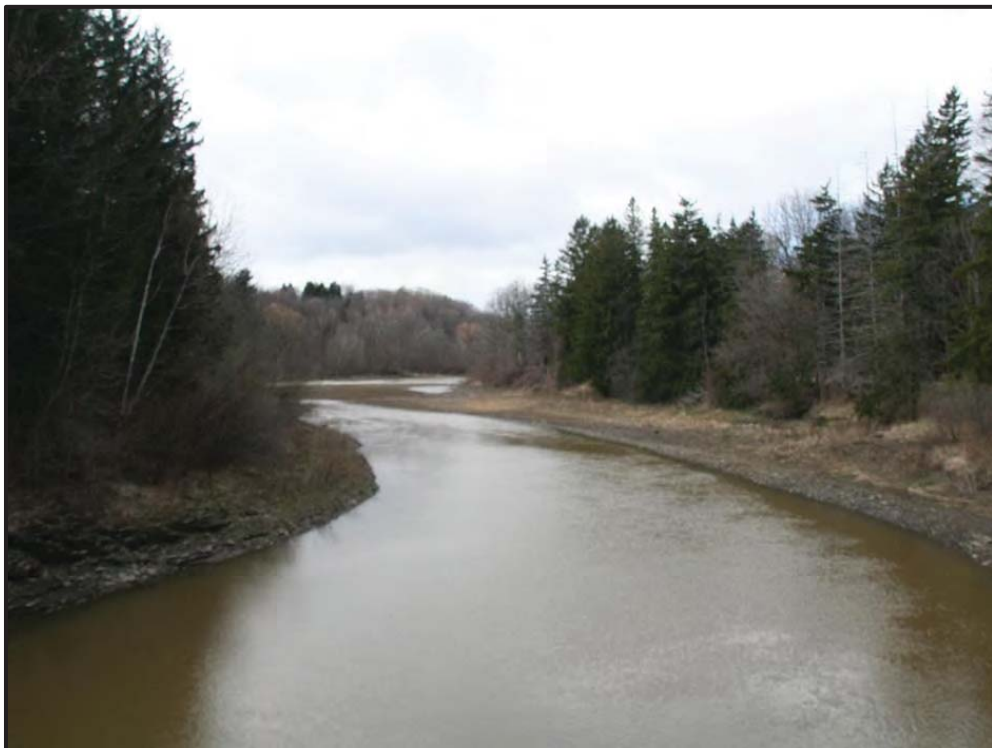
Plate 20: Looking upstream from dam over reservoir

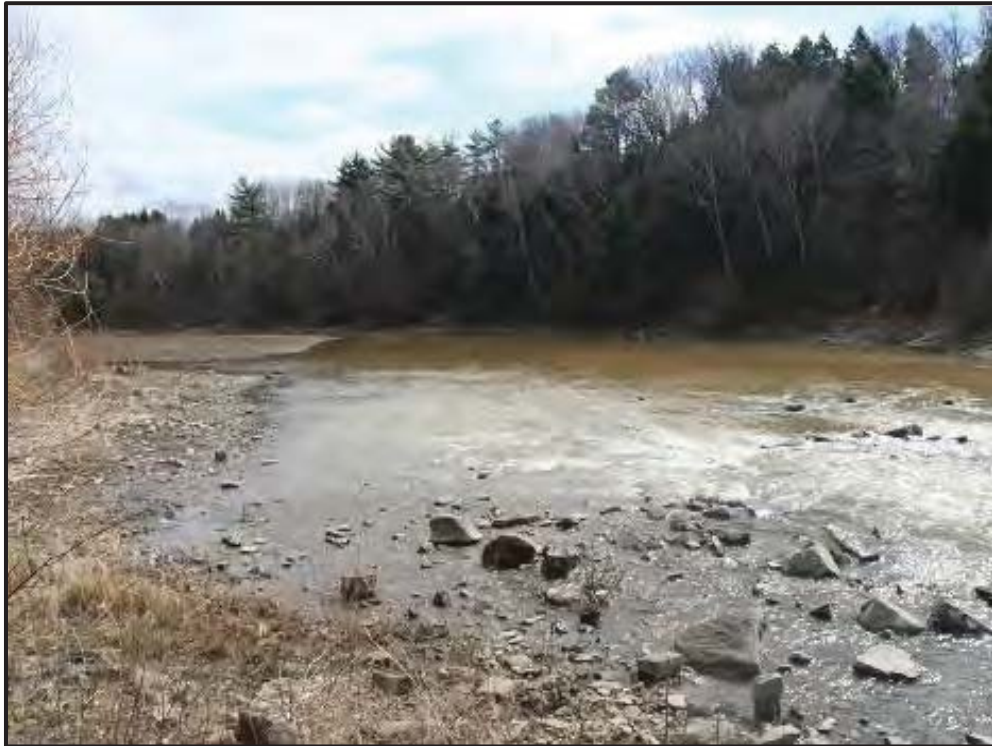
Plate 21: Looking downstream over reservoir at Morden Mill Dam

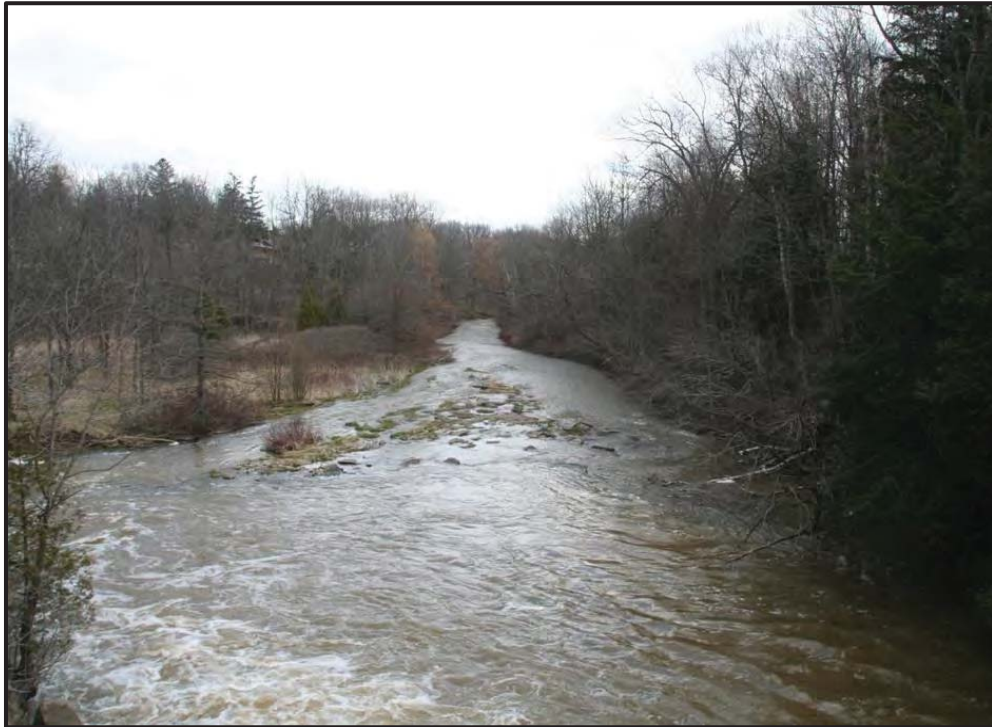
Plate 22: Spencer Creek downstream from dam. The Cockburn mill ruin is on the left side of the creek in the middle of the photo.

The stream landscapes are distinctly different above and below the Crooks Hollow Dam. Between the Dam and Cockburn mill downstream, Spencer Creek flows in a narrow, well defined and relatively straight channel along the south valley wall. There is no flood plain. The north bank of the creek forms a undulating flood plain containing the ruins of the mill. (Plate 22)

The proposed naturalization of the former reservoir will create another man-made landscape from re-shaping the slit and engineering the creek channel. The historic landscapes of the undammed Spencer Creek can be seen in the former mill pond above the Cockburn Mill (Plate 22) and the Morden Mill (Plate 23).

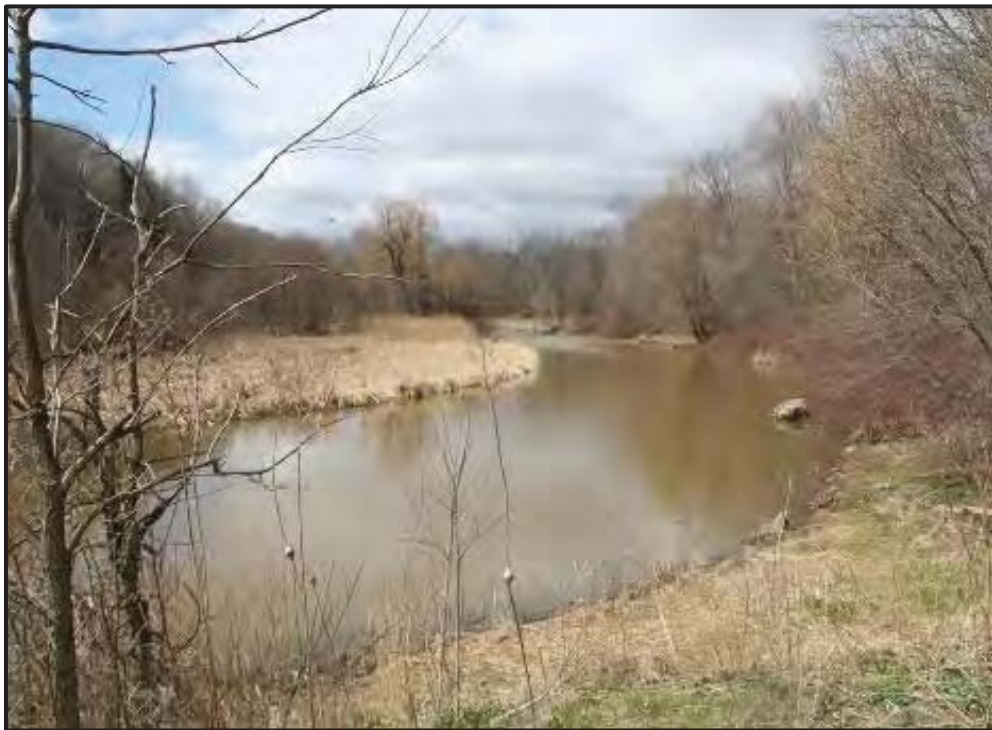
Plate 23: Spencer Creek upstream from Morden Mill dam

The upstream end of the reservoir occurs just below the Modern Mill Dam ruins. At this point the valley consists of a broad flat valley. The course of the river is ill defined over a rock strewn stream bottom. (Plate 23)

Above the end of the reservoir at the Morden Mill dam ruin, Spencer Creek flows through a meandering channel marsh land and meandering river channel. (Plate 23) This section of the creek appears to be flowing through the vestiges of the silted-in, 19th century mill pond.
