Board of Directors Meeting Agenda

Thursday May 2, 2024

Board of Directors Meeting

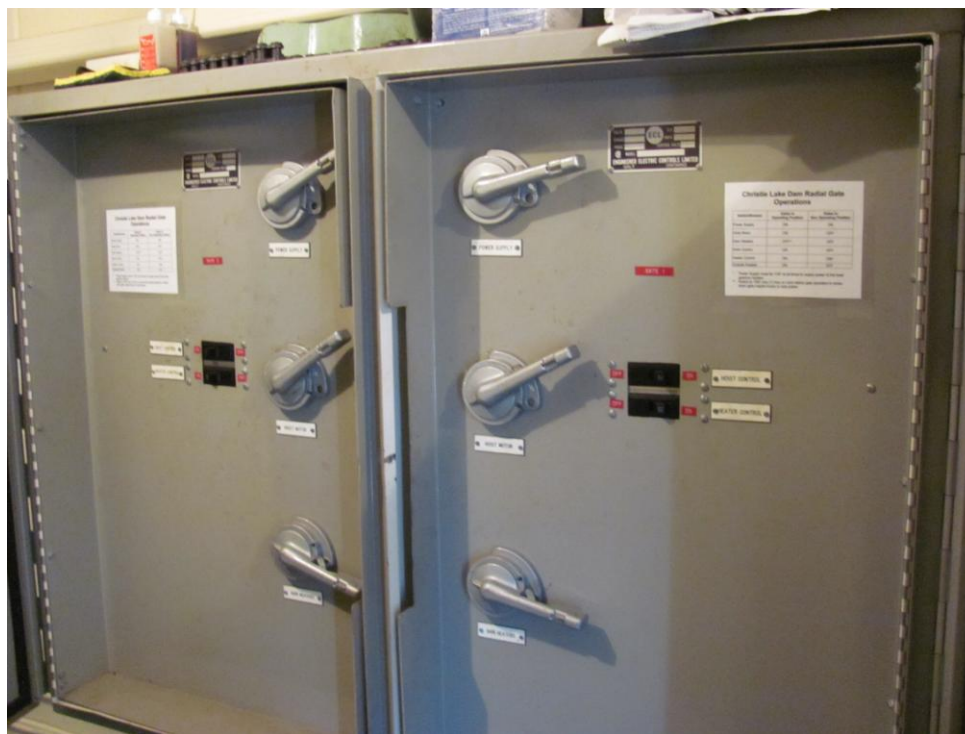
The operating controls for the radial gates are located in the Control Building on the north wall overlooking the gates. There are two control panels (one for each gate) located on the south wall in the electrical room. Prior to operating the gates, the levers and switches located in the control panels need to be correctly set. The control panels are shown in the photo below.

Each gate can be operated independently and both of the two gates may be operated at the same time.

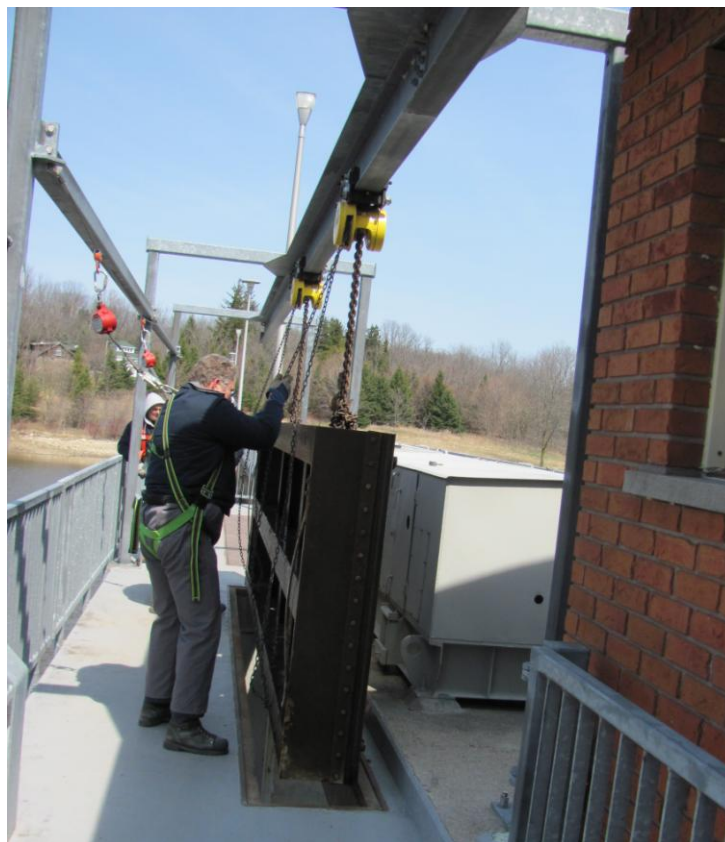
A photo of the overhead gantry system at Christie Lake Dam is shown below.

The overhead gantry for the dam consists of the following:

- Galvanized vertical supports.
- Two 2 ton chain hoists.
- Galvanized horizontal track for horizontal movement of hoists.

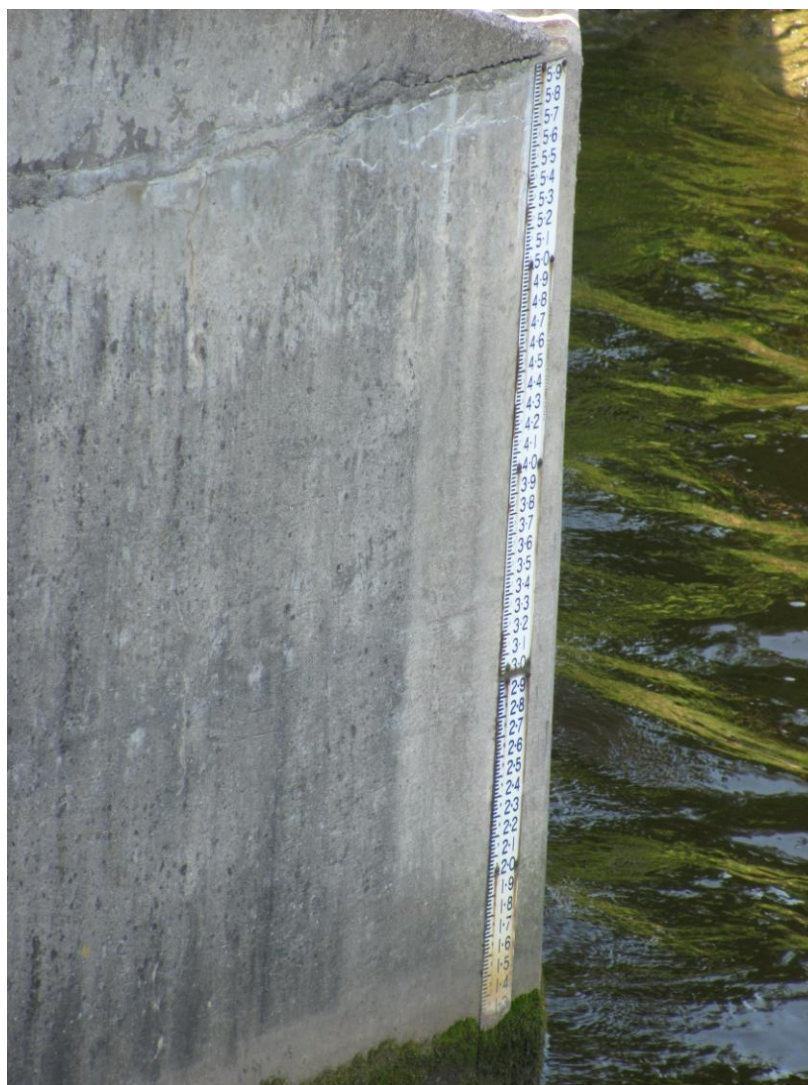
The Christie Lake Dam staff gauge is shown in the photo below. The gauge is correlated to its Canadian Geodetic Datum elevation (in ft). It is mounted on the south wing wall of the concrete control structure on the upstream side.

The staff gauge at the dam is 6.0 ft long. The elevation of the top of the gauge is 776.00 ft GSC. The staff gauge readings can be taken to the nearest 0.01 ft. It is difficult to read the staff gauge due to algae growth.

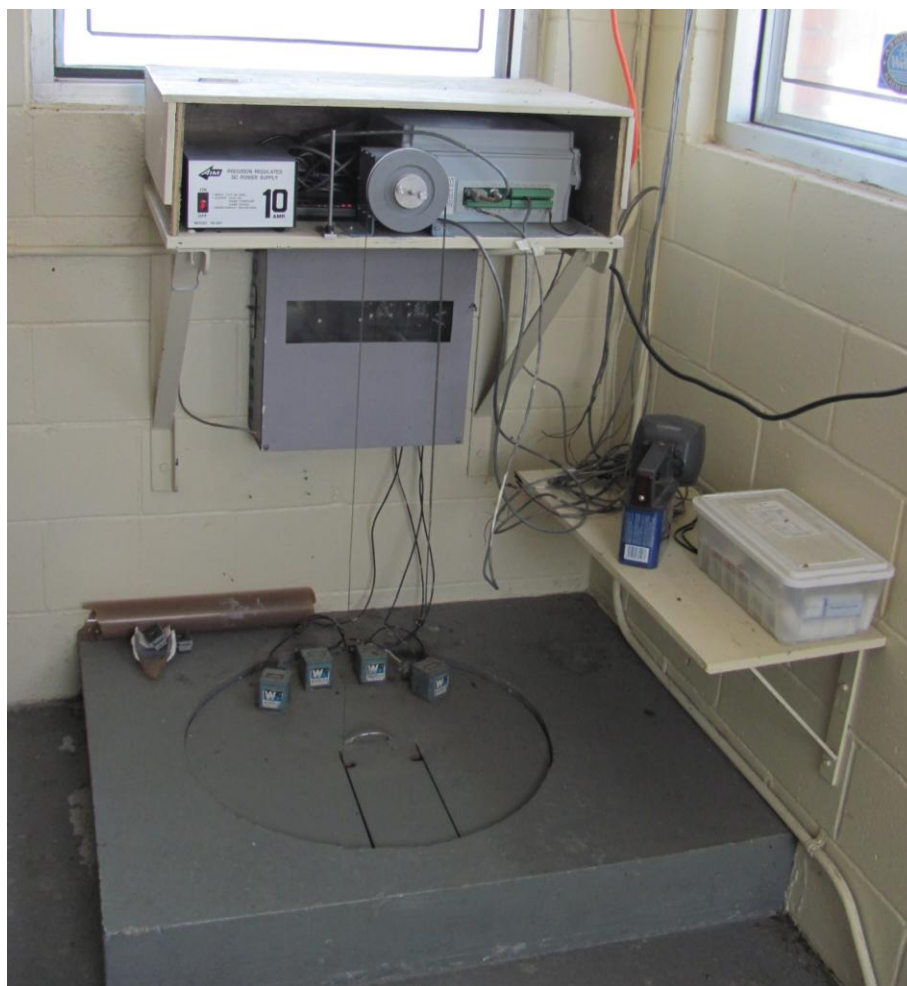
In addition to the staff gauge, there is an automatic water level gauge with data logger located inside the control room (photo shown below).

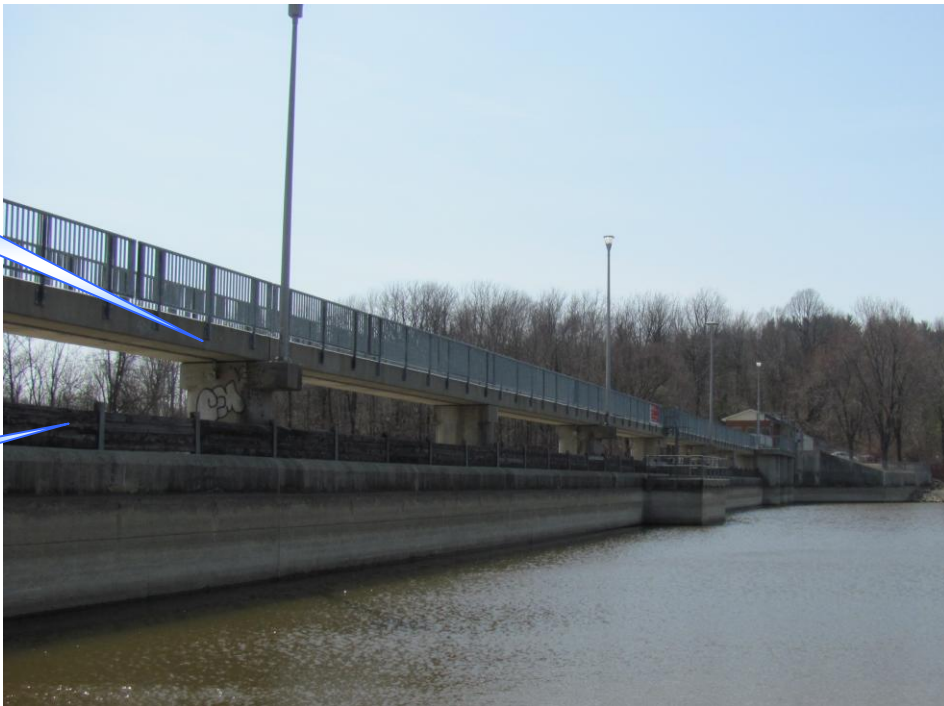
Photo 6: View of upstream face of ogee weir (April 2011)

Concrete Walkway

Flashboards

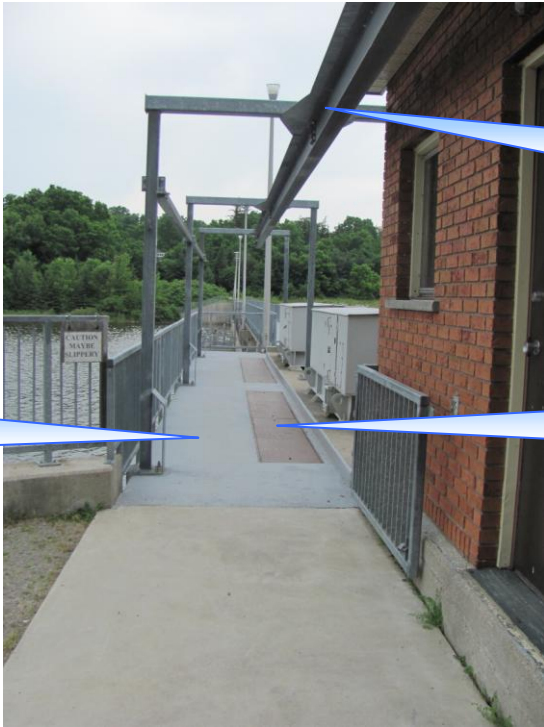
Photo 9: View of south side of dam (July 2011)

Overhead
Gantry

Stop Log Gain
Covers

Non-slip
Surface Coating

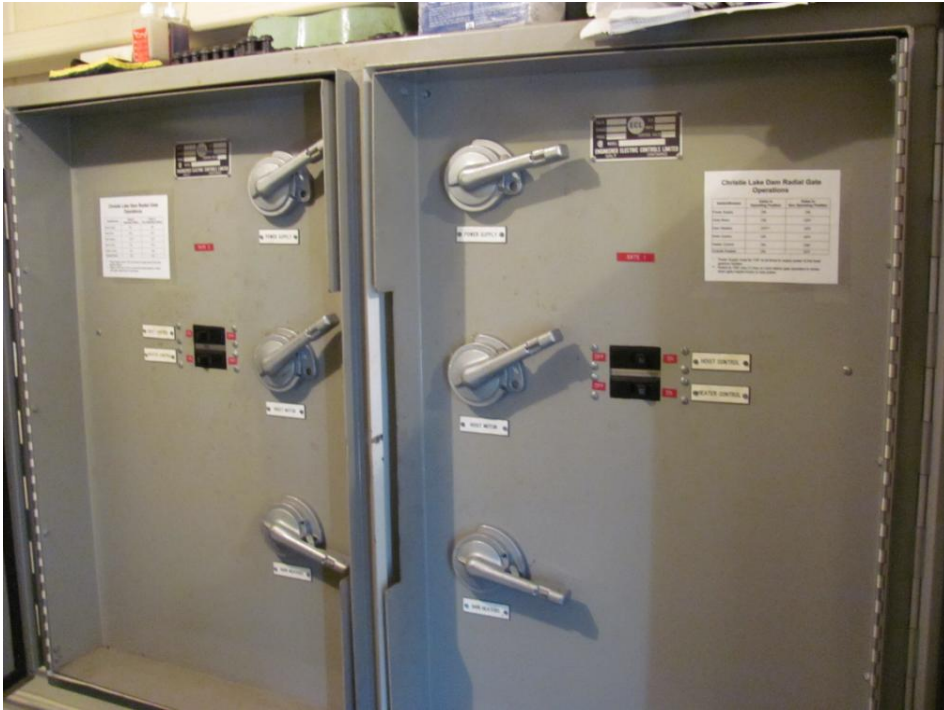
Photo 13: Radial gates control panel (April 2011)

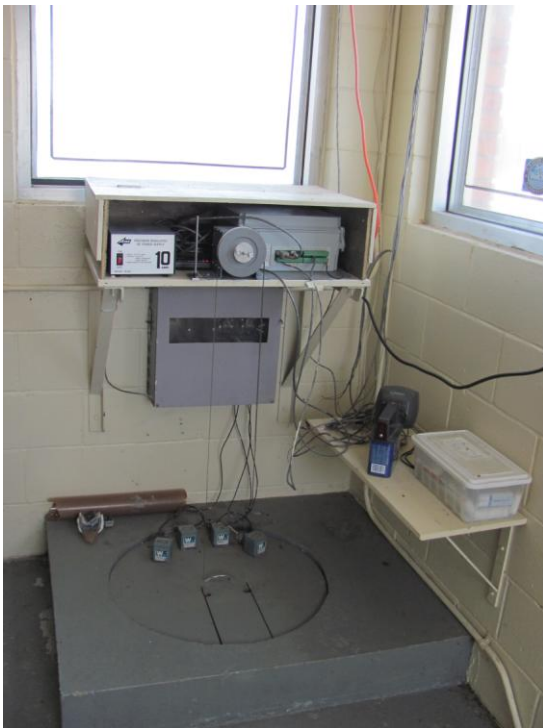
Photo 14: Automatic water level gauge with data logger (April 2011)

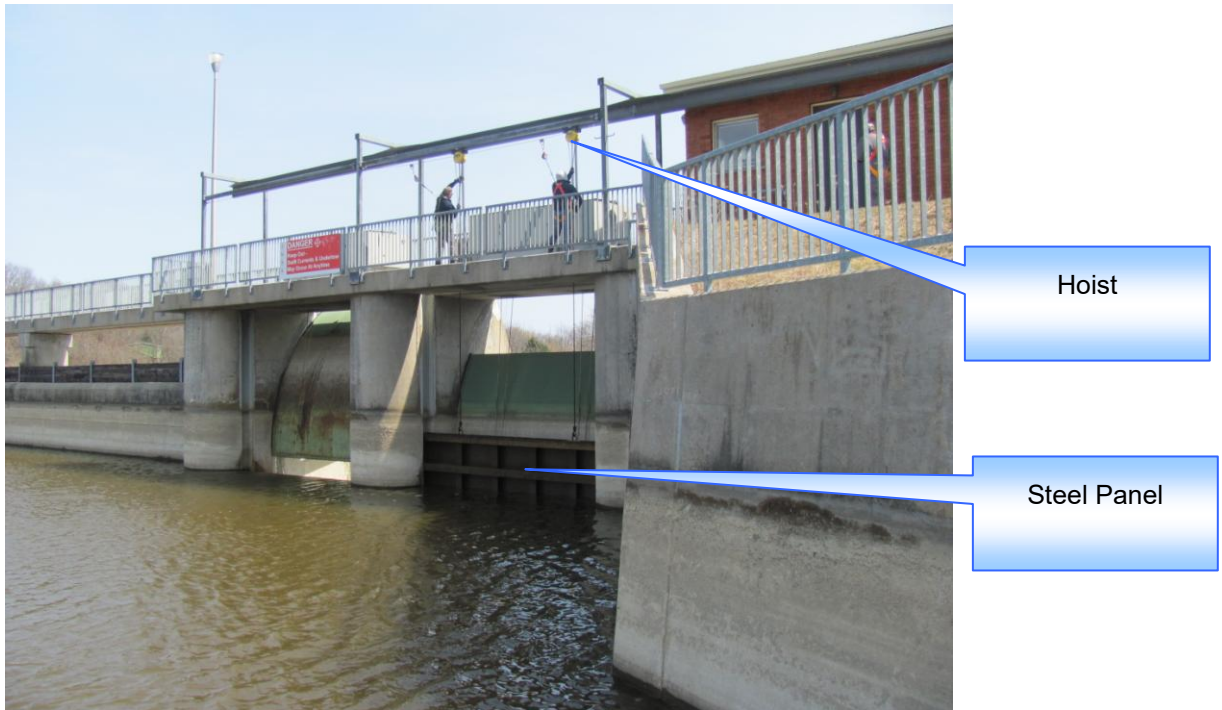
Photo 15: Removing the steel panel from the stop log bays (April 2011)

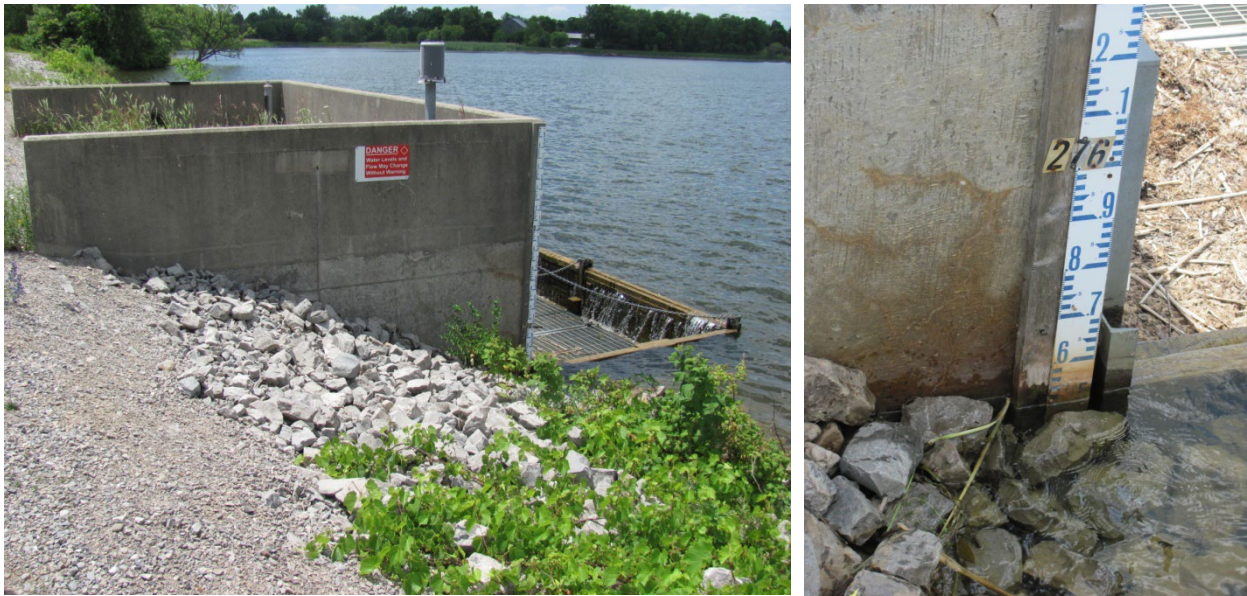
The Valens Dam staff gauge is shown in the photos below. The gauge is correlated to its Canadian Geodetic Datum elevation. It is mounted on the east wall of the concrete control structure on the upstream side.

The staff gauge at the dam is 3.0 metres long. The elevation of the top of the gauge is 278.00 m GSC. The staff gauge readings can be taken to the nearest 0.01 m.

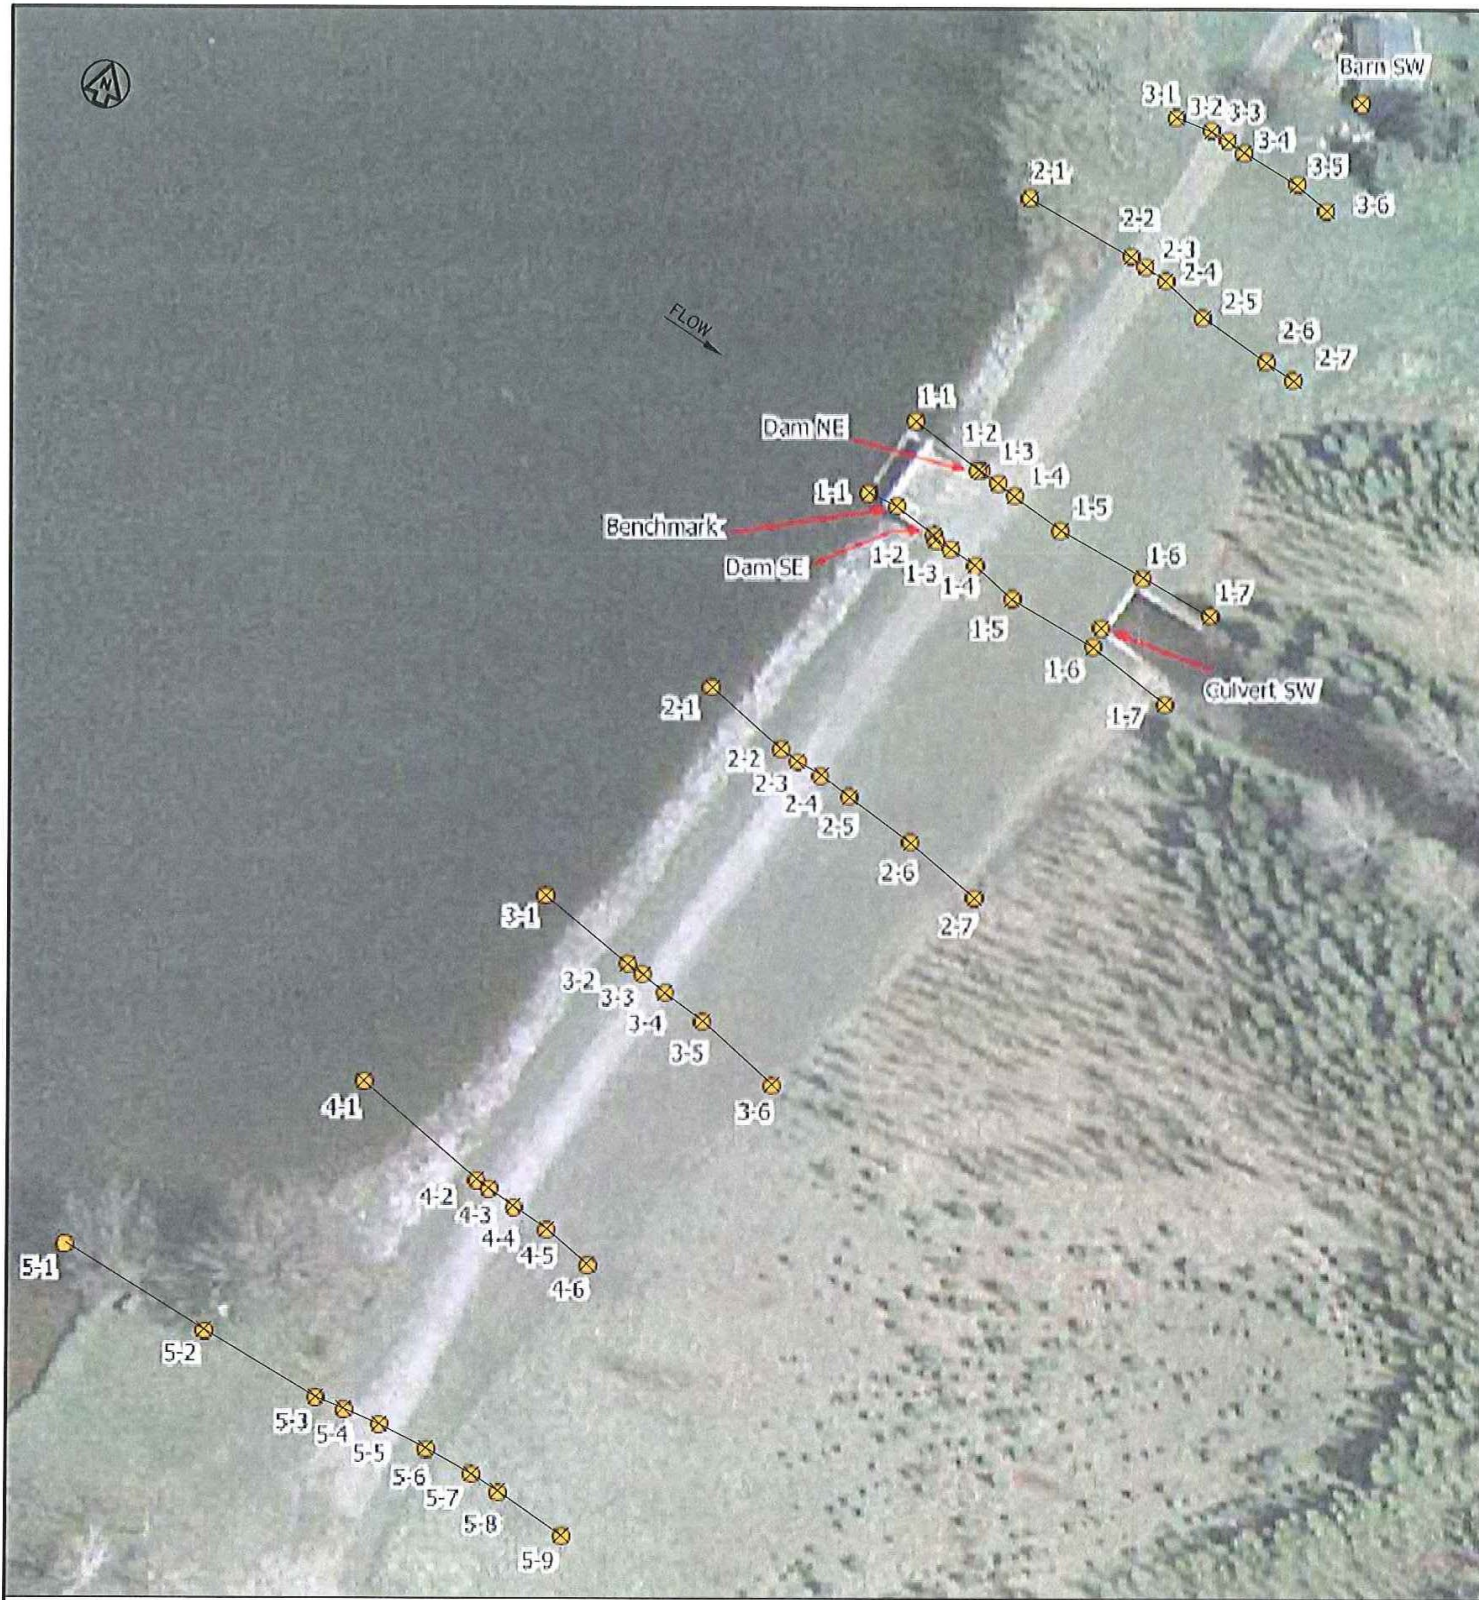
DRAWING No. 15816-GT-002

DAM - AS CONSTRUCTED CROSS SECTION LOCATIONS
 SCALE 1:300

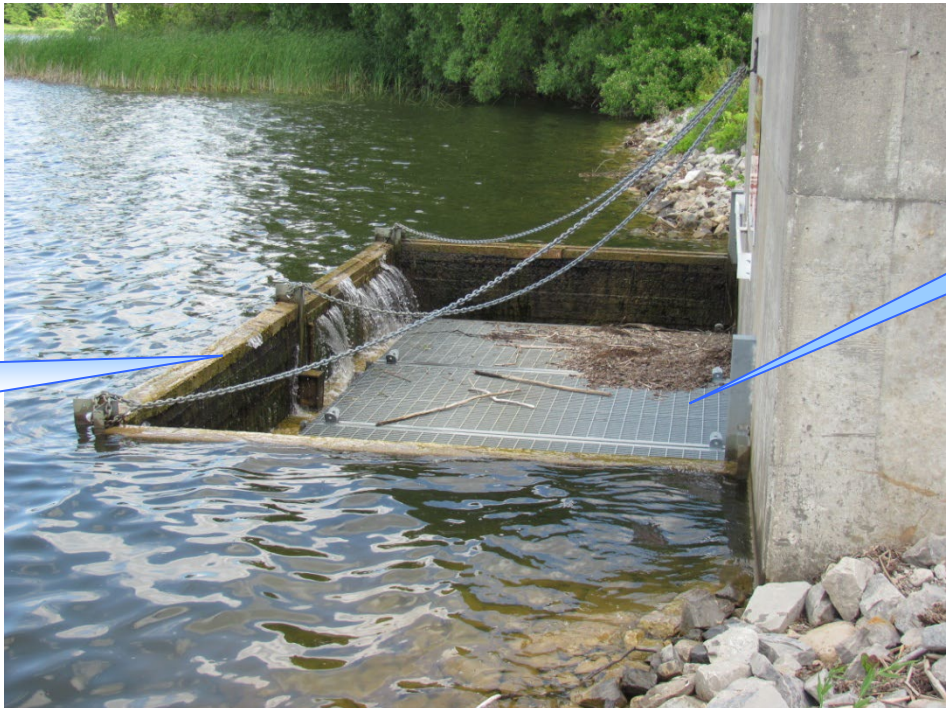
Photo 8: Drop inlet structure (July 2011)

Steel Grates

Stoplogs

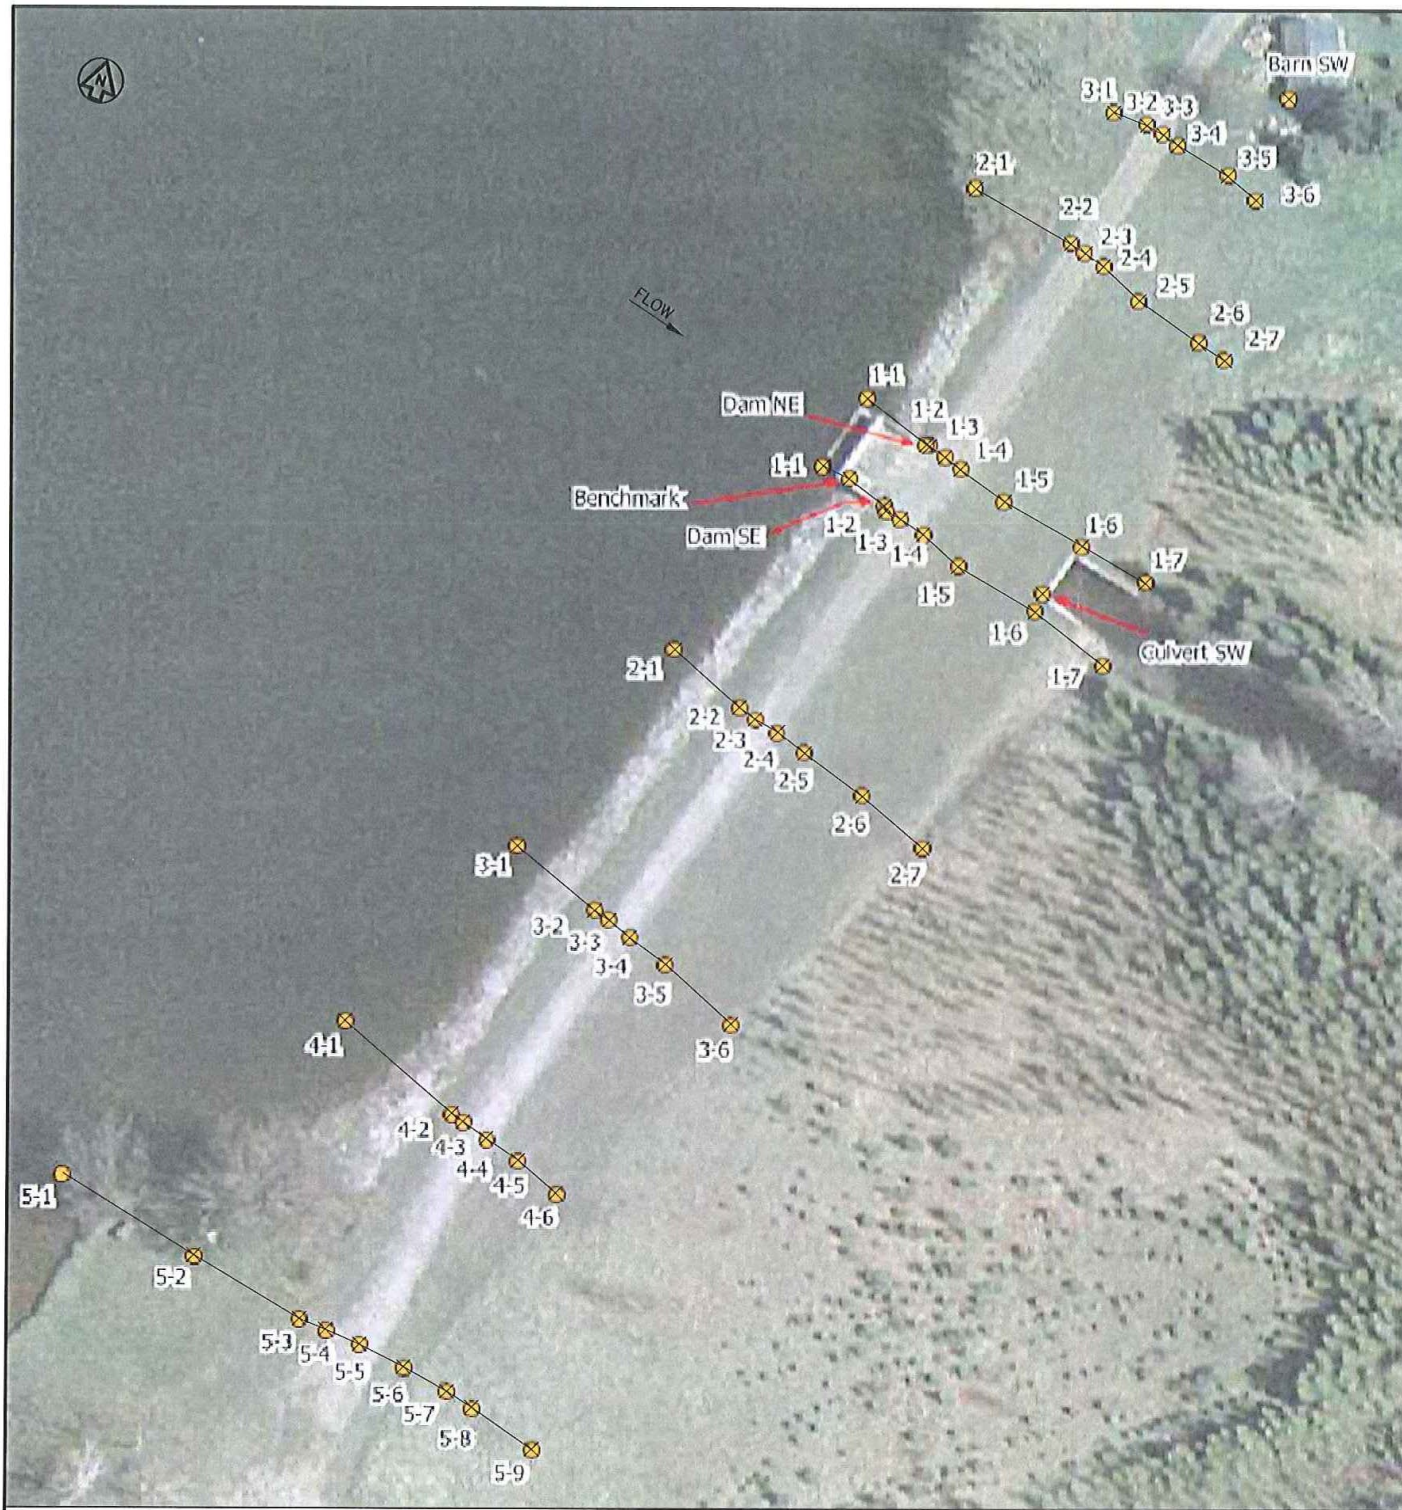
DRAWING No. 15816-GT-002

DAM - AS CONSTRUCTED CROSS SECTION LOCATIONS
 SCALE 1:300

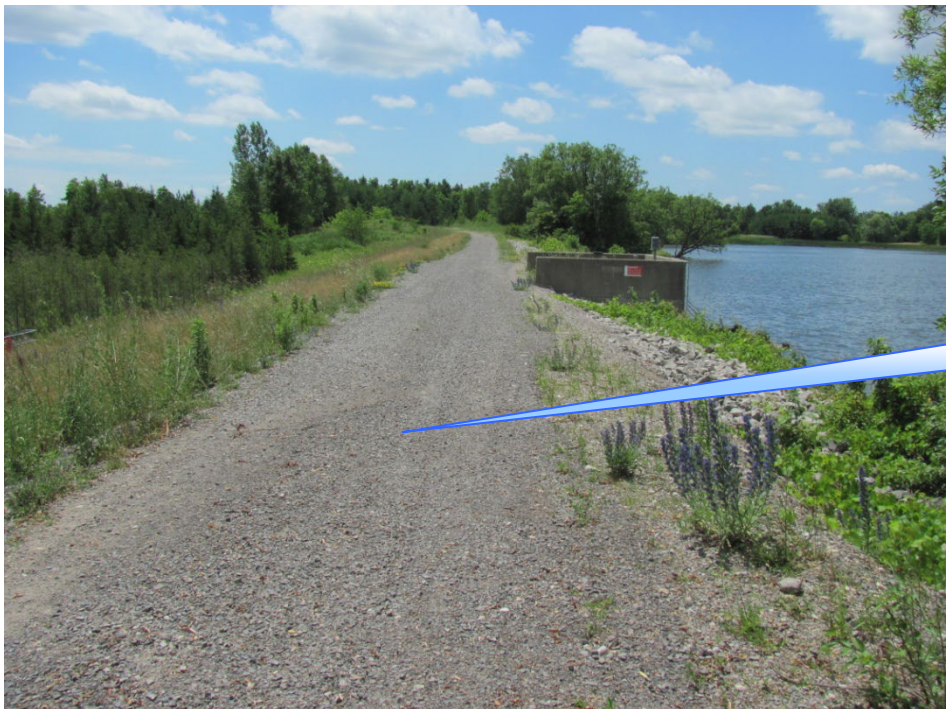
Photo 7: Looking north at dam (July 2011)

Dam
Crest/Roadway

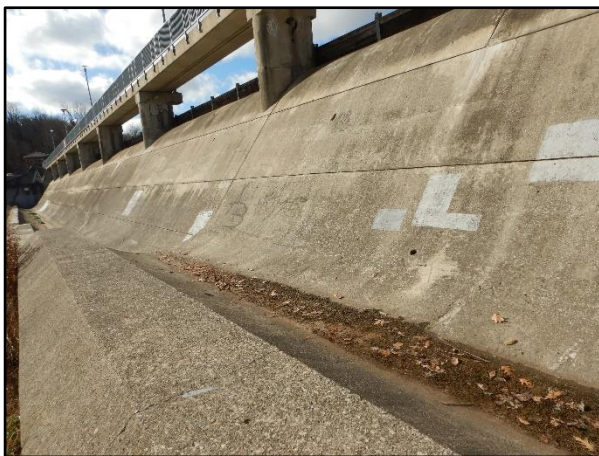
Photo 7 – Overflow Weir

- An approximately 109 m long overflow weir with a crest elevation of 235.93 m. Flashboards, measuring 0.6 m high, are installed on top of the overflow weir and can be removed in the event of a major flood. The ogee weir is shown in **Photo 7** and the flashboards can be seen in **Photo 9**.

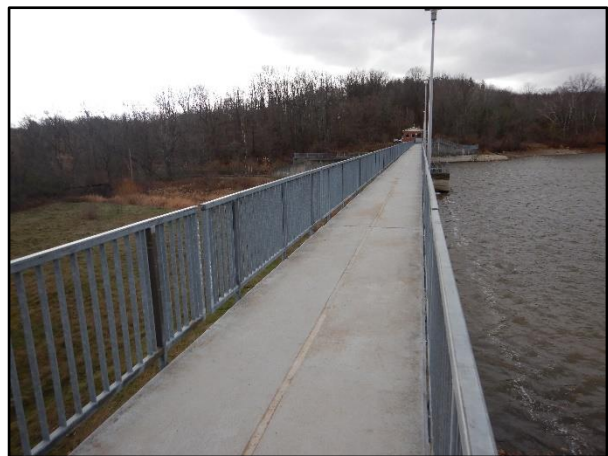
Photo 8 – Pedestrian Walkway

- A pedestrian walkway across the top of the dam (**Photo 8**).
- A drop inlet structure containing three (3) 1.83 m wide stoplog controlled bays, two (2) 0.6 m x 0.6 m gate valves and a 0.15 m diameter low flow valve. The stoplog bays have a sill elevation of 234.48 m. 0.53 m high (total) stop logs are installed in each bay during summer. The gate valves have an invert elevation of 229.52 m. The low flow valve has an invert elevation of 231.50 m.

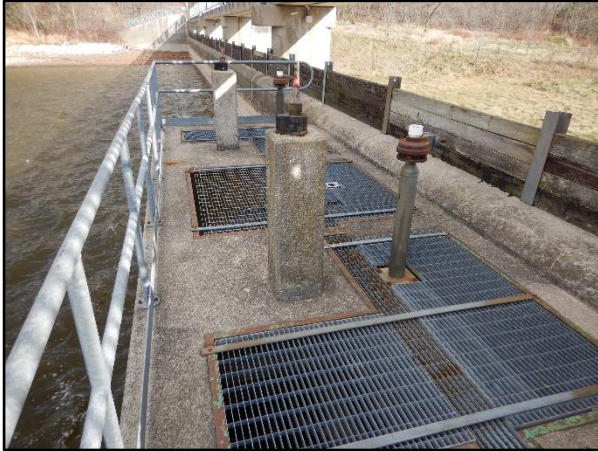
Photo 9 – Drop Inlet Structure Deck

The drop inlet structure deck is shown in **Photo 9**, the upstream side of the drop inlet structure is shown in **Photo 10** and the low flow outlet is shown in **Photo 11**. Flows out of the low flow outlet are discharged through the low flow channel (**Photo 12**) that flows through the emergency spillway (**Photo 13**).

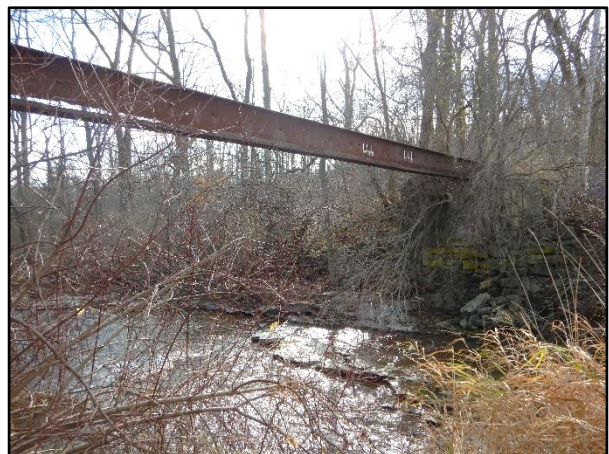
Photo 14 – Bridge Remnants

Along the low flow channel there is the remnants of an old bridge structure (**Photo 14**) and the Darnley Cascade (**Photo 15**), a natural feature.

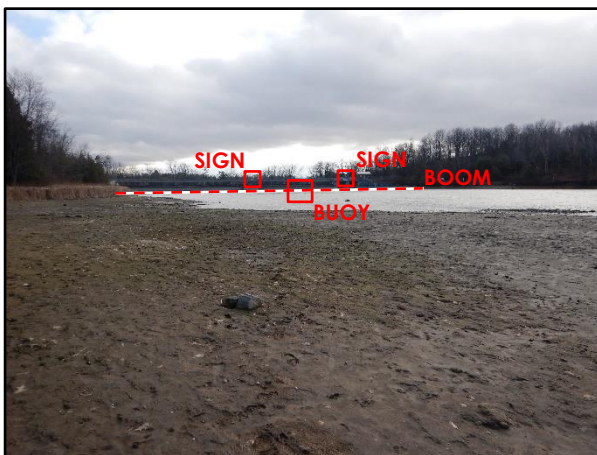
Photo 17 – Public Safety Signs and Safety Boom/Buoy from Upstream Area

- **Public Safety Signs** – There are upstream facing public safety signs installed on the dam. The signs are located above the drop inlet structure and the main spillway. As shown in **Photo 17**, these signs are difficult to see from the majority of the component area; however, they would be visible once approaching the dam. There are also ice safety signs (**Photo 18**) installed at various locations within the component area during the winter months.

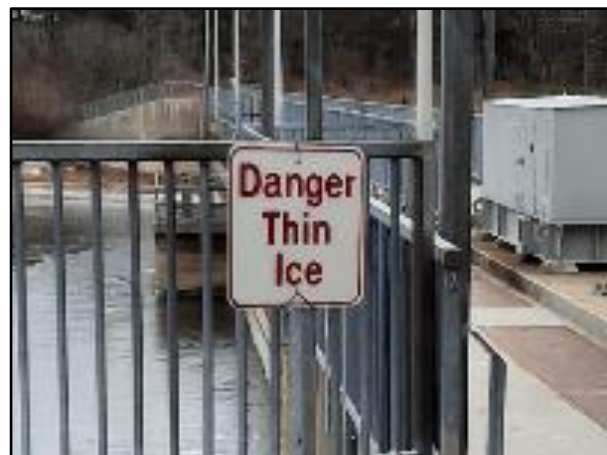
Photo 18 – Ice Safety Sign (Typical)

- **Public Safety Signs** – There are upstream facing public safety signs installed on the dam. The signs are located above the drop inlet structure (**Photo 21**) and the main spillway (**Photo 22**). The signs can be clearly seen from upstream of the public safety boom. There are also ice safety signs (**Photo 18**) installed at various locations within the component area during the winter months.

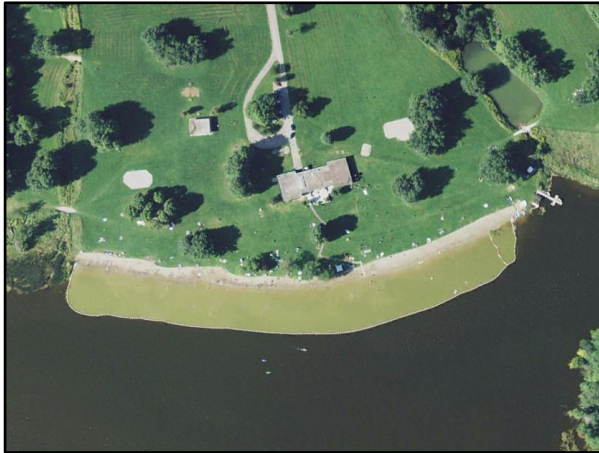
Photo 19 – Aerial View of Designated Swimming Area

- **Designated Swimming Area** – There is a designated swimming area located within the Conservation Area (**Photos 19** and **20**). This encourages swimming in a relatively safe area and away from the dam.

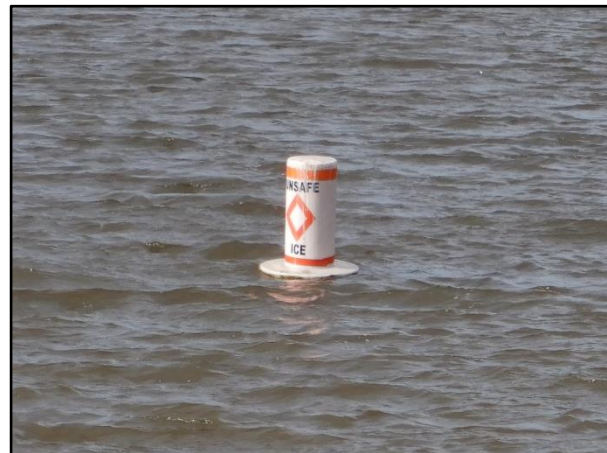
Photo 24 – Safety Buoy

- **Public Safety Boom and Buoys** – There is a public safety boom as well as a safety buoy installed upstream of the dam. The public safety boom and safety buoy are intended to warn members of the public as they approach the dam and the public safety boom is intended to prevent entry into the Headpond component area (Danger Area). The public safety boom (**Photo 23**) and the safety buoy (**Photo 24**) would be visible as members of the public approach the dam. The safety buoy includes the words “UNSAFE ICE” and generally appears to be in good condition, with the exception of a buildup of bird droppings. The public safety boom has alternating red and white floats and is in very poor condition. The floatation units are cracked/broken and HCA staff reported that some floatation units do not maintain buoyancy. The public safety boom is removed for winter.

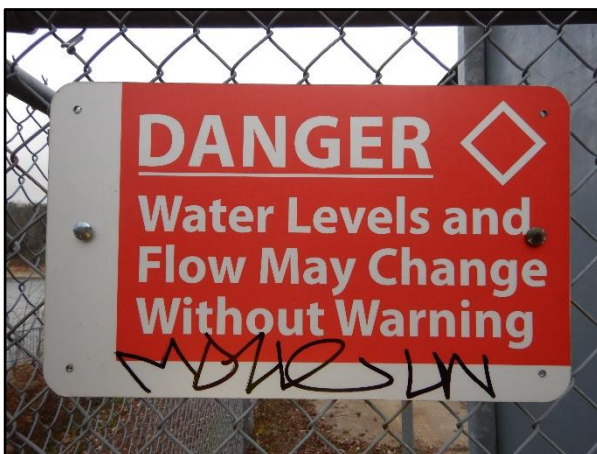
Photo 25 – Public Safety Sign on Right End of Storage Area for Winter Gate Panels

- **Public Safety Signs** – There are public safety signs warning members of the public installed on both the right (**Photo 25**) and left (**Photo 26**) sides of the dam. In addition there is a sign prohibiting the use of the overflow weir for skateboarding, biking and rollerblading (**Photo 29**). The signs are generally in good condition; however, the sign on the right side of the dam has some graffiti.

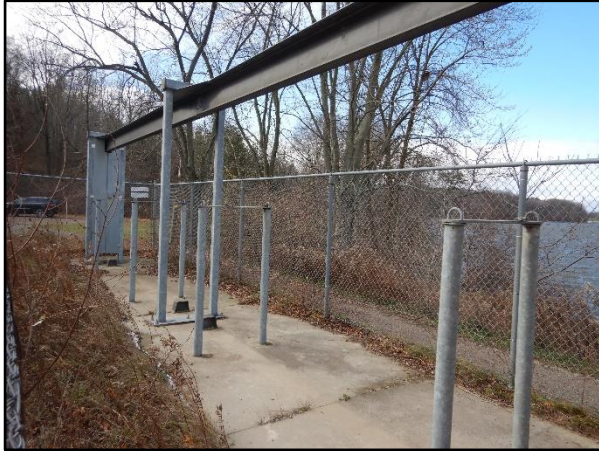
Photo 27 – Storage Area for Winter Gate Panels

- **Fencing/Railings** – There is chain link fencing around the storage area for the winter gate panels (seen in **Photo 27**) and railings on the wingwalls and around all sections of the dam deck (typical railing shown in **Photo 28**). The fencing and railings appear to be adequate for their intended purposes.

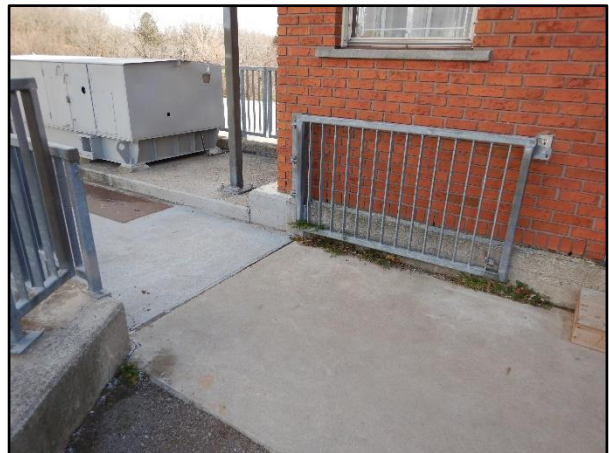
Photo 30 – Typical Pedestrian Barricade

- **Barricades** – Barricades have been installed at both ends of the dam structure (**Photo 30**). These barricades can be closed to block members of the public from accessing the deck of the dam during operations and maintenance. The gates are locked in the open position when they are not being used. There is also a barricade on the left side of the dam that would block larger vehicles (i.e. ATVs) from gaining access to the deck of the dam (**Photo 31**). It is understood that a person on horseback attempted to cross the dam but got stuck at this gate.

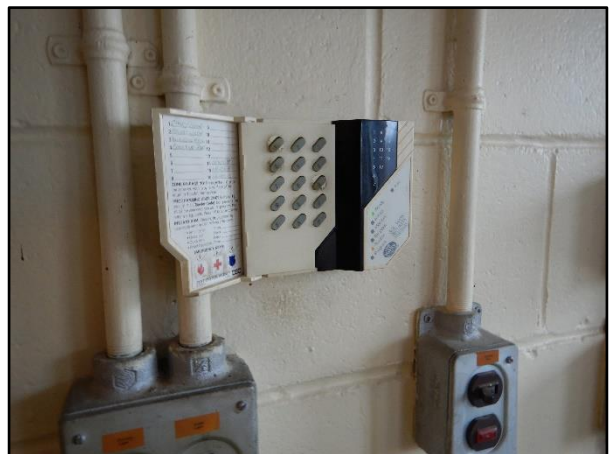
Photo 32 – Security System Keypad Inside Control Building

- **Video Surveillance and Control Building Security System** – A security camera was previously installed on the control building. The security camera is missing, however, its mounting plate (**Photo 33**) and identification sign (**Photo 34**) remain. HCA staff indicated that they are in the process of replacing the security camera. There is also a security system installed in the control building. The security system protects both the upper and lower floors of the control building and there is a key pad (**Photo 32**) on the upper floor to arm/disarm the alarm.

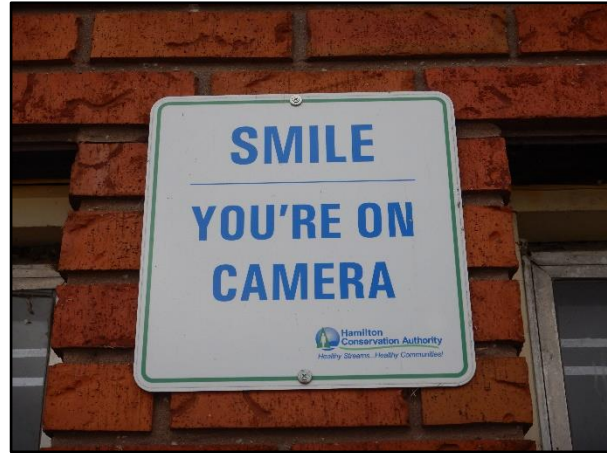
Photo 33 – Broken Security Camera

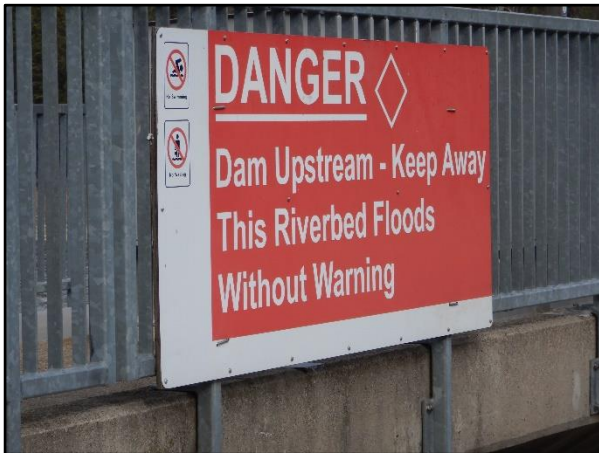
**Photo 35 – Public Safety Sign
Above Main Spillway**

- **Public Safety Signs** – There are downstream facing public safety signs installed on the dam. The signs are located above main spillway (**Photo 35**) and the low flow outlet (**Photo 36**). The signs can be clearly seen from the Main Spillway and Low Flow / Emergency Spillway component areas.

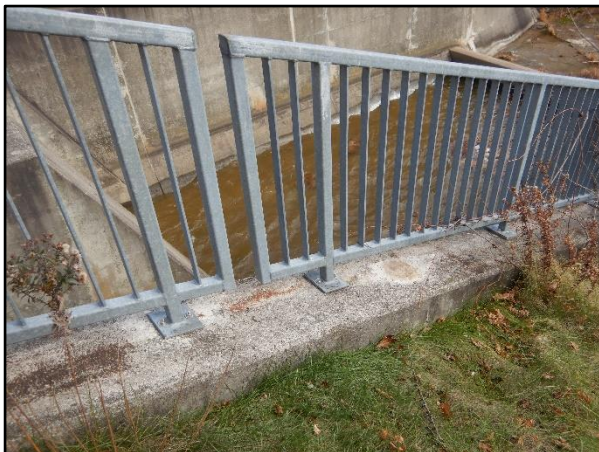
Photo 37 – Typical Railing

- **Fencing/Railings** – There is a railing along the top of the right retaining wall (**Photo 37**). The railing appears to be adequate for its intended purpose. There are no railings or fencing along the tops of the retaining walls (**Photo 38**).

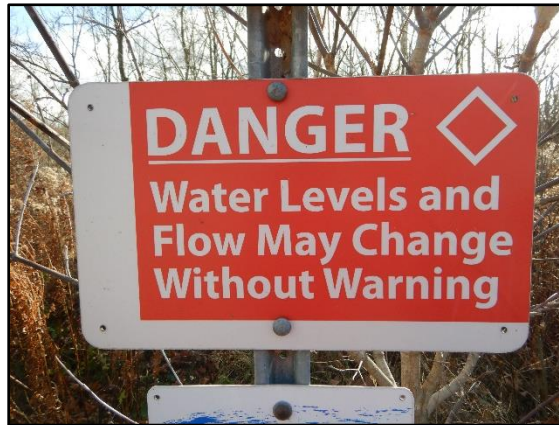
Photo 39 – Downstream Public Safety Sign

There are areas further downstream that may be impacted by changing water levels and flows. A typical public safety sign is shown in **Photo 39**. It is understood that these (or similar) signs are installed at the Crooks Hollow Conservation Area, Greensville Optimist Park and Webster Falls.

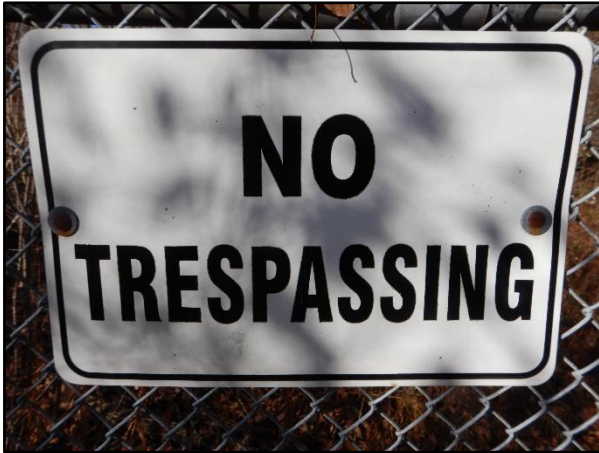
Photo 40 – Typical No Trespassing Sign

- **Public Safety Signs** – There are “No Trespassing” signs located at a number of locations around the exterior fencing (**Photo 40**) and a sign warning that the stone walls are in imminent danger of collapse located on the east wall of the mill ruins, adjacent to the Crooks Hollow Road bridge (**Photo 41**). The signs are generally in good condition; however, they do not surround the entire structure.

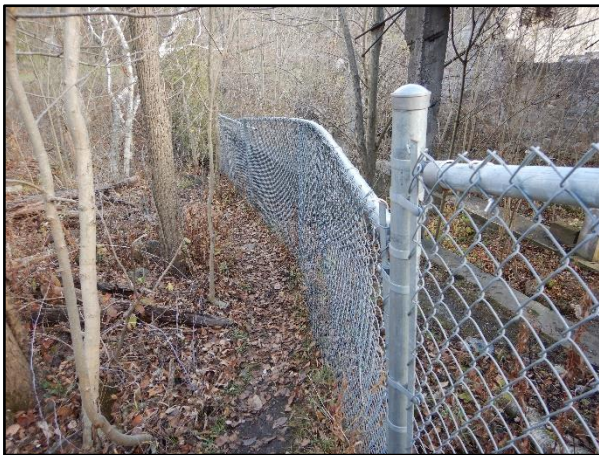
Photo 42 – Exterior Fencing

- **Fencing/Railings** – There is a fence that surrounds the majority of the mill ruins (**Photo 42**). A number of deficiencies were identified during the site visit. The end of the fencing on the northeast side of the mill structure stops short of the slope and does not return to the mill structure (**Photo 43**). This means that members of the public can simply walk around the fence to access the mill ruins. Other deficiencies with the fencing include bent sections and broken joints. Examples of these deficiencies are shown in **Photos 44** and **45**.

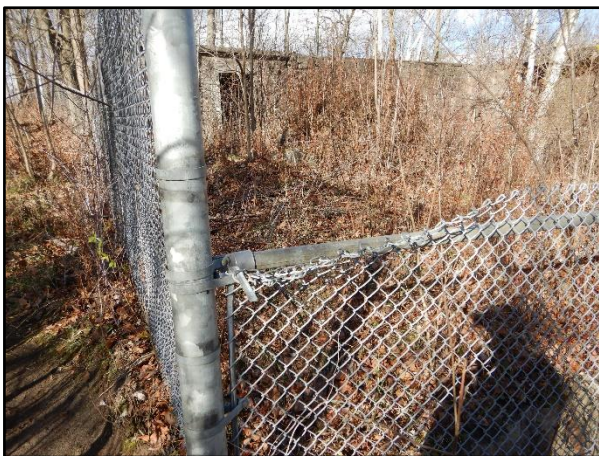
Photo 44 – Exterior Fencing Deficiency (Possible Evidence of Fence Climbing)

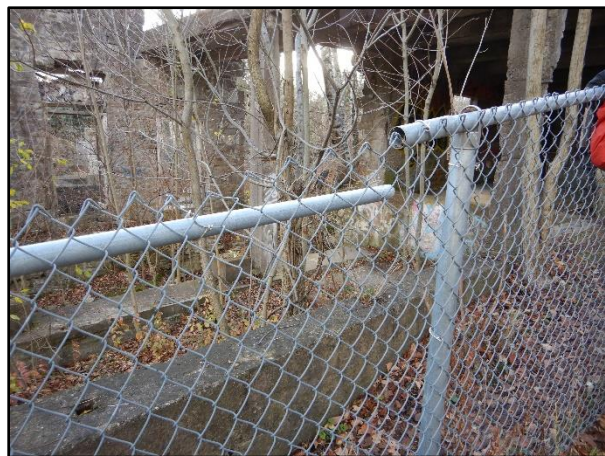
Photo 45 – Exterior Fencing Deficiency

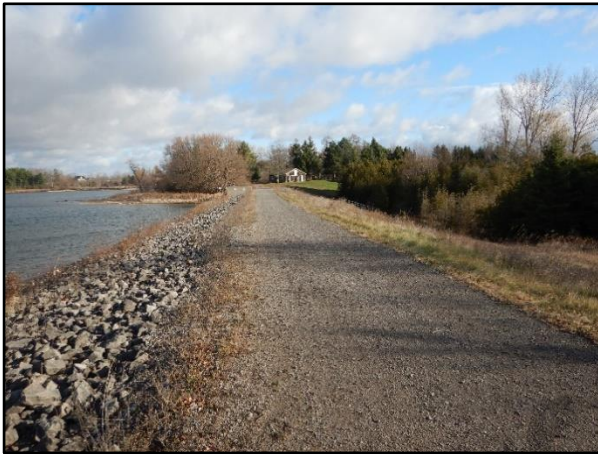
Photo 1 – Access Road Across Dam

- An access driveway, an access road across the top of the dam (**Photo 1**) and a parking area on the right side of the dam (**Photo 2**).
- An approximately 122 m long, 6.5 m high earth embankment (**Photos 3** and **4**).
- A concrete drop inlet structure with removable stoplogs (**Photo 5**).
- A low flow intake controlled by a valve (**Photo 6**).
- An outlet structure and tailrace channel (**Photos 7** and **8**).
- A conservation area that includes a number of recreational facilities, including trails, picnic areas, fishing, camping, boat launch/rentals and a swimming beach.

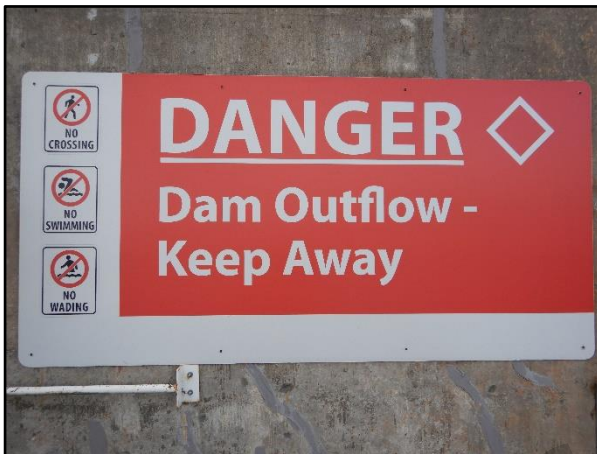
Photo 9 – Upstream Facing Sign

- **Public Safety Signs** – There is an upstream facing public safety sign installed on the inlet structure (**Photo 9**). The sign would be difficult to see from the majority of the component area; however, it would be visible once approaching the dam. There are also ice safety signs (**Photo 10**) installed during the winter months when the ice is considered to be unsafe. Note that the sign in **Photo 10** is shown installed at the Christie Lake Dam, however the signs used at the Valens Lake Dam are the same.
- **Designated Swimming Area** – There is a designated swimming area located within the Conservation Area (**Photos 11 and 12**). This encourages swimming in a relatively safe area and away from the dam.

- **Public Safety Signs** – There is an upstream facing public safety sign installed on the inlet structure (Photo 9).

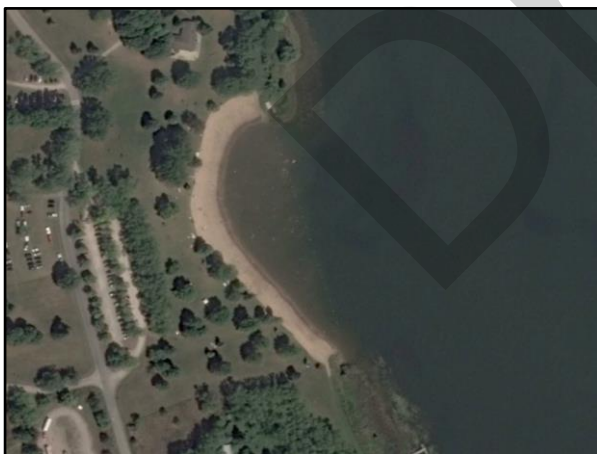
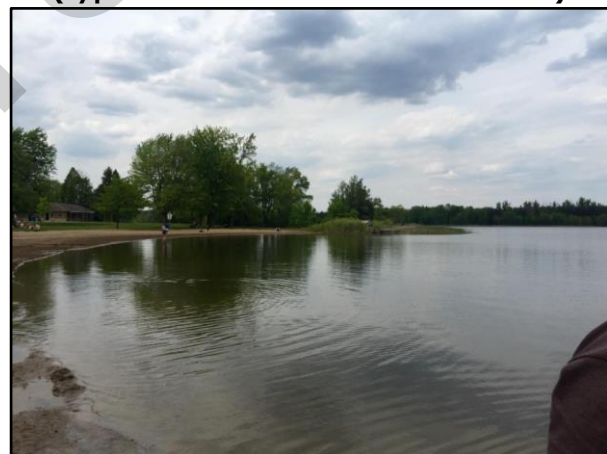
- **Designated Swimming Area** – There is a designated swimming area located within the Conservation Area (**Photos 11 and 12**). This encourages swimming in a relatively safe area and away from the dam.

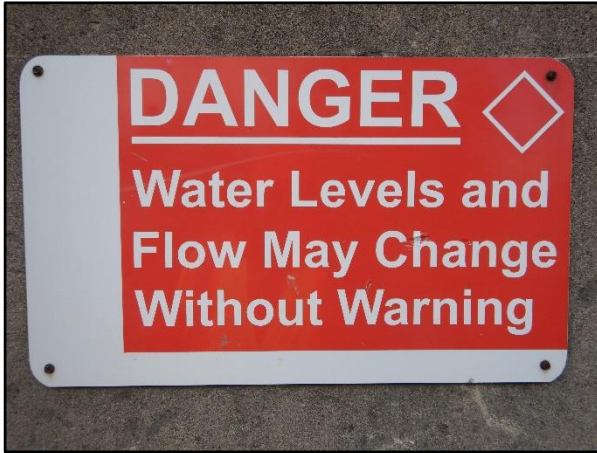
Photo 13 – Typical Inlet Structure Sign

- **Public Safety Signs** – There is an upstream facing public safety sign installed on the inlet structure (**Photo 9**). There are also public safety and information signs located on both sides of the inlet structure (**Photos 13 and 14**) and on the outlet structure railing, facing upstream (**Photos 15 and 16**).
