Board of Directors Meeting Agenda

Thursday May 2, 2024

Board of Directors Meeting

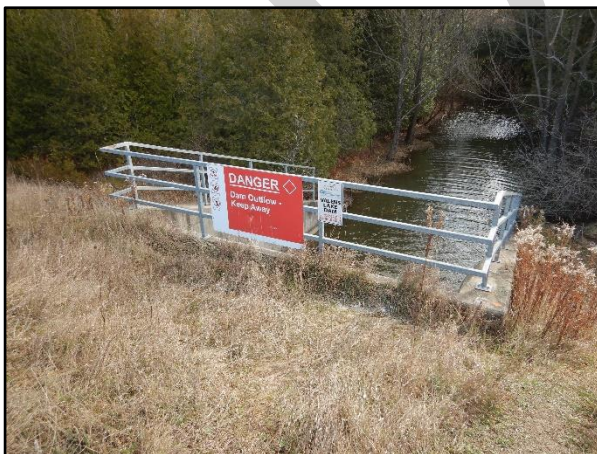
Photo 17 – Outlet Structure Railing

- **Fencing/Railings** – There is a railing around the top of the outlet structure headwall and wingwalls (**Photo 17**). The railing does not meet the requirements of the Ontario Building Code.

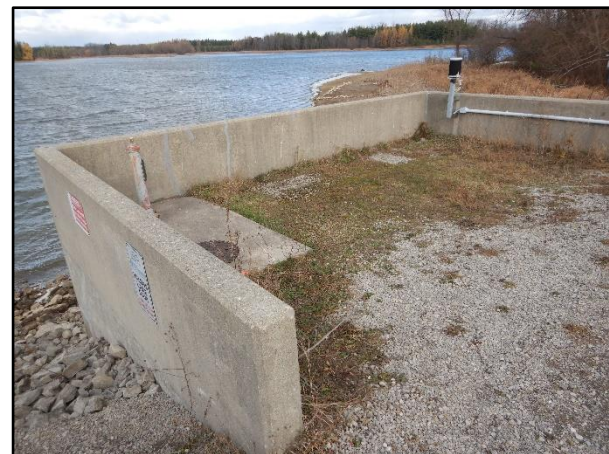
Photo 18 – Inlet Structure Barricade

- **Barricades** – There is a concrete barricade around the inlet structure (**Photo 18**). This barricade generally appears to be adequate for its intended purpose.

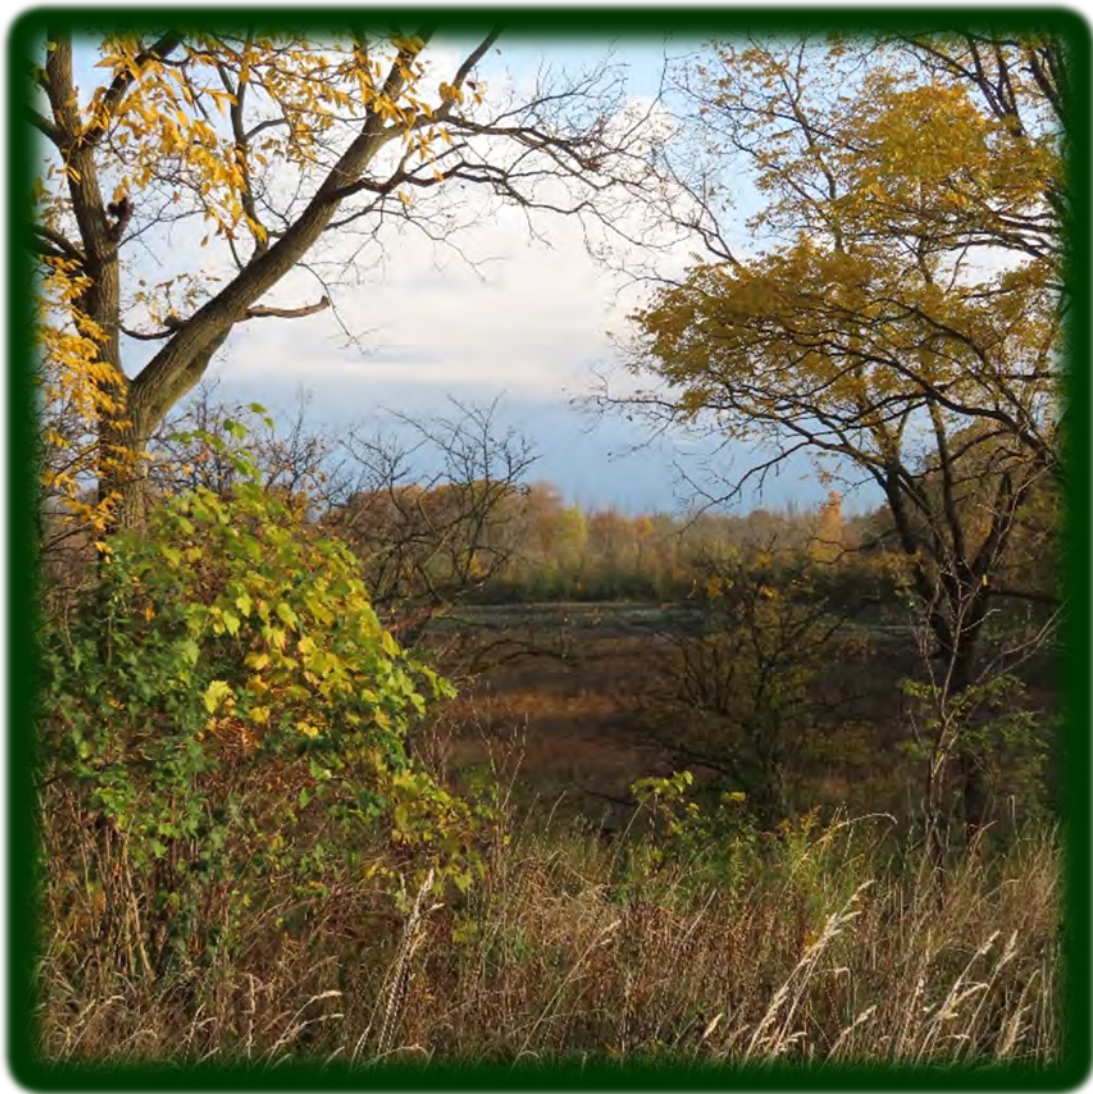
FIGURE 4. CITY OF HAMILTON ZONING

The Saltfleet Conservation Area BC-1 property is under the City of Hamilton's Rural Official Plan (OP, City of Hamilton 2018) and Stoney Creek Zoning By-law, Ward 9, and is classified as Rural Land Use 'Specialty Crop' and zoned A1 Agricultural and P6 Conservation/Hazard Land. The

Agricultural Zone (A1) is the major area of the SCA property, formerly farmed. The Conservation/Hazard Land Zone (P6) applies to the wooded area northwest of the creek.

The City zoning regulations prescribe permitted uses, setbacks for buildings and parking areas, and the wetland areas as mapped by the Hamilton Conservation Authority. The City of Hamilton planning department has been consulted and their comments addressed in the preparation of this Master Plan.

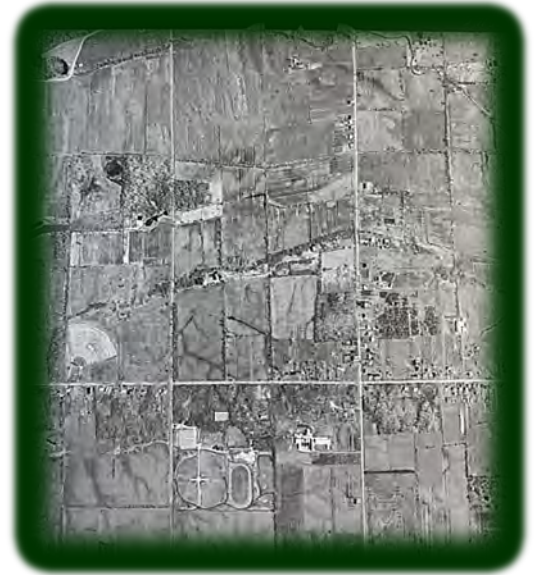
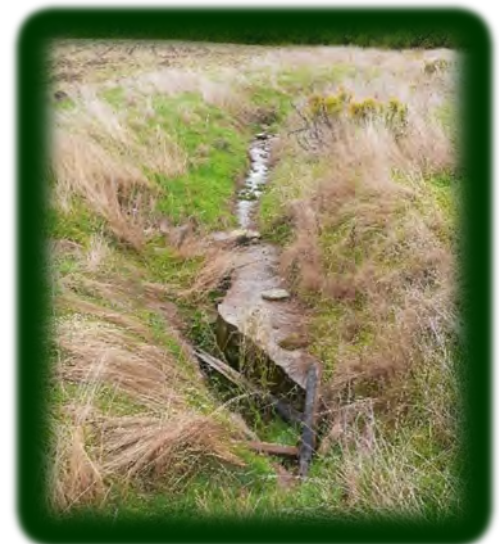
FIGURE 6. STRUCTURES AND KARST FEATURES

The site contains karst topography that affects drainage patterns on site. The most noticeable karst features are the seeps at the base of the Eramosa Escarpment in the middle of the site, the sinkhole in the open field south of the main entrance with a disappearing stream, and the stream that flows from the base of ridge. Infiltration and runoff are difficult to separate, and infiltrated precipitation may break out in springs as secondary runoff. Noticeable karst features are noted on Figure 6 Structures and Karst Features. Further investigation of the karst features is recommended in the capital projects plan, see Section 8.2.

See Sections 4.6 and 4.7 for site historic information and Figure 6 for structures and karst feature locations.

When HCA acquired the SCA property only a few structural items and debris were left from the former farm occupation. Debris piles were found near the entrance gate and parking area which HCA staff removed to open the laneway and parking area to the public. Remnant farm features of interest for further interpretation include the stone silo and stone wall near the karst stream, and the silo and building foundation ruins. Further study of these areas is recommended.

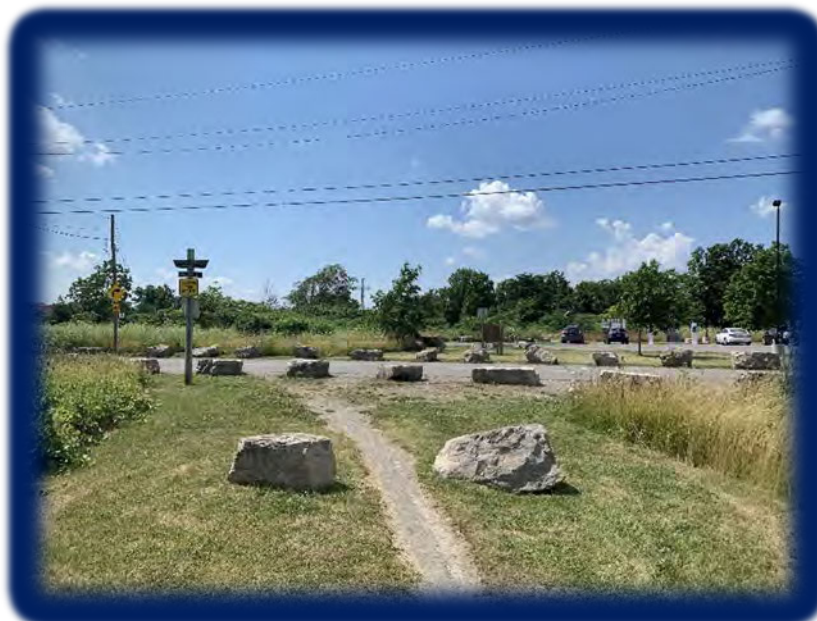
The trail-head for the west end of the trail is located at the DPCA visitor parking lot on Ridge Road. Visitors may access the Dofasco Trail as well as the Bruce Trail from this location

The Ridge Road trail entrance does not have the trail gates and barriers found at most other road crossings for the trail. Instead, there are large rocks spaced along the side of the road to restrict vehicle parking and access onto the trail.

Where the trail crosses Stoney Creek there is a clear-span steel bridge in good condition.

The trail surface for most of this section is mown grass, with a stone chip path varying in width down the center making it suitable for cyclists. At First Road East, there is a typical trail gate/barrier allowing cyclists and pedestrians to pass through while restricting vehicles. However, it was observed that unauthorized motorized access (ATV's) was occurring at this location on the farm lane running due west to Ridge Road. HCA staff have had to place temporary barricades and sign this lane as off-limits to trail users. Unauthorized access such as this will need to be addressed in the wetland design project proposed for the DPCA SC-5 property.

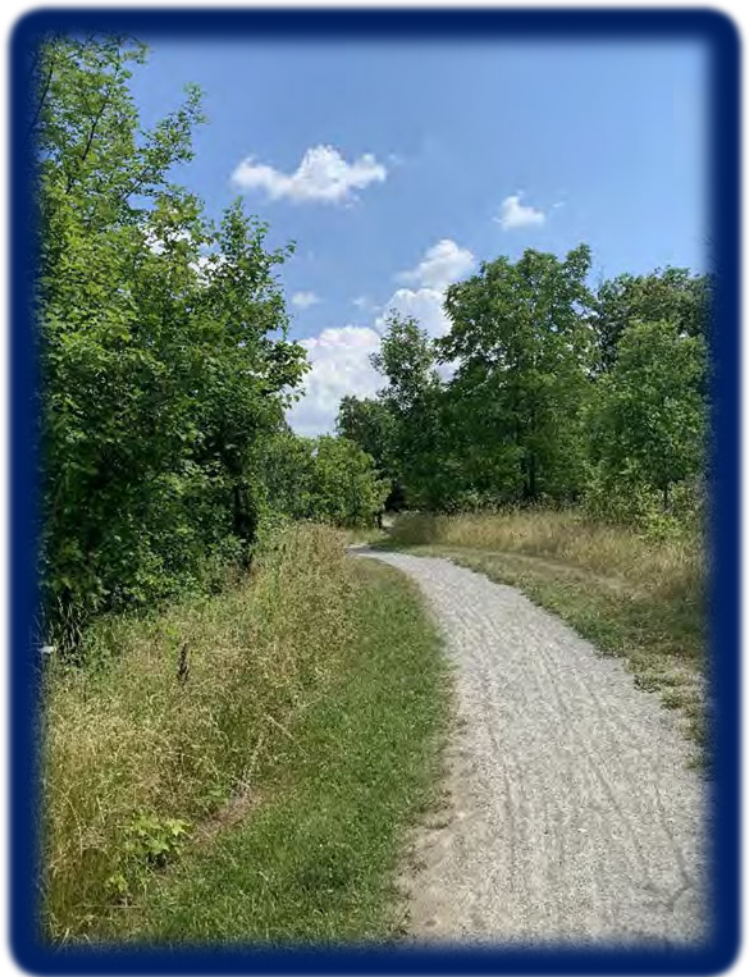
The surface is stone chip and the entire stretch of trail is enclosed by well-pruned vegetation. The entrances at First and Second Road East have standard gate arrangements, however the entrance at Second Road is missing one post from the typical configuration. A large rock is in its place. The sightlines at Second Road East need improvement, pedestrians and cyclists must get very close to the road edge in order to see oncoming vehicles. There is a culvert under the trail along this stretch that is in poor condition and should be replaced.

At the time that this inventory was completed, the Saltfleet wetlands were under construction. In September 2022 Saltfleet re-opened to the public, with trail access from the Dofasco Trail connecting to the Saltfleet parking lot. Trail users are just starting to discover this trail connection and parking area for the Dofasco Trail.

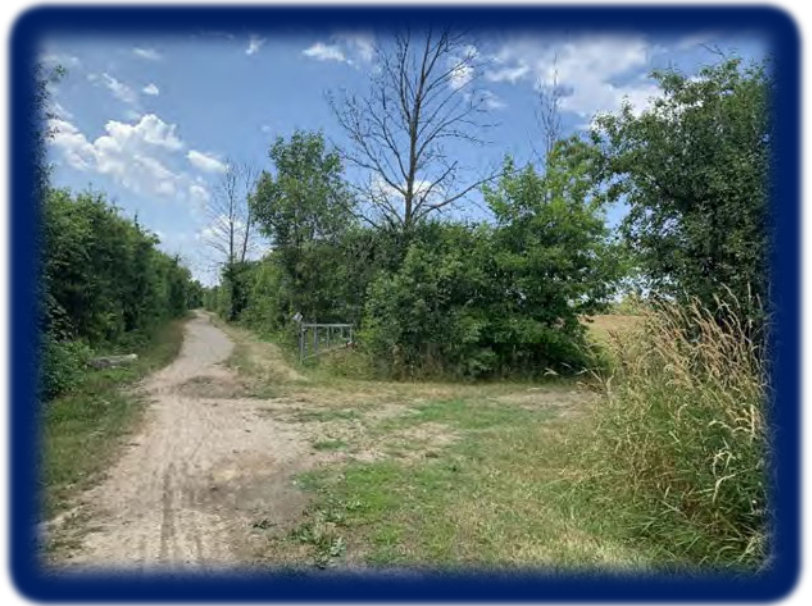
The standard trail gates on the east side of Second Road East are set back further than on the west side. This allows farmers enough room to use the start of the trail as an access point to fields on either side of the trail. Further east, access points from these fields through the trees were visible on both sides of the trail. The openings could allow ATV access to the trails. The trail surface through this section is grass, compacted earth or stone chip. Near Third Road East there is a clear span bridge with wood decking crossing Stoney Creek. The bridge looks to be in good condition, but due to seasonal flooding, the trail design on the west side of the bridge should be reviewed. The gate at Third Road East is in the typical configuration allowing for bicycle and pedestrian access.

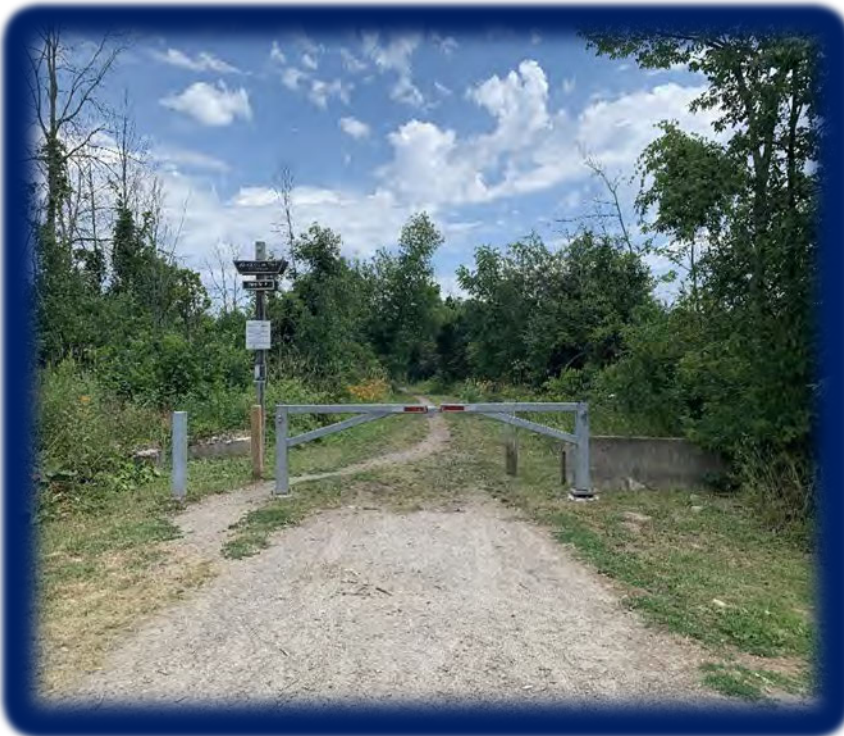
The gate on the east side of Third Road East is laid out in the standard configuration. There is a concrete barricade blocking vehicle access on the south side of the gate. The trail passes through woods north and south of the trail, the forest cover offers shade and natural habitat. HCA owns the forested property to the south.

The trail gate on the west side of Tapleystown Road is set back about 245 meters from the road. This setback allows adjacent land owners to access their property from the unopened road allowance. However, no access onto adjacent lands from the trail was observed, and dumping and vandalism were occurring on this part of the trail. This activity could be curtailed if new trail gates and barriers were permitted to be installed closer to Tapleystown Road. If new gates are installed closer to Tapleystown Road, they will be a style that facilitates accessibility for all trail users. Further review of this area with the City is recommended.

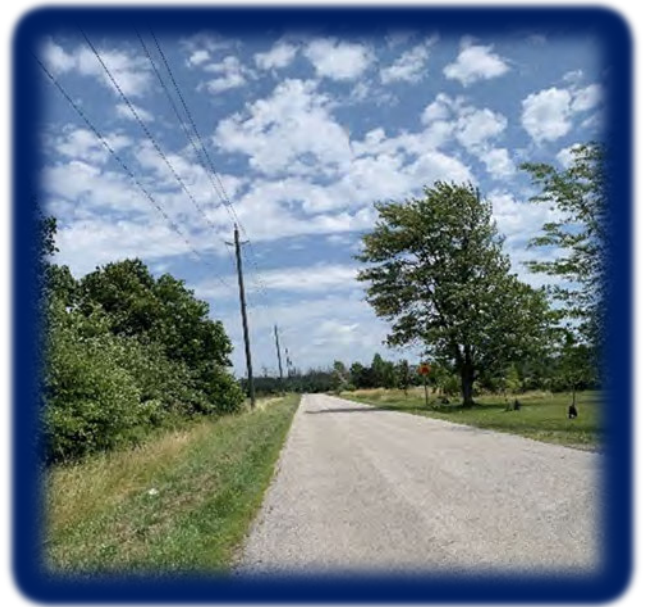
This is the only on-road section of the Dofasco Trail. Trail users can walk along Powerline Road from Tapleystown Road to Fifth Road East, a distance of about 875 meters. The road surface is asphalt and there is no sidewalk or gravel shoulder, nor signs indicating this is a portion of the trail. When this road requires replacement, it would be desirable to accommodate the trail in the road design. It is common for visitors to park their vehicles on Powerline Road and access the trail at Fifth Road East leading into the Vinemount South Swamp.

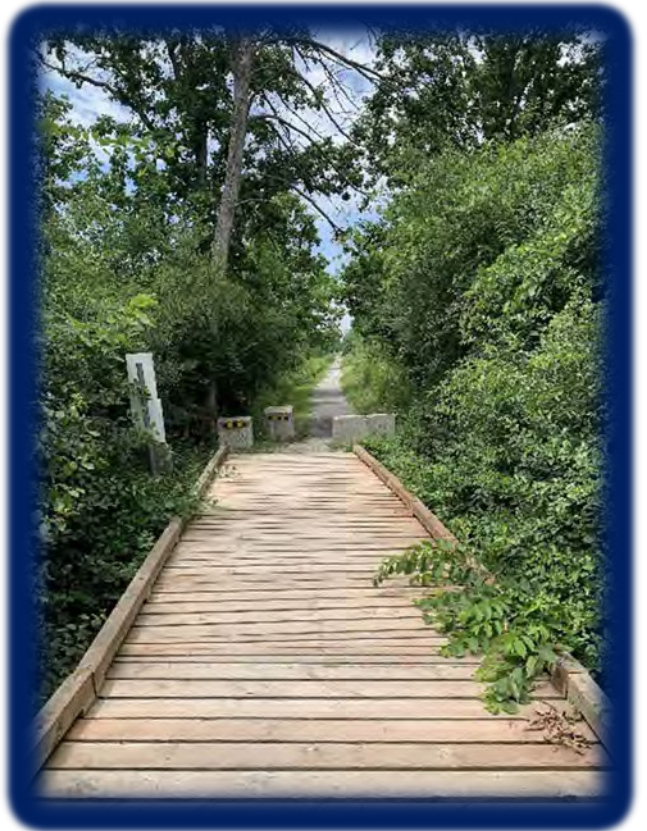
Sixth and Seventh Road East do not extend through this area, so the trail from Fifth to Eighth Road East doesn't have any road crossings. The east side of Fifth Road East has trail gates allowing pedestrian and cyclist access. Heading east, the trail has a stone chip surface for about 400 meters to reach the boardwalk at the Vinemount South Swamp. There is also a clear span bridge with wood decking crossing a watercourse near the center of this segment. This bridge appears to be in good condition. The boardwalk is almost two kilometers in length, with a 380 meter stone chip trail section mid-way to Eighth Road East. At the beginning of each boardwalk section, concrete blocks are in place to prevent motor vehicle access. These were originally installed in 2010 and should be reviewed for safety and accessibility, as well as the grade of the trail up to the boardwalk. The boardwalk was recently replaced by HCA and is in very good condition. At the time of this inventory, there was one remaining boardwalk section to be replaced (west end of east boardwalk); this was completed in the winter of 2023. At Eighth Road East, the boardwalk starts about 140 meters in from the road. Approaching the boardwalk, the trail has a stone chip surface. The gate on the west side of Eighth Road East is in the standard arrangement. Parking along the shoulder of Eighth Road East has been observed, this may be a popular access point for visitors.

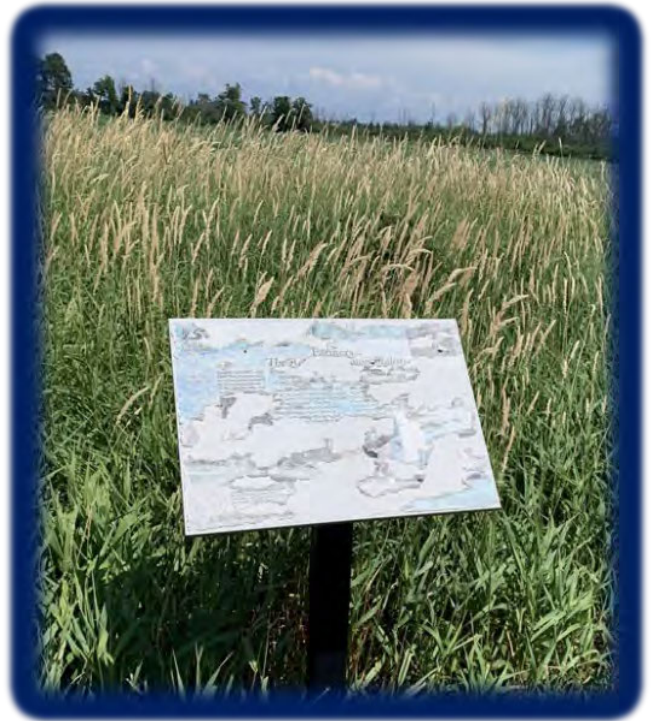
Ninth Road East does not extend through this area, so the trail is uninterrupted between Eighth and Tenth Road East. The gate on the east side of Eighth Road East is in the standard arrangement. The trail surface between Eighth and Tenth Road East is stone chip, but the mown grass is encroaching on the trail surface for various lengths leaving a narrow stone chip path down the center. This trail section is very open, mostly passing between agricultural fields. Hedgerows along some parts of the trail section provide shade and windbreak.

There is an interpretive sign about 130 meters east of Eighth Road East that is in very poor condition. The sign panel has deteriorated leaving only about 50% of its content. There is a steel bridge crossing Forty Mile Creek near Tenth Road East that appears to be in good condition. Along Tenth Road East, there is an active quarry run by Waterford Sand and Gravel on the south side of the trail that produces a fair amount of noise. The quarry property is fenced off from the trail and has “No Trespassing” signs posted. The Canadian Pacific Railroad crosses the trail at Tenth Road East. The trail follows on Tenth Road East and does a jog across the railroad tracks, the safety of this crossing should be reviewed.

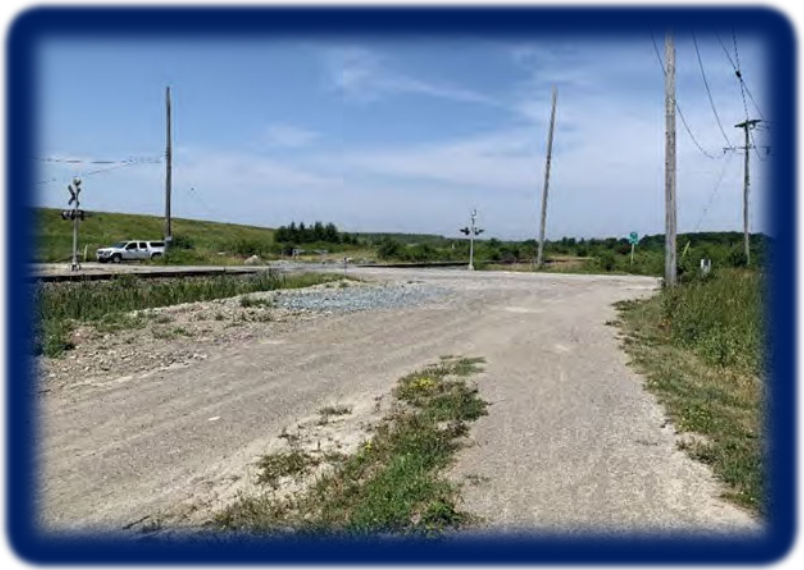
The intersection at Tenth Road East poses some challenges for trail navigation. The trail alignment is interrupted by the railway tracks, and there are no trail gates on the east side of Tenth Road East.

A private driveway on the east side of the road, and the trail entrance, merge at this location. Trail wayfinding and safety signage could be improved in this location.
