# Hamilton Conservation Authority Shoreline Management Plan

**Hamilton Conservation Authority**

October 20, 2023

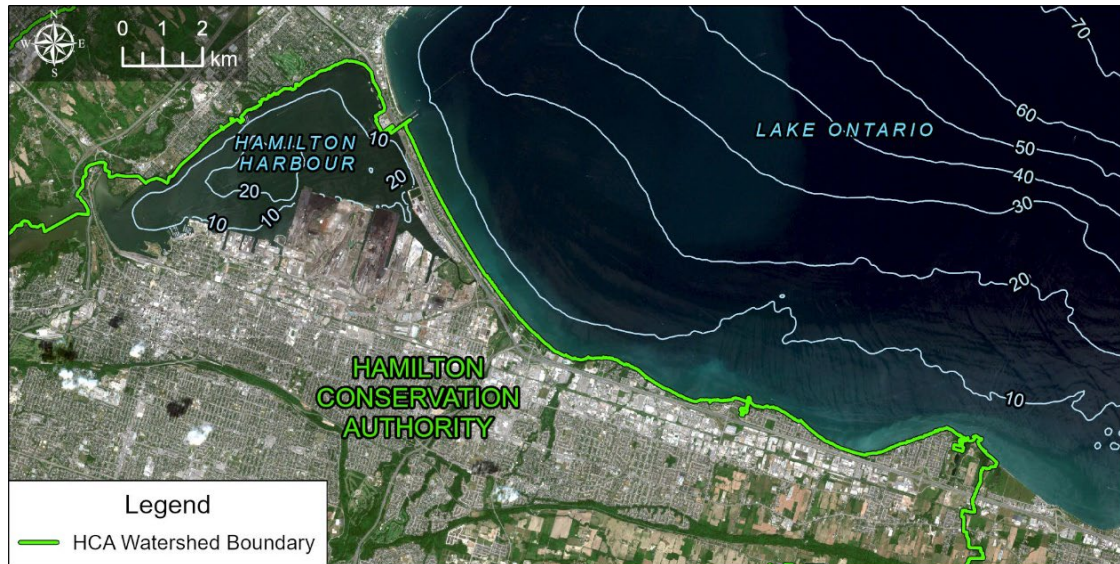
Figure 1.1 Hamilton Conservation boundary

Zuzek Inc. in partnership with SJL Engineering Inc. (SJL) and DHI were retained by the Hamilton Conservation Authority (HCA) to update the existing coastal hazard mapping and prepare this Shoreline Management Plan (SMP). Section one outlines the principles and objectives of the SMP, summarizes the report structure, and provides vertical datum conversions. A map of the HCA boundary along the shoreline is provided in Figure 1.1.

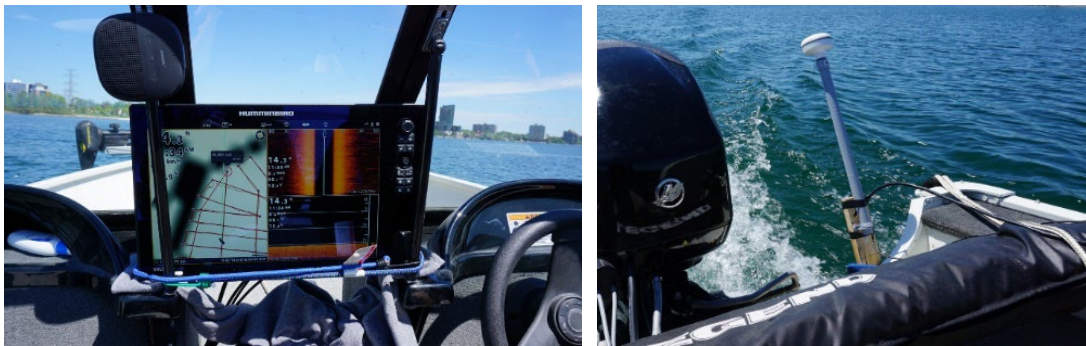
**Figure 3.7 SOLIX data collection unit and transducer mount**

Staff from Zuzek Inc. conducted a nearshore bathymetry survey from September 17-18, 2022. The raw data was collected with a SOLIX, a single-beam bathymetric and sonar system with built-in navigation and recording tools. The transducer was mounted at the back of the boat with a dedicated GPS antenna located directly above the unit. Refer to Figure 3.7. The unit auto-

corrects for the depth of the transducer below the lake surface, with depths recorded every second.

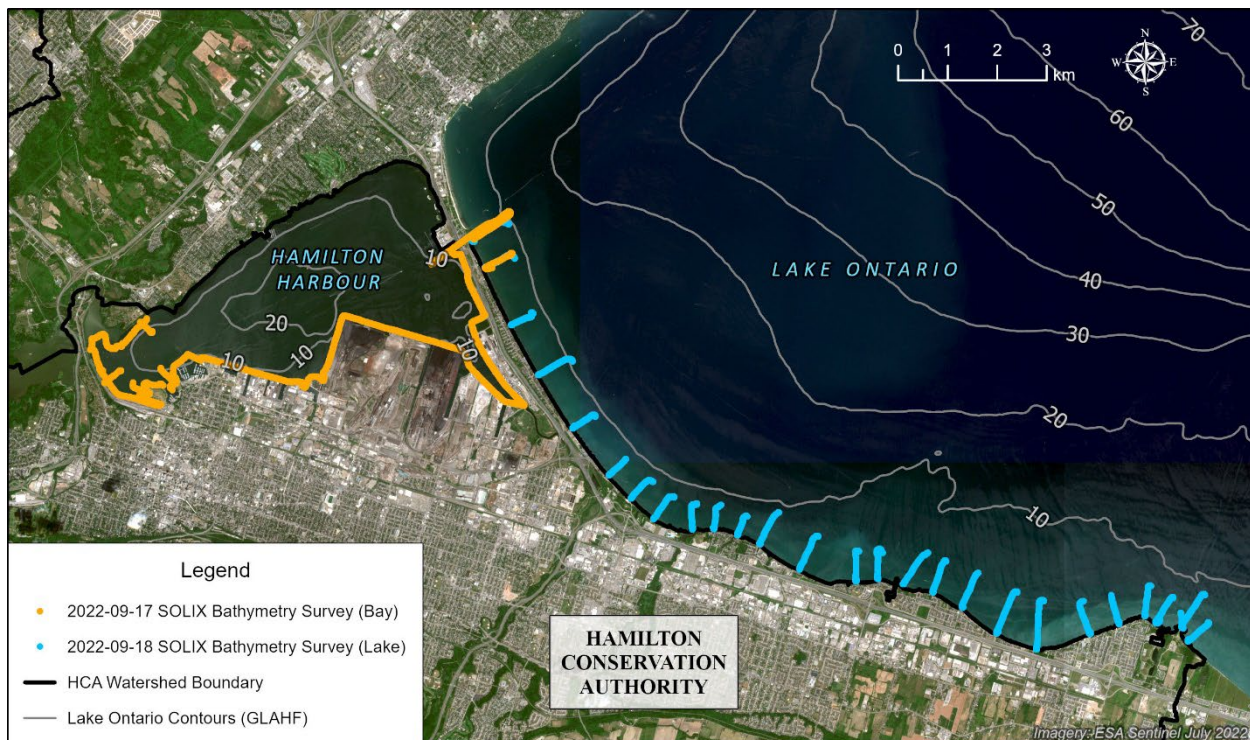
**Figure 3.8 August 2021 SOLIX bathymetry survey**

A total of 29 recordings were collected within the project study area. See Figure 3.8 for an overview of the bathymetry data collected.

The depth readings for each survey were corrected using an average of hourly measured water levels for the day of the survey, from the Burlington water level gauge (#13150) acquired from the Government of Canada (Fisheries and Oceans) water level website. To calculate the corrected lake bottom elevation in the IGLD'85 datum, the average water level was added to the SOLIX depth for the corresponding day. For example, the average hourly water level for the duration of the survey completed in on Sept 18, 2022, was 74.58 m IGLD'85, taken from the

To determine appropriate horizontal setbacks to account for wave uprush along the HCA shoreline, uprush calculations were completed at 30 locations where bathymetry was collected. Refer to Figure 3.8 for the locations of each bathymetric profile collected for the study. The water level used in the wave uprush analysis was the 100-year flood level (+76.2 m IGLD85'),

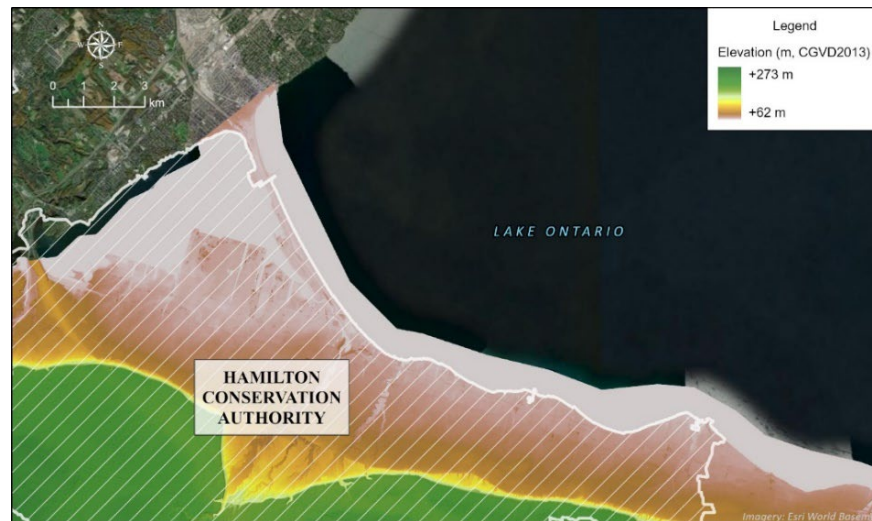
**Figure 3.10 NRCan 2021 LiDAR elevation coverage**

The 2021 LiDAR acquisition is the most recent LiDAR collection that provides complete coverage of the Lake Ontario shoreline and Hamilton Harbour. Digital Terrain Model (DTM) raster products were downloaded from Open Government and mosaiced into one raster covering the study area (Figure 3.10). The DTM's have a horizontal resolution of 1 metre and elevations are referenced to the Canadian Geodetic Vertical Datum of 2013 (CGVD2013). The DTM

mosaic was converted to an IGLD'85 vertical datum by adding 0.52 m to all elevations within the DTM. Refer to Section 3.3.1 for additional information on vertical datum conversions.

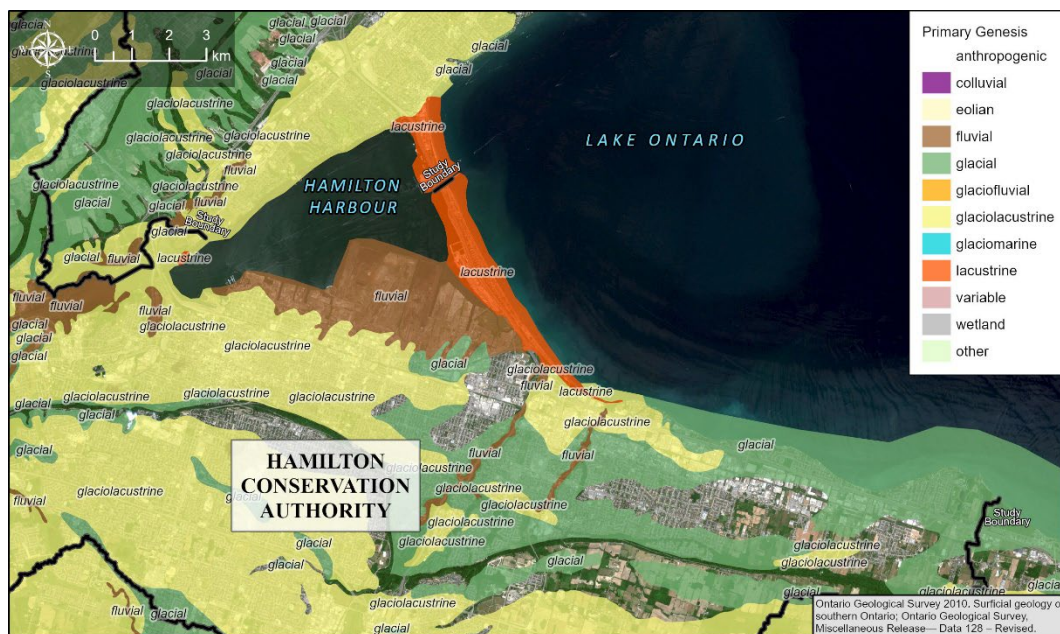
**Figure 3.11 Surficial Geology of Southern Ontario (Ontario Geological Survey, 2010)**

Mapping of the surficial sediment for the study area is available from the Ontario Geological Survey (2010). Refer to the map in Figure 3.11. Areas with bedrock exposures, such as the Niagara Escarpment, are not mapped. The shoreline from Fifty Point to Confederation Park features sediment that was deposited during previous glacial periods, such as glacial till (consolidated cohesive sediment that forms at the base of glaciers). The shoreline from Confederation Park to the federal navigation channel consists of lacustrine sediment, sands and gravels, deposited in the modern lake environment (the existing post-glacial period). These sediments were eroded from the shore and lake bottom and transported northwest to form the historical barrier bar that separated Hamilton Harbour from Lake Ontario. The port lands on the south shore of Hamilton Harbour were constructed of lake fill, classified as fluvial sediment. Finally, the southwest and west shorelines of Hamilton Harbour feature glaciolacustrine sediment, deposited in lake environments during glacial periods.

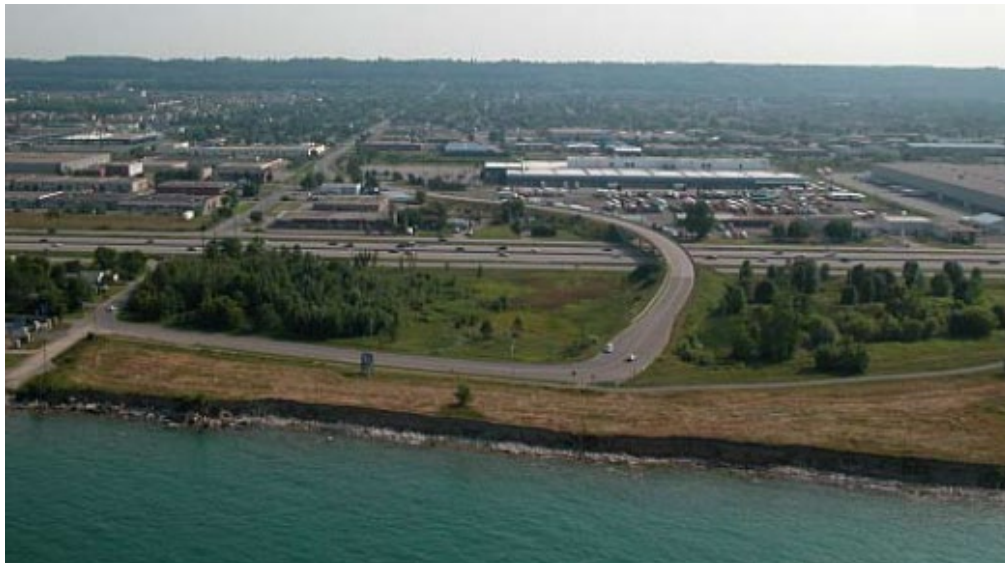
Cherry Beach was selected as a detailed study site for the International Joint Commission (IJC) water level regulation study for Lake Ontario and the St. Lawrence River (Baird, 2006). The conditions of the eroding bank in August 2003 were captured in an oblique photograph (Figure 4.6) prior to being armoured. The site in April 2022, photographed for this SMP, is presented in Figure 4.7. The long term recession rate at the site, from 1954 to 2002 was 0.53 m/yr. This rate provides valuable information on the historical rate of bank recession prior to armouring.

**Figure 4.6 Oblique photograph of Cherry Beach on August 9, 2003 (note location of highway overpass)**

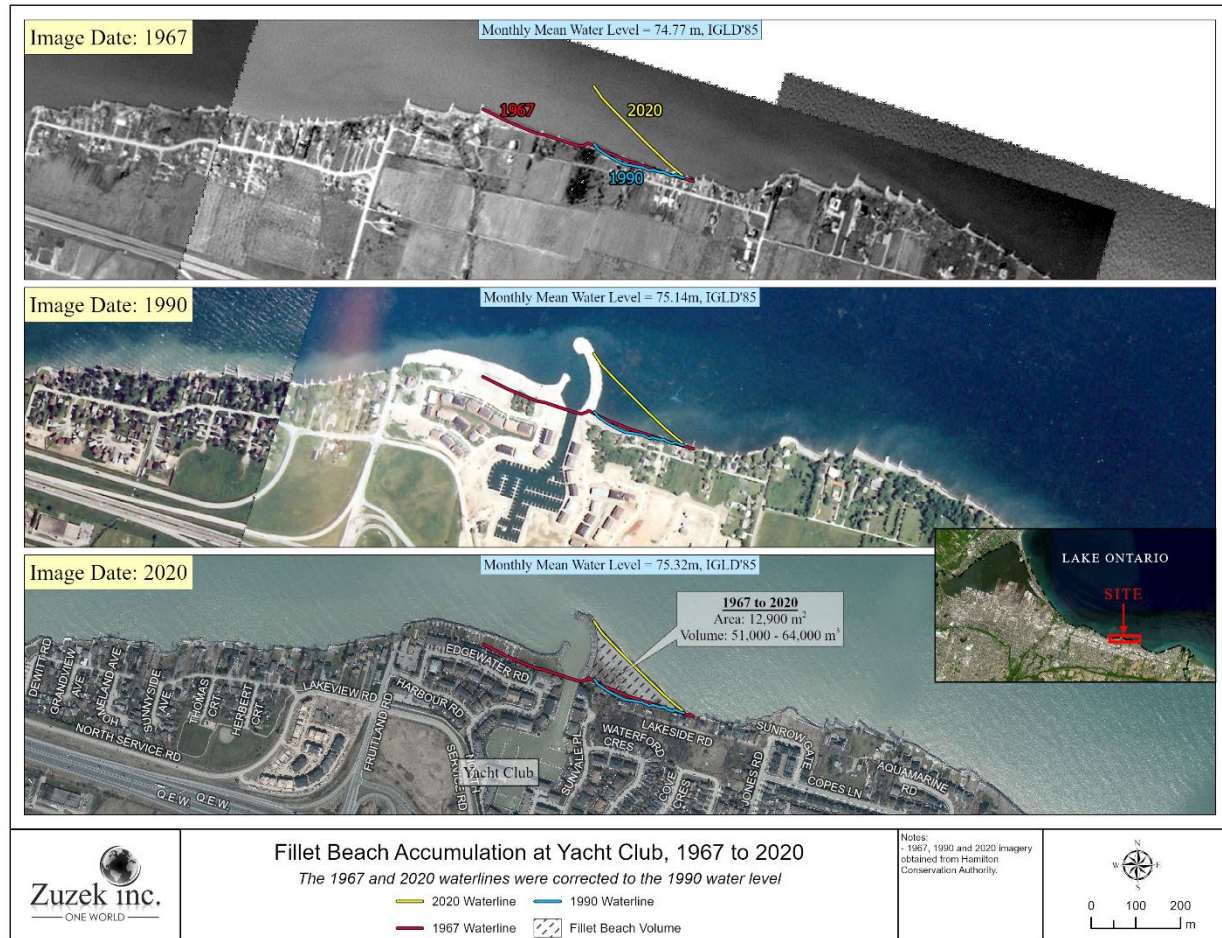
Refer to Figure 4.12 for an illustration of the fillet beach evolution at the Newport Yacht Club. The exact date of construction of the rubble mound breakwater is unknown. The 1967 aerial represents a pre-construction condition. In 1990, the jetty was fully constructed but the fillet beach had not yet accumulated much sediment and appears to have eroded slightly landward of the 1967 waterline position. In 2020, the fillet beach is near full capacity and considered stable. Using GIS, the growth of the fillet beach from 1967 to 2020 in terms of its footprint (area) was estimated to be 12,900 m<sup>2</sup>. The vertical difference in elevation between the lakeward toe of the fillet beach (in-water) and the landward top of the beach was estimated to be in the range of +4 to +5m. This represents a fillet beach volume between 51,000 m<sup>3</sup> and 64,000 m<sup>3</sup>.

**Figure 4.12 Fillet beach evolution at the Newport Yacht Club**

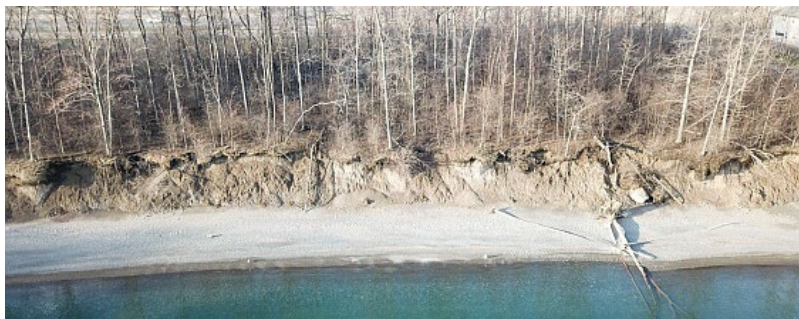
**Figure 4.15 Eroding bank at Lewis Road**

An oblique photograph of the eroding bank at the foot of Lewis Road is presented in Figure 4.15. The combined lake bottom and bank profile (Profile 7) is plotted as the blue line in Figure 4.16. The profile features the classic concave shape of an eroding cohesive sediment shoreline, but one that is extremely deep in the nearshore. The Lewis Road site is compared to an eroding cohesive profile from Port Stanley on Lake Erie, which features a similar shape but with a much shallower nearshore. The deep nearshore at Lewis Road is further contrasted with Profile 8B from the Maitland Valley CA, which is a concave cobble lag protected profile. The 2 m depth contour extends almost 700 m offshore, while the 2 m contour at Lewis Road is only 10 m from the waters edge. These comparisons illustrate the relative deep water encountered near the HCA shoreline when compared to other eroding cohesive sediment shorelines throughout the Great Lakes, leading to relatively high wave exposure of the shoreline.

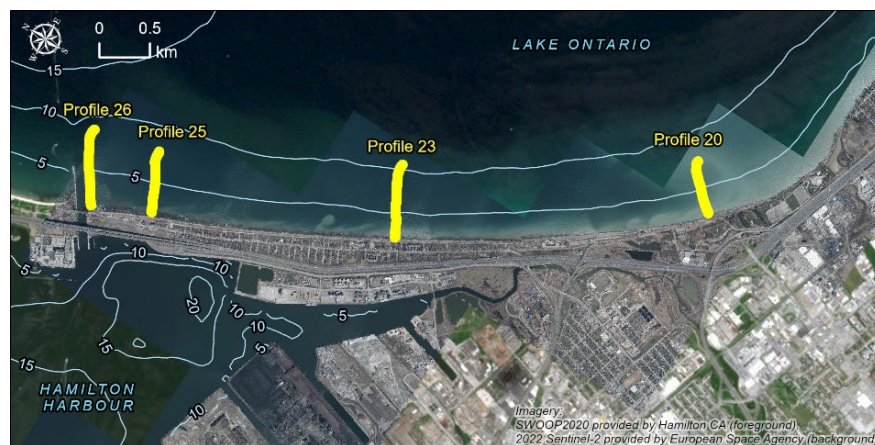
**Figure 4.19 Profile Locations, Hamilton Beach**

A final set of profile comparisons are provided in Figure 4.20 for Hamilton Beach, Reach 4. The location of Profiles 20, 23, 25, and 26 along Hamilton Beach are shown in Figure 4.19. Key observations include:

- Profile 20, at the southern end of the reach, is the deepest and features one well defined nearshore bar.
- Profile 23, in the central portion of the reach, is shallower than Profile 20 and features two sand bars.
- Profiles 25 and 26 are located close to the navigation channel and are the shallowest of the group. This progression suggests the net direction of longshore sand transport is from south to north. However, this observation is at odds with shoreline change comparisons, which did not show any sand accretion against the navigation channel jetty. It may be that the historical trend was a net longshore transport direction from south to north, but the alignment of the shoreline and geometry of the nearshore profiles has long-since achieved dynamic stability whereby net transport has become relatively small.

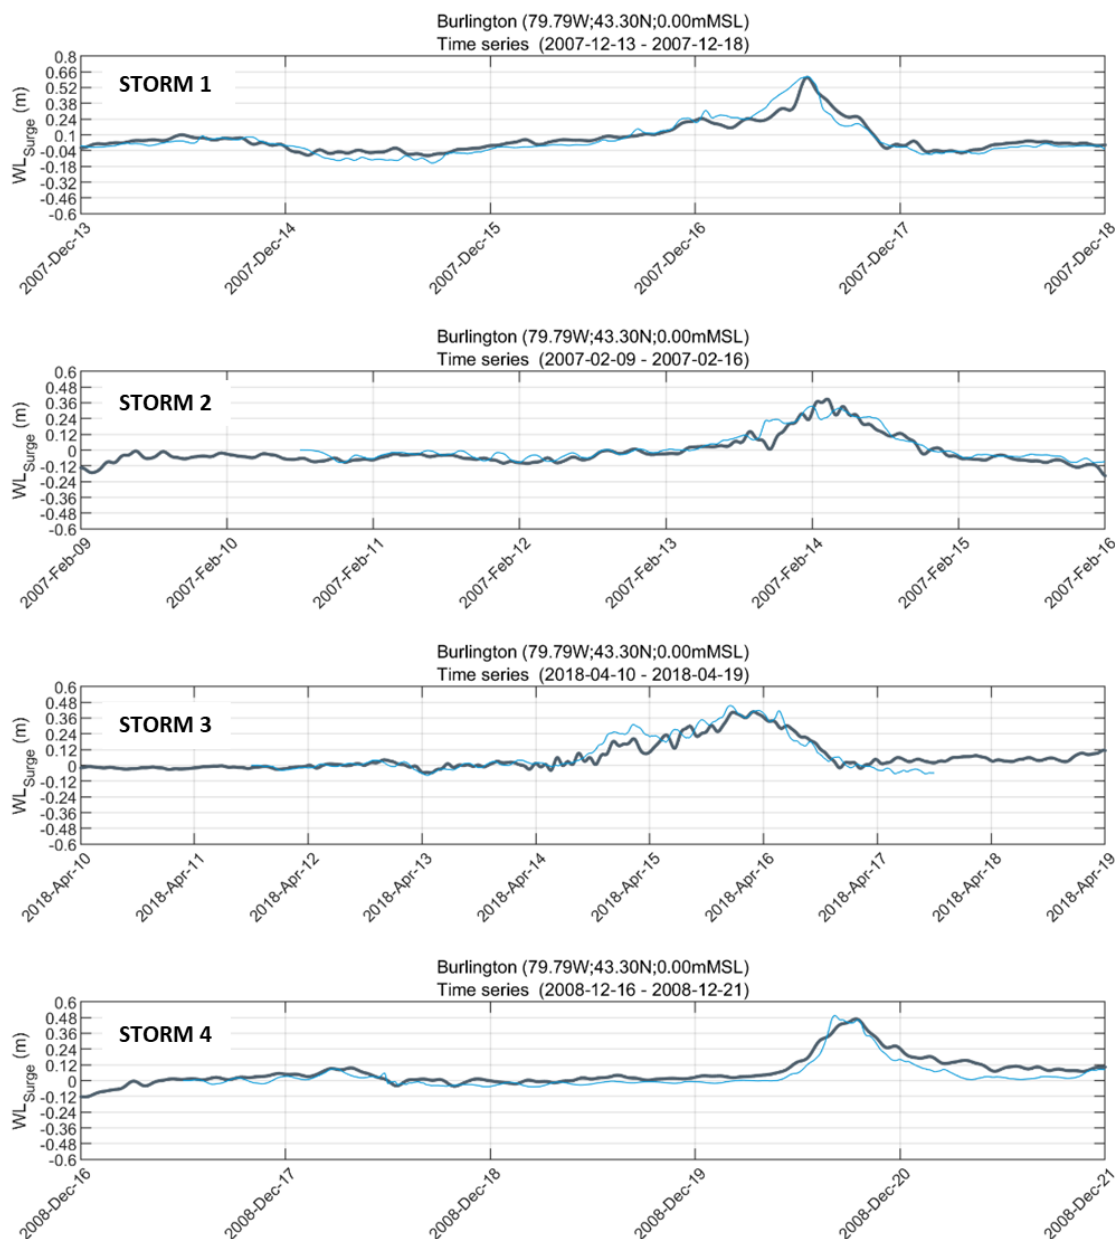
**Figure 4.25 Hydrodynamic Model Calibration (blue is modelled, grey is measured)**

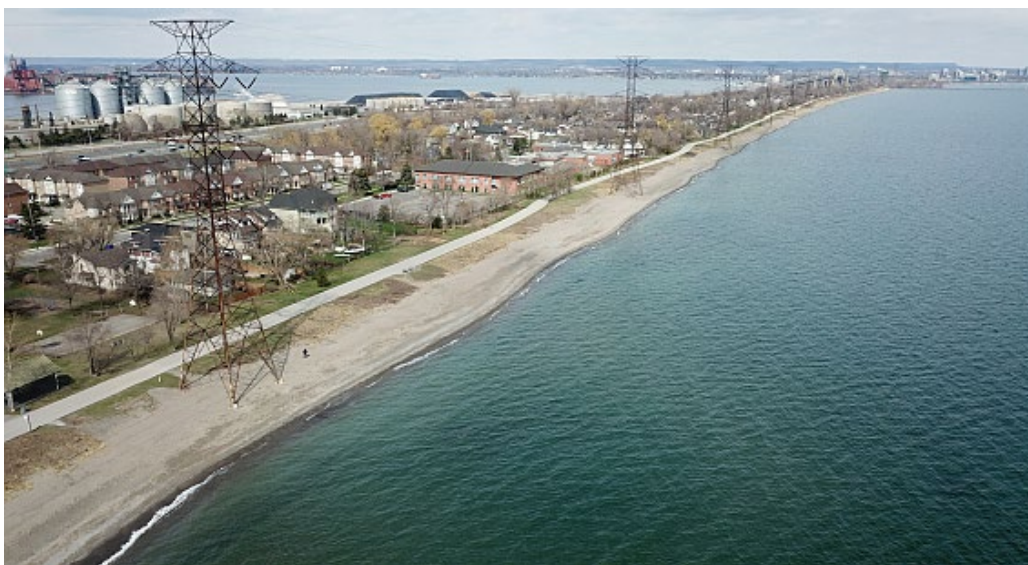
Figure 7.1 Natural beach shoreline in Reach 4

The principal objective of the preserve strategy is to maintain natural shorelines since they are resilient to hazards, protect infrastructure and development, and deliver social and ecological benefits. This category recognizes that in addition to the critical ecological and environmental benefits of maintaining natural shorelines, preserving nature is often the most cost effective means to mitigate risk associated with the shoreline hazards. An oblique photograph of natural beach shoreline in Reach 4 is provided in Figure 7.1.

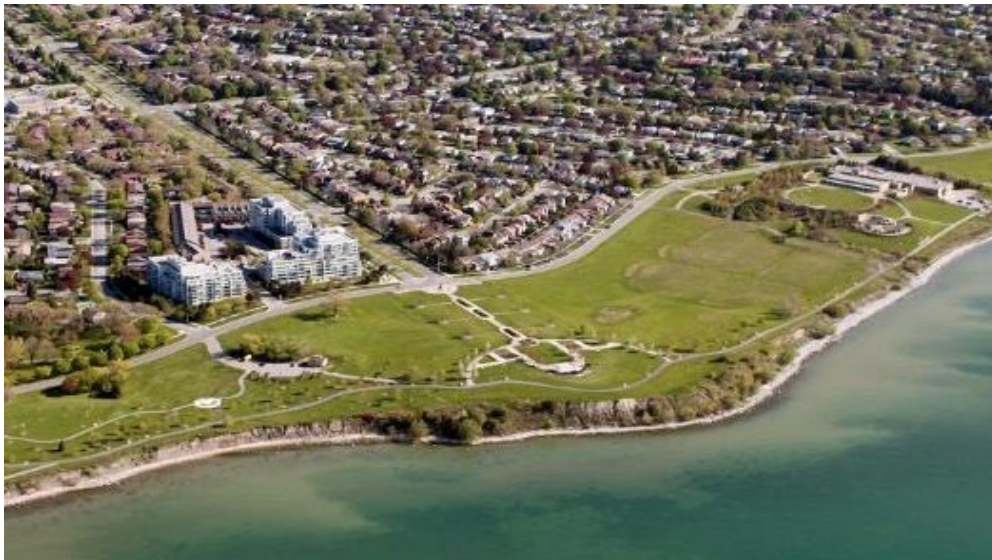
**Figure 7.2 Example of the Avoid strategy where a large natural buffer was included in the planning of residential subdivisions on Lake Ontario**

The goal of the avoid strategy is to reduce future exposure of people and property to shoreline hazards and coastal risk by locating new development and redevelopment away from hazardous lands. This concept is also the cornerstone of Ontario's natural hazard policies as outlined in the PPS (MMAH, 2020) and in the Technical Guide (MNR, 2001a). This planning strategy is best applied when locating development on greenfield sites, but is also applicable for infill development, construction on lots of record, or re-development (tear down and rebuild). Avoid is a very cost effective hazard mitigation strategy since future problems are not created by present-day land use decisions. Figure 7.2 presents an example of the avoid strategy for an eroding shoreline on the north shore of Lake Ontario where a large natural buffer was incorporated into the residential subdivisions.

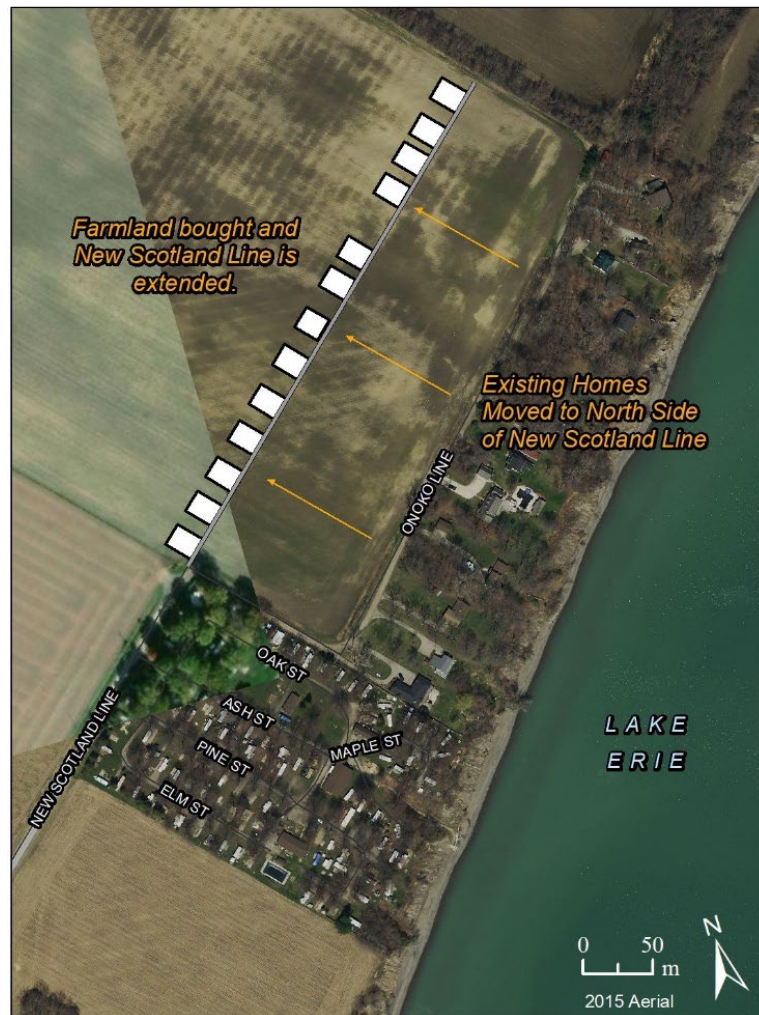
**Figure 7.3 Road and home re-alignment further inland to reduce erosion threats**

transformed to more resilient options, such as reinstating natural shoreline buffers or riparian vegetation and coastal wetlands that also create habitat and ecosystem benefits. Figure 7.3 presents an example of the retreat concept on Lake Erie that includes extending an existing road through farmland (New Scotland Line) and relocating buildings presently on the edge of an actively eroding bluff to a location landward of the new road (white boxes). This strategy requires undeveloped lands behind existing development, which is uncommon in the study area, leading to limited locations for its application. However, at risk buildings could be re-located to new locations inland.

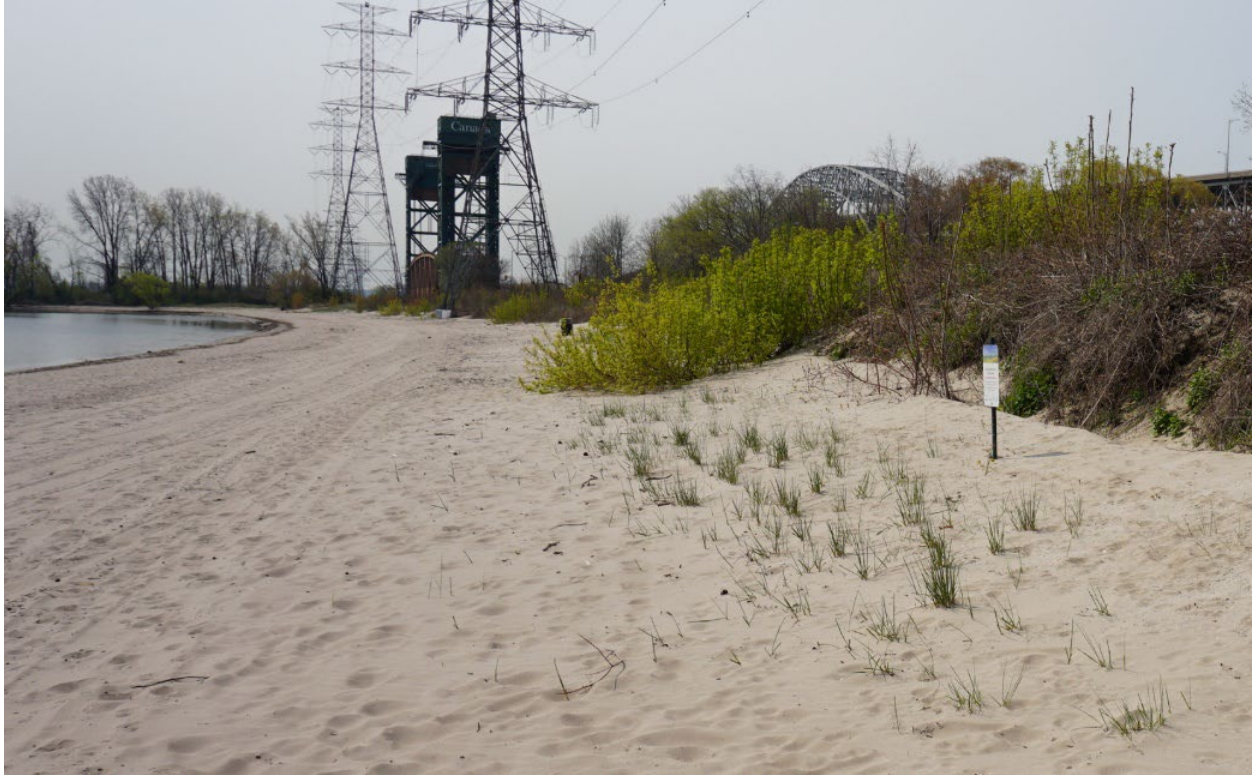
**Figure 7.5 Foredune restoration at Burlington Beach with beachgrass**

The protect strategy is focused on safeguarding people, property, and infrastructure from exposure to shoreline hazards, with the use of nature-based solutions (first priority) and traditional engineered structures (second priority). Beach nourishment and dune restoration strategies are examples of nature-based protection options, as depicted in Figure 7.5 at nearby Burlington Beach. For shorelines with relatively low wave exposure, such as those within Hamilton Harbour, hybrid grey-green (traditional–nature based) protection structures can also be implemented, such as stone revetments fronted by vegetated buffers, rock shoals, or habitat islands with vegetation. Figure 7.6 provides an example of the existing use of habitat islands and rock shoals as shoreline protection within Hamilton Harbour.

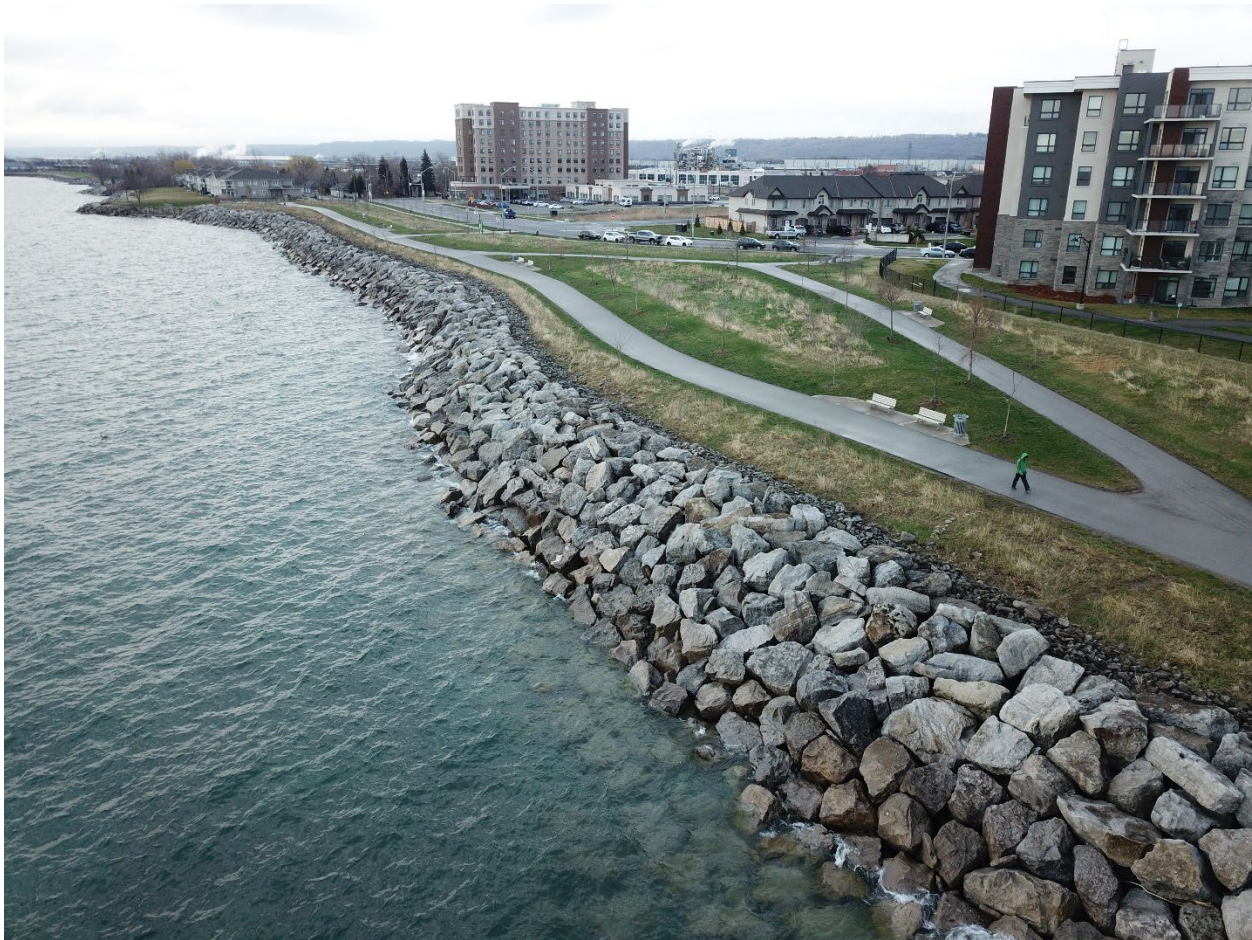
**Figure 7.7 Conventional, multi-layer armour stone revetment on the HCA Lake Ontario shoreline**

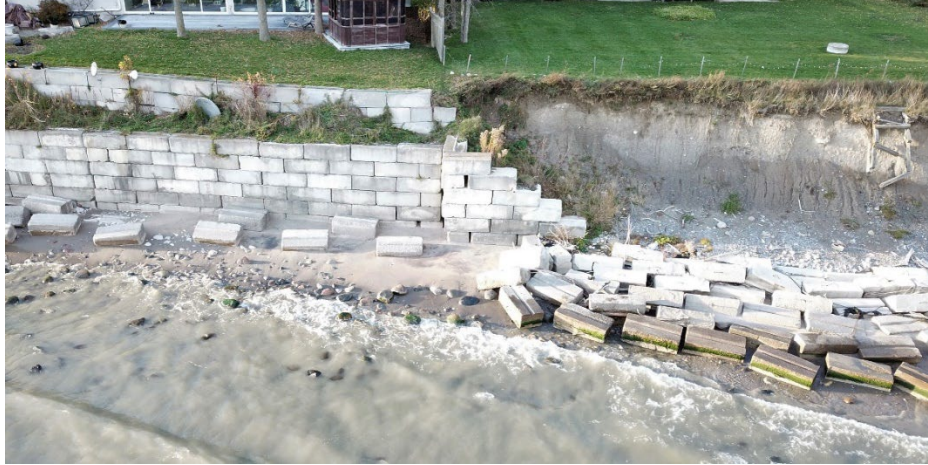
**Figure 7.10 Failed vertical stacked concrete block seawall on Lake Ontario**

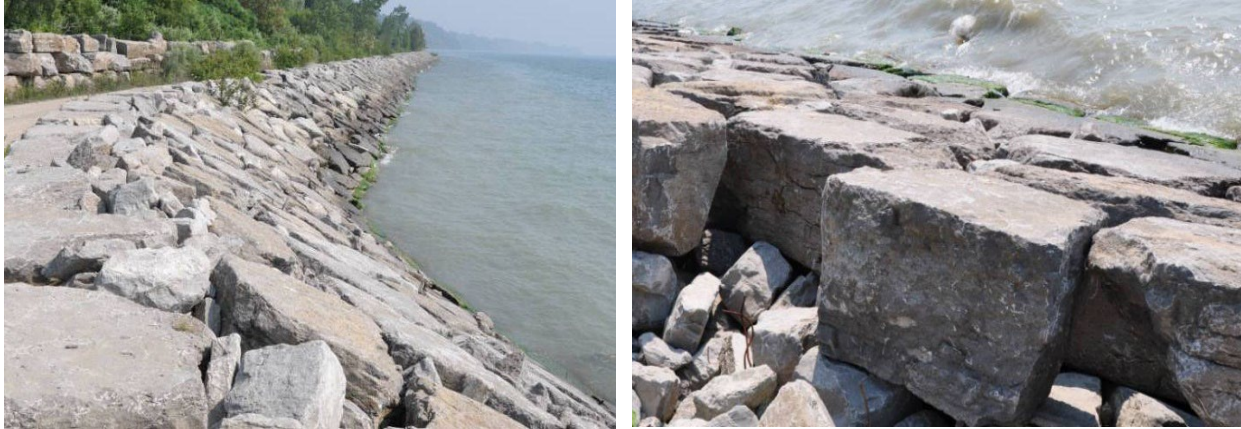
**Figure 7.11 Examples of single-layer, blocky armour stone revetments on the Great Lakes**

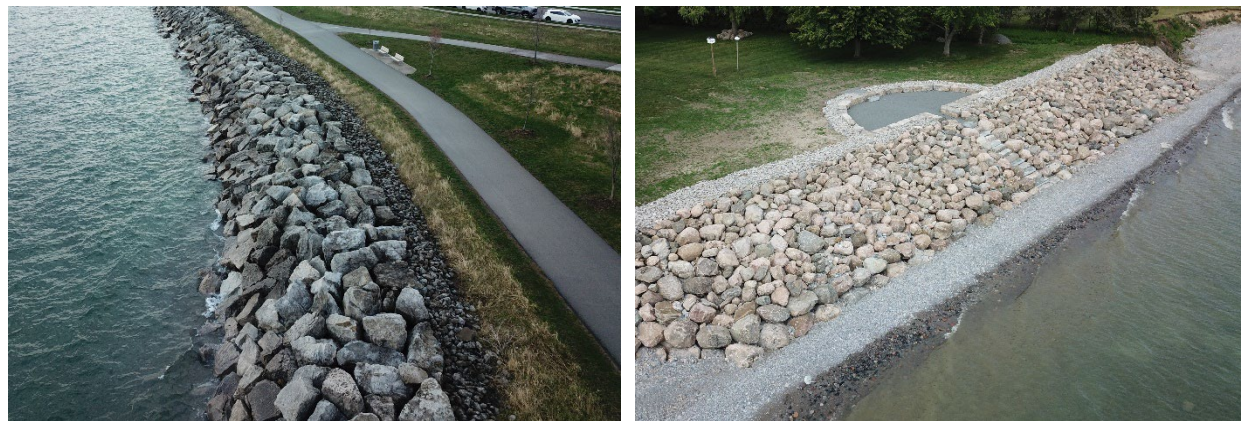
**Figure 7.12 Examples of conventional, randomly placed, multi-layer armour stone revetments on the Great Lakes constructed with irregular armour stone (left) and field stone (right)**

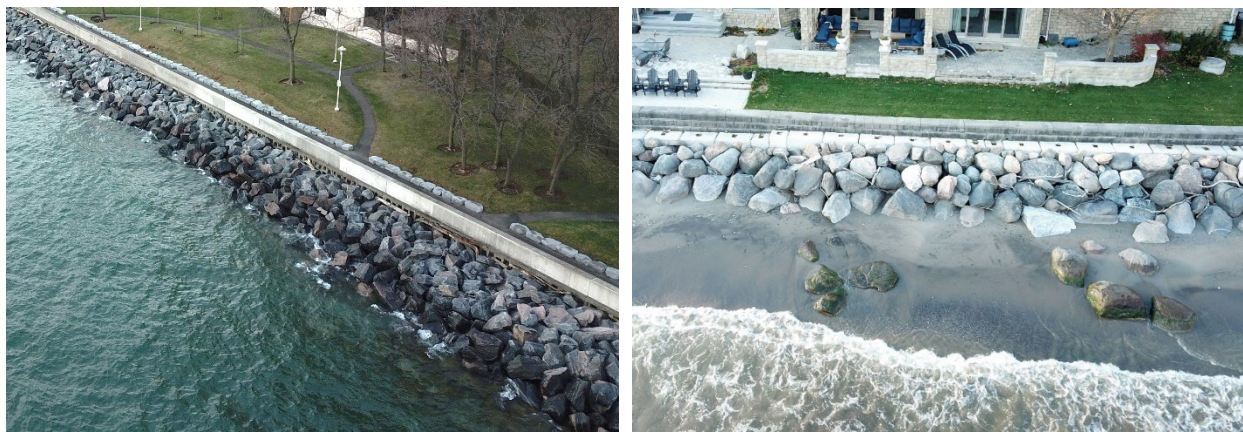
**Figure 7.13 Examples of stone berms placed in front of vertical structures to reduce erosion at the toe, reduce wave reflection and overtopping, and provide added stability to the structure**

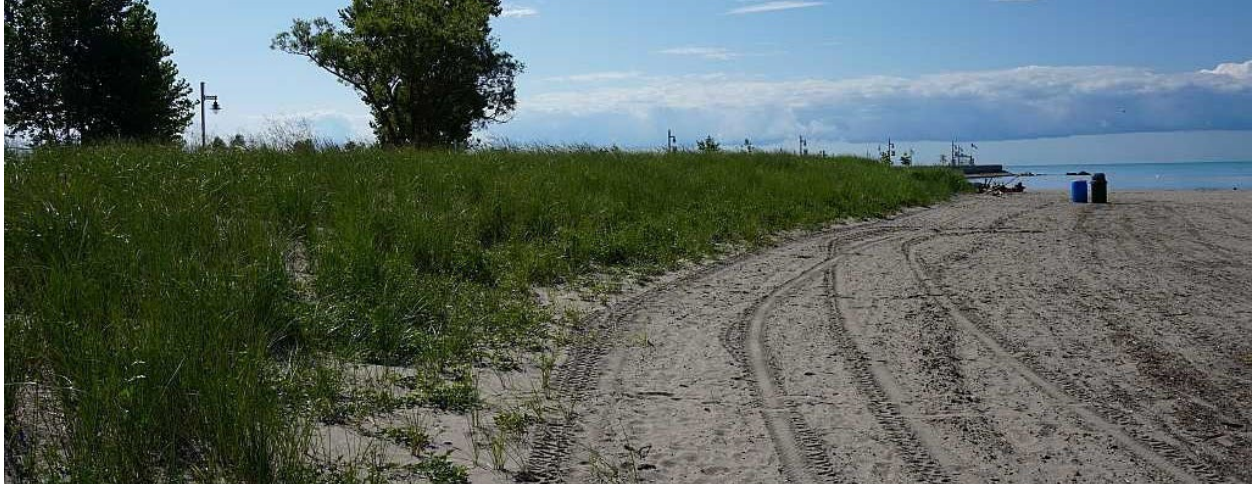
**Figure 7.14 Example of successful dune restoration at Port Stanley, Lake Erie**

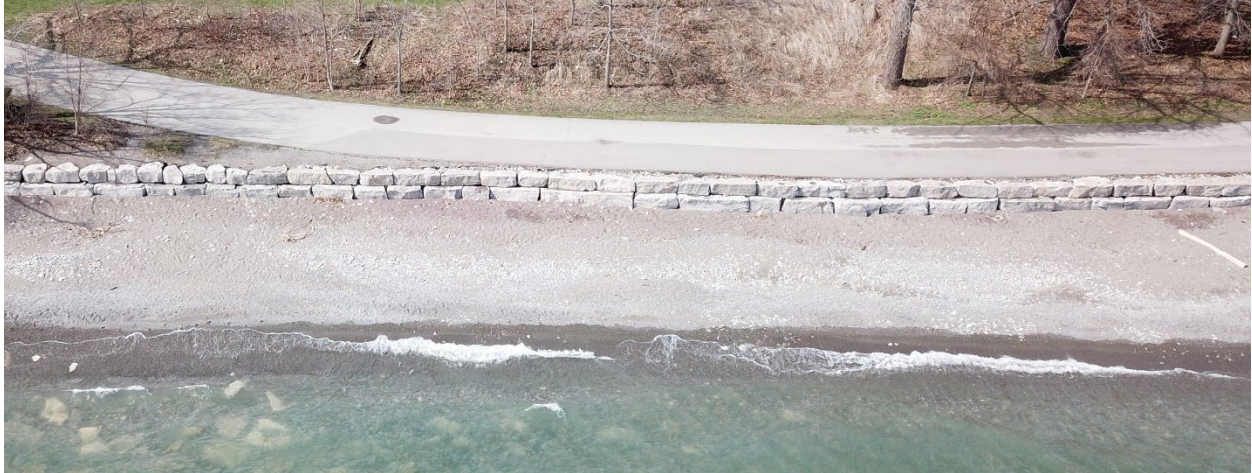
**Figure 7.15 Example of a stacked armour stone beach curb at Confederation Park, Hamilton**

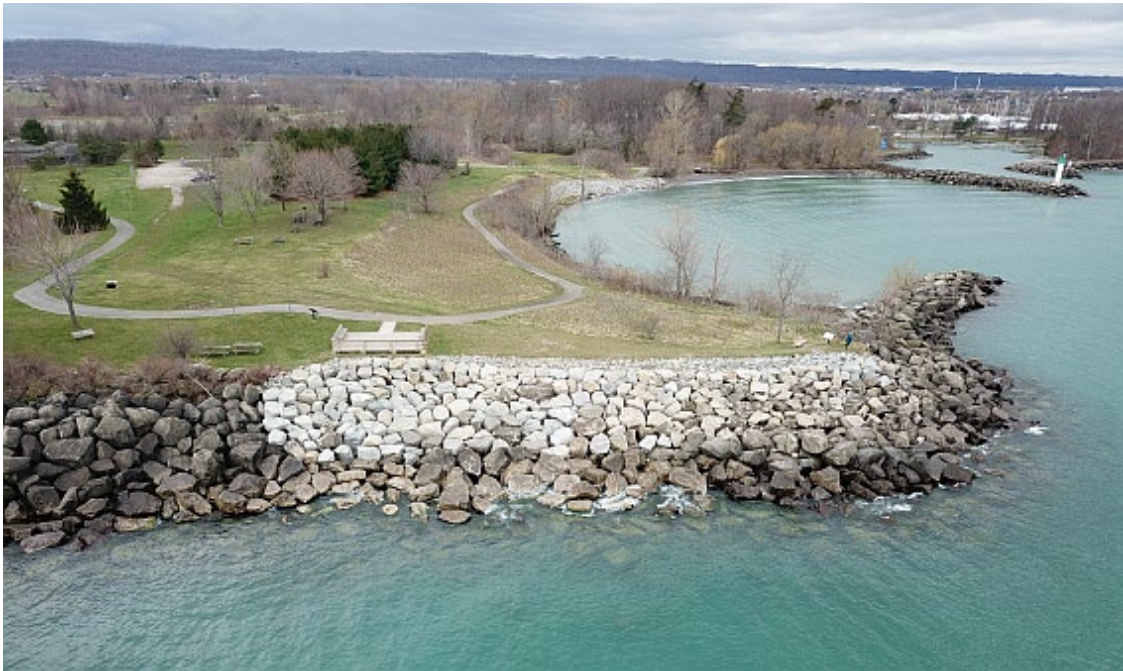
- The east fillet beach at Fifty Point is low crested and in some locations the Flood Hazard Limit extends further inland than the Dynamic Beach Hazard limit. See below.

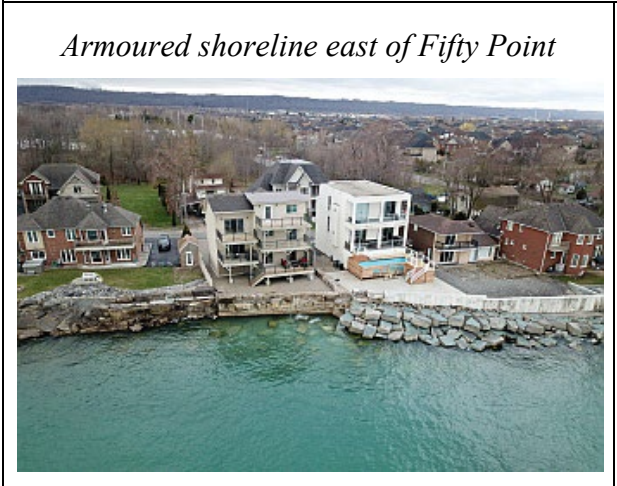
*Armoured shoreline east of Fifty Point*

An aerial photograph showing a residential area with several houses, including a prominent white modern house with a swimming pool, situated behind a concrete and rock breakwater that separates the property from the water. The shoreline is armoured with large rocks and concrete structures. The water is a deep teal color. In the background, a town and distant hills are visible under a cloudy sky.

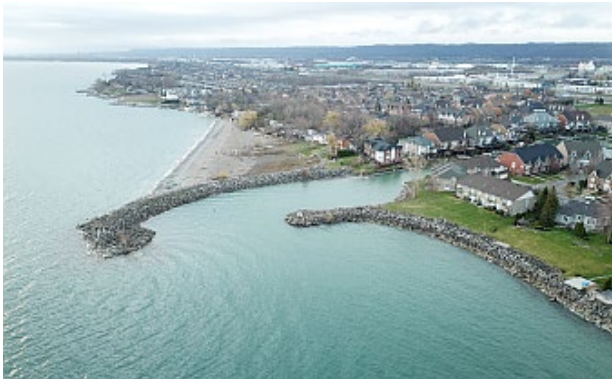
*Newport Yacht Club Jetty*

An aerial photograph showing a long, curved stone jetty extending from a shoreline into a body of water. The jetty is constructed from dark, irregular stones. To the right of the jetty, there is a residential area with several houses, some with red roofs, and a green lawn. In the background, a town or city is visible, followed by a range of hills under a cloudy sky. The water is a light blue-green color.

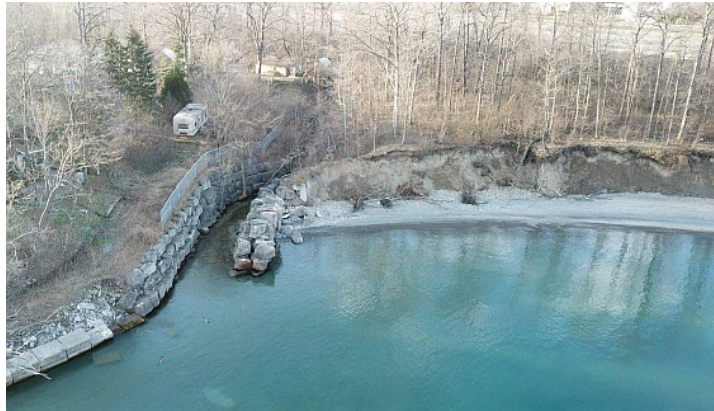
- Bank erosion at the foot of Lewis Road is threatening a hardened creek/stormwater outfall. See oblique image below.

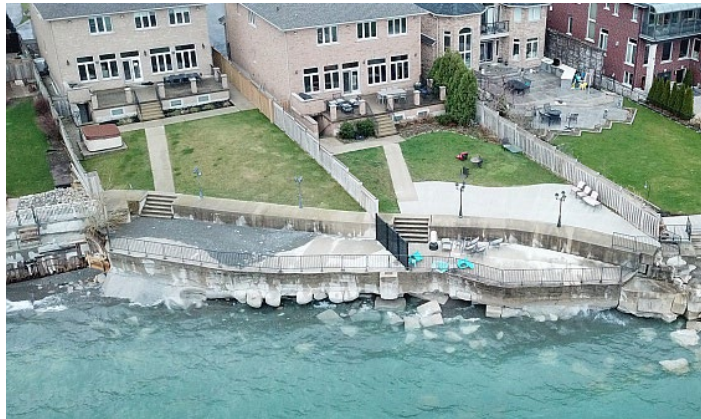
- Vertical downcutting of the lakebed leads to undermining (see below) and failure of shoreline protection structures and increased wave exposure due to increased water depths. Relics of failed structures and structures in poor condition make structural upgrades challenging.

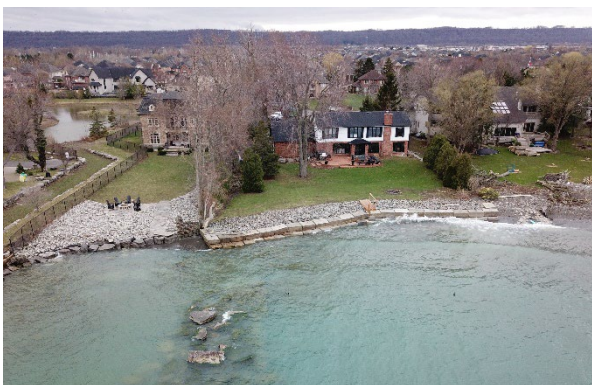
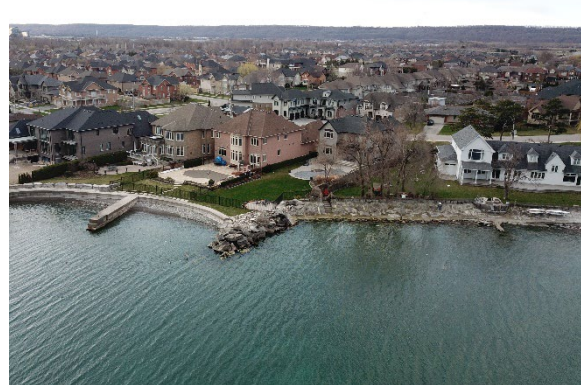
- Due to the high wave exposure, deep nearshore and low elevation of table lands, large portions of shoreline within Reach 2 are highly susceptible to wave overtopping and associated flooding and damage/erosion. This is particularly true for the shoreline from the Fifty Point Marina to East St.

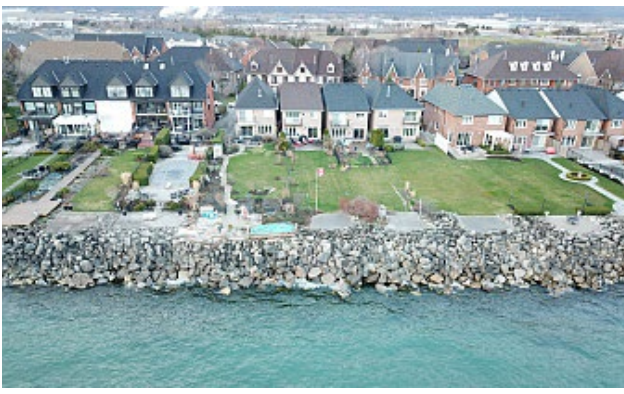
*Continuous Shoreline Armouring at Edgewater Drive*

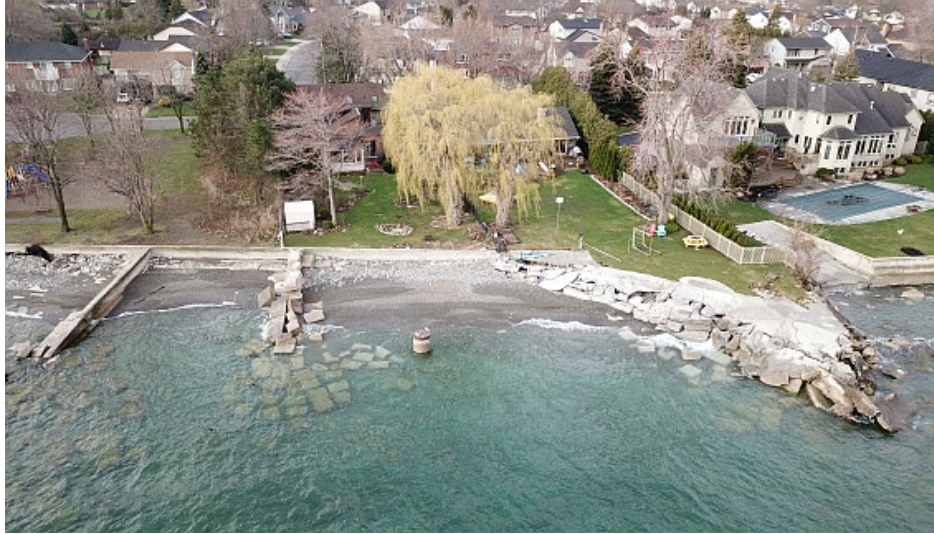
- The Erosion Hazard Limit is the greatest challenge for new development or re-development in Reach 3, as seen by the updated mapping below. In many cases, development would only be possible provided a new or substantially upgraded shoreline protection structure is in place with a 25-year design life, as specified by the Shore Protection Standard.

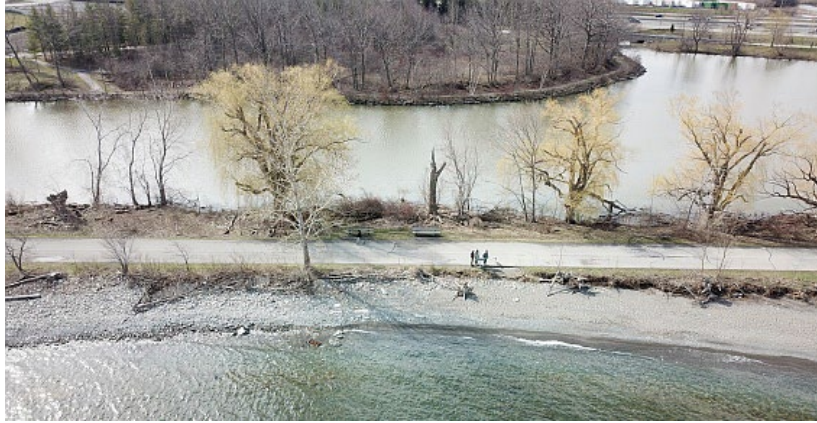
- The southern half of Reach 4 is low-lying and vulnerable to flooding and erosion, especially during periods of high lake levels such as 2017 and 2019. See erosion scarp at the back of the beach in the photograph below.

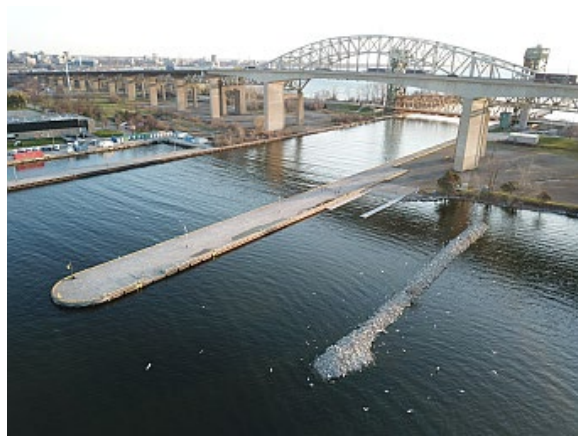
*Hamilton Harbour Jetty and Boat Launch*

- The boat launch south of the jetty on the Hamilton Harbour side is partially protected by a breakwater, but is open to the longest fetch in Hamilton Harbour (7.5 km). The boat launch is subjected to significant wave exposure when winds are from the southwest. See map below.
- The flood hazard limit also extends inland to include the parking lot adjacent to the boat launch.

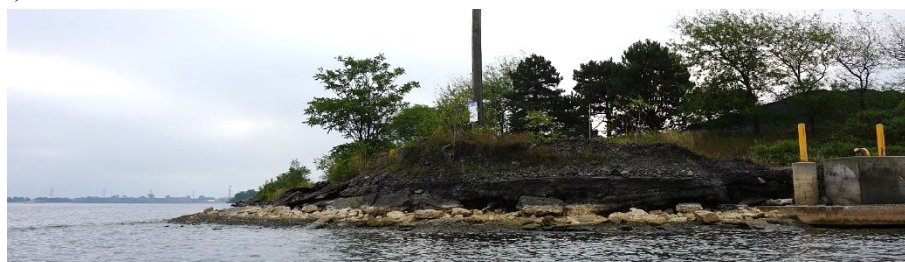
- There are limited flood risks in Reach 6 given the shoreline is extensively armoured and in many cases the crest elevation of the shore protection is high due to the industrial land use and ship berthing that occurs.
- Some occurrences of bank erosion were identified where shore protection is not continuous (see below).

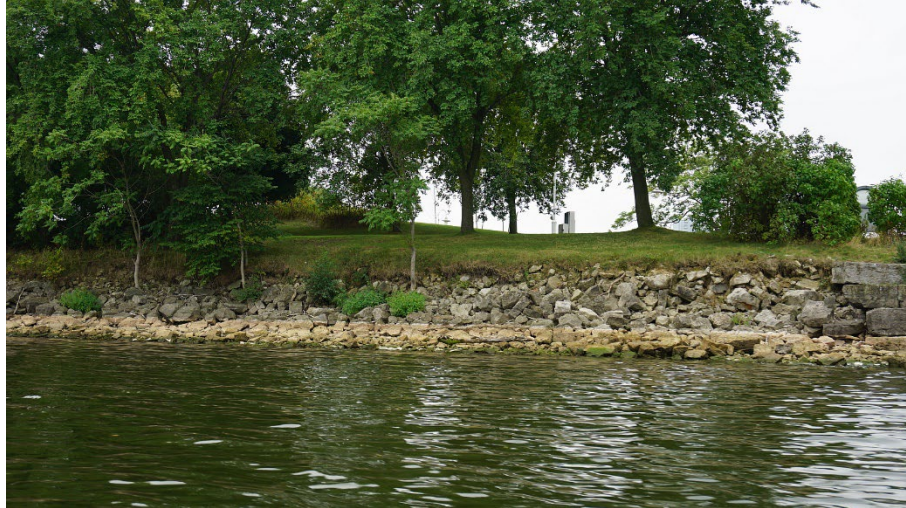
- There is limited flood risk in Reach 7 given the significant amount of shore protection, small wave heights inside the bay, and existing land-uses, which are mostly recreational.
- Minor bank erosion was observed above the shore protection around Bayfront Park. See below, possibly associated with the record high lake levels in 2017 and 2019.
