# Hamilton Conservation Authority Shoreline Management Plan

**Hamilton Conservation Authority**

October 20, 2023

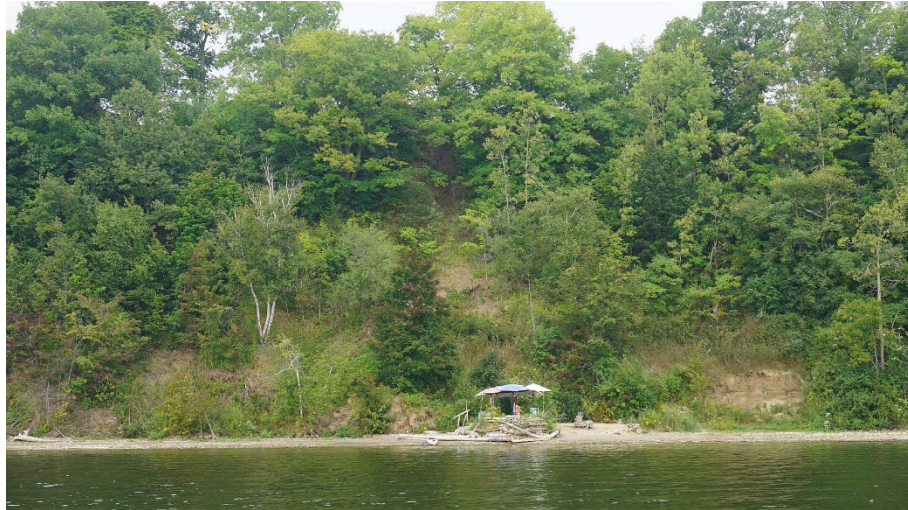
- Minor slope instability along the bluffs fronting Woodland Cemetery, as seen in the photo below.

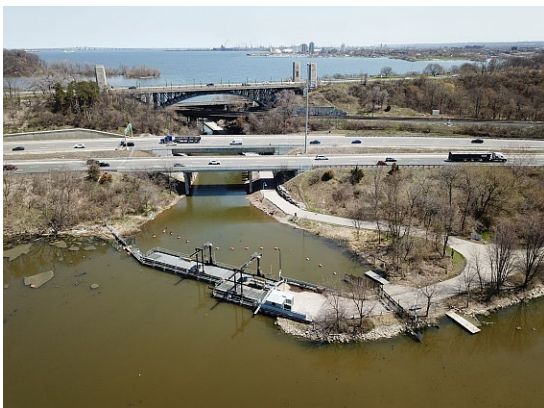
*Carp Barrier at Connection to Hamilton Harbour*

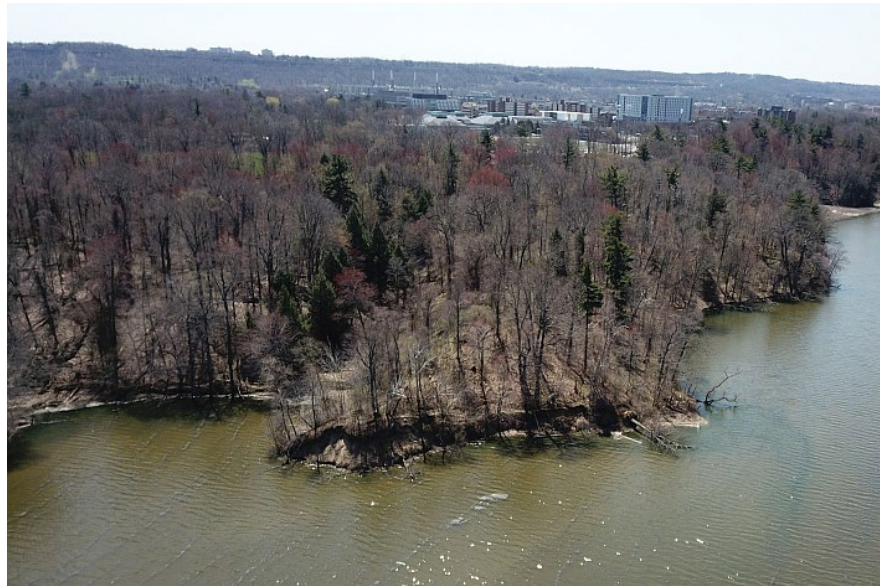
- Given the sheltered conditions in Cootes Paradise and natural shoreline conditions, there are only limited challenges with natural hazards in Reach 9.
- Minor shoreline erosion and slope instability were observed at select locations, often at headlands with exposure to the largest fetches in the bay.

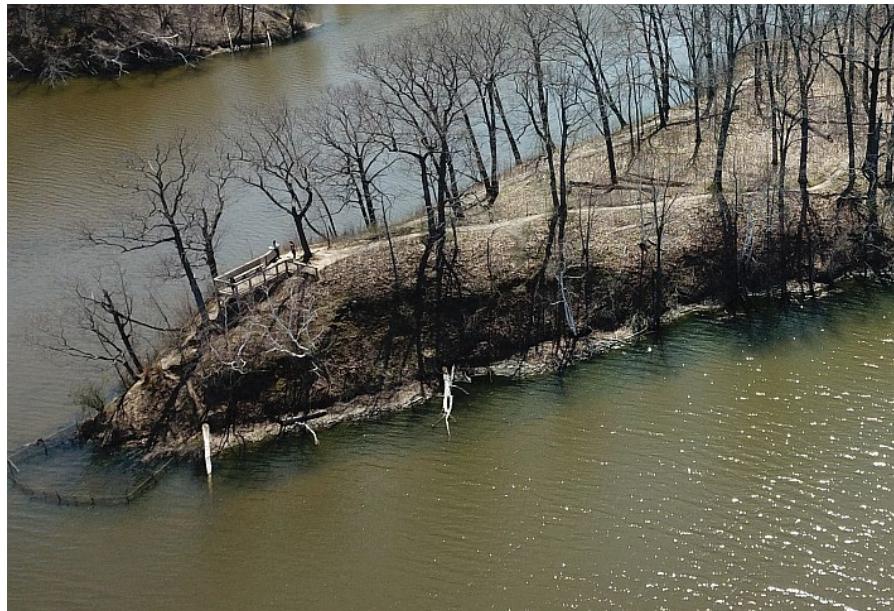
- The location of future trails and especially lookouts should consider the stability of the shoreline and the potential for additional erosion and slope instability. See example of lookout below where the shoreline appears to feature a low recession rate with evidence of minor slope failures.
