## **Board of Directors Meeting**

- 10.3 Request to Award Tender – Slope Slump Repair at Mineral Springs  
Detention Facility – Scott Peck

**Subject:** Request to Award Tender – Slope Slump Repair at Mineral Springs Detention Facility

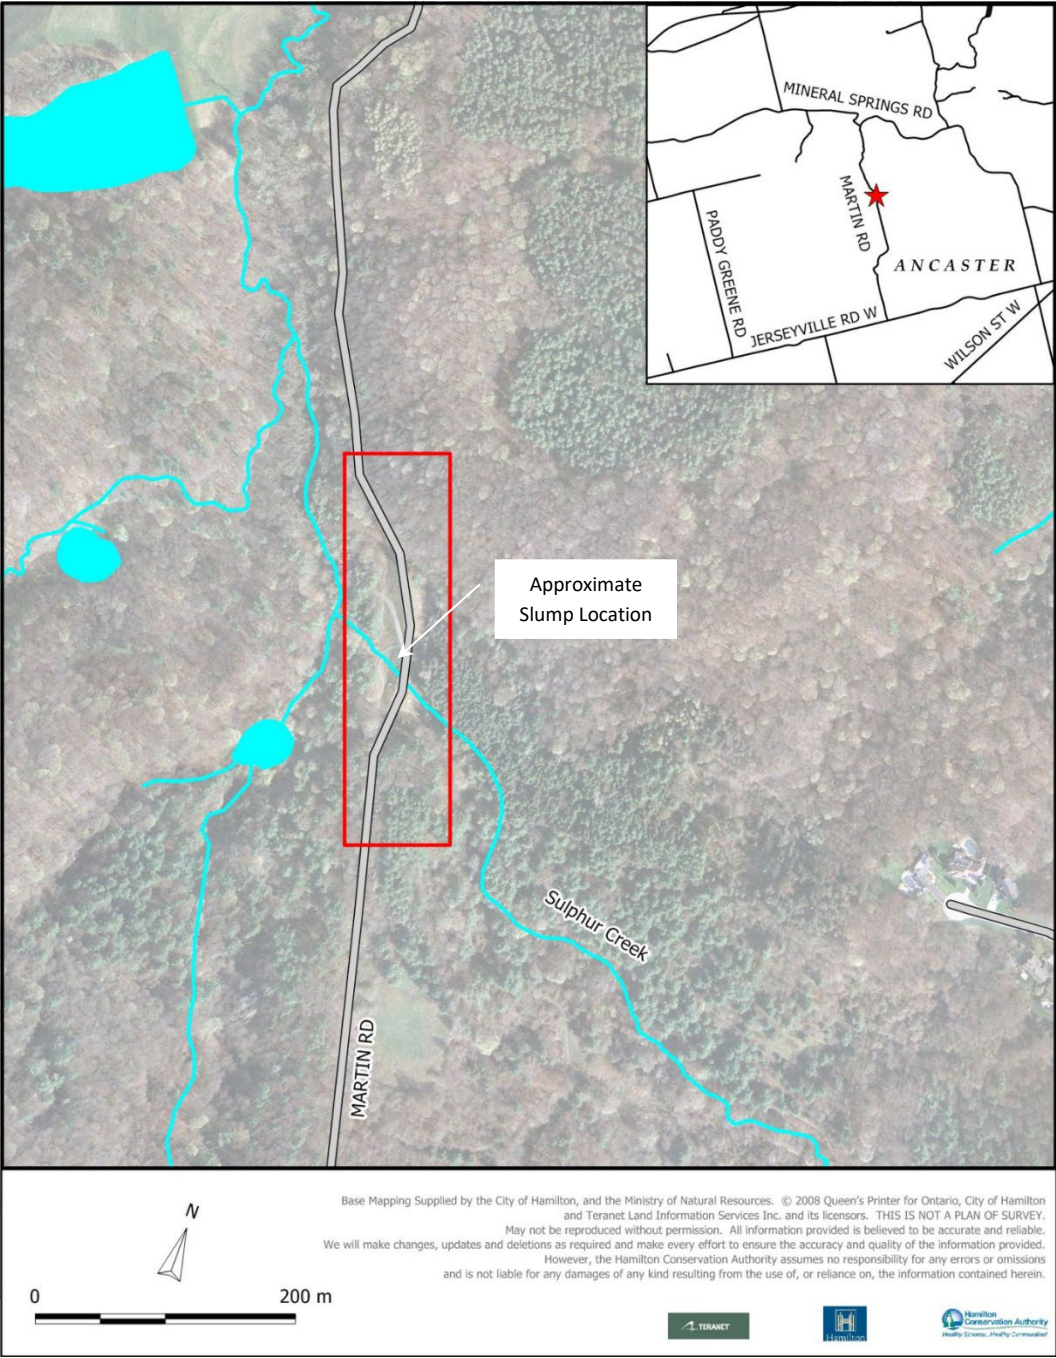
**Figure 1. Sulphur Creek Sub-watershed and Slump Location, Mineral Springs Detention Facility**

The Mineral Springs Detention Facility is located on the Sulphur Creek crossing with Martin Road immediately south of the 380 Martin Road driveway in Ancaster (Figure 1). The detention facility was constructed in early 1990's to provide flood control for the downstream community in Mineral Springs.

In 2021, HCA retained TULLOCH Engineering Inc. to assess a slope slump identified in the embankment, located in the upper portion of the downstream slope within the south end. The consultant concluded that the slope slump was minor in nature, was not a structural issue and was not considered a stability issue at that time. It was recommended to continue routine inspections.
