Hamilton Conservation Authority
Ancaster, Ontario

Dam Stability and Condition Assessment

Crooks' Hollow Dam

Final Report
July 2007

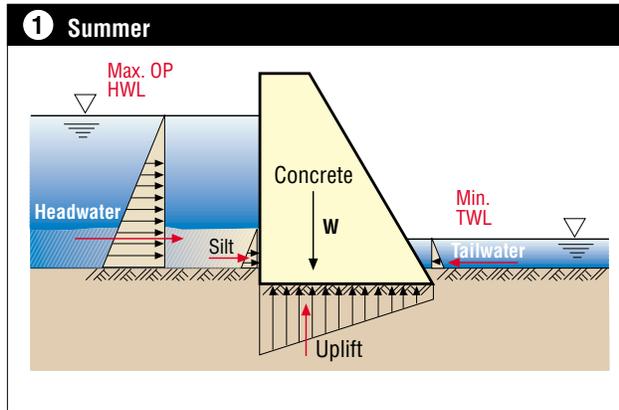
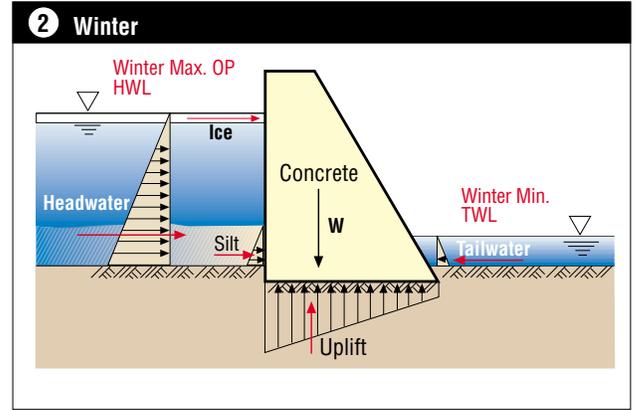
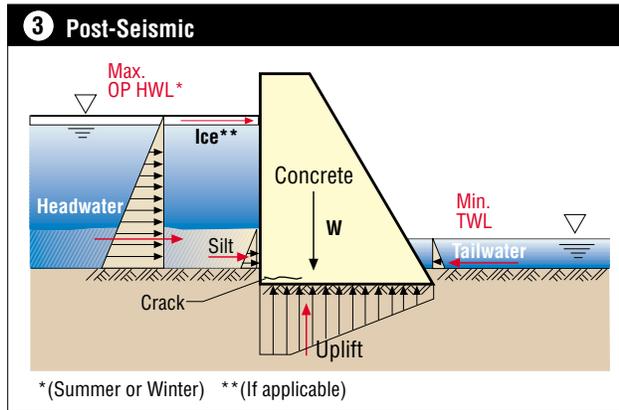
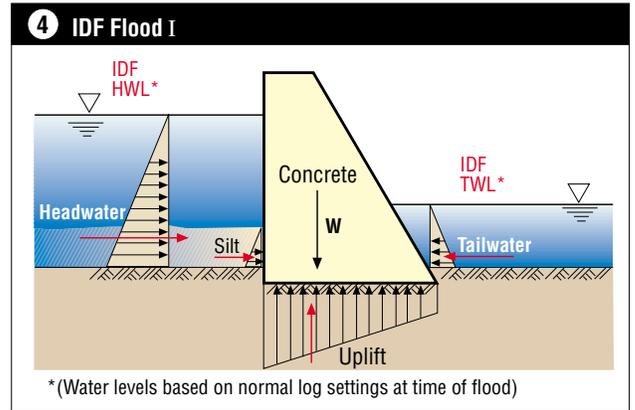
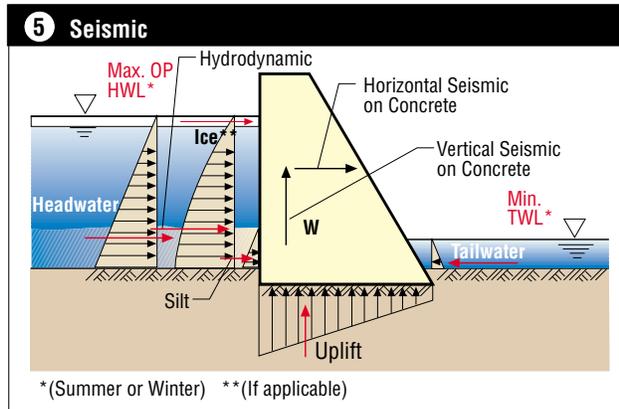
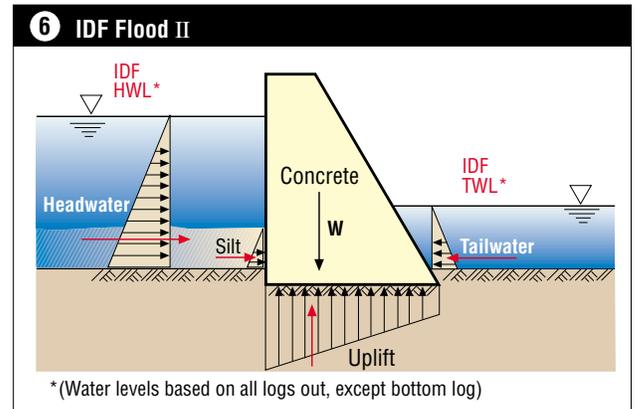
Figure 7.1
Hamilton Conservation Authority
Crooks' Hollow Dam
Schematic of Load Cases

The various loading combinations used in the stability assessment of the Crooks' Hollow Dam are shown schematically in Figure 7.1 and are described as follows. Numbers in parentheses refer to the numbers in Figure 7.1.
