# **Board of Directors To Sit As Hearing Board**

# Thursday, July 11, 2024 at 6:00 p.m. Section 28 Hearing Re: 10 Lakeside Drive, Stoney Creek Permit Application No. SC/F,C,A/24/40

Hearing under Section 28.1(5) of the *Conservation Authorities Act* for an Application by Sayed Shakour for Development in a Regulated Area of Lake Ontario at 10 Lakeside Drive, City of Hamilton (Stoney Creek)

# Coastal Engineering Analysis, Hazard Limit Delineation & Seawall Design

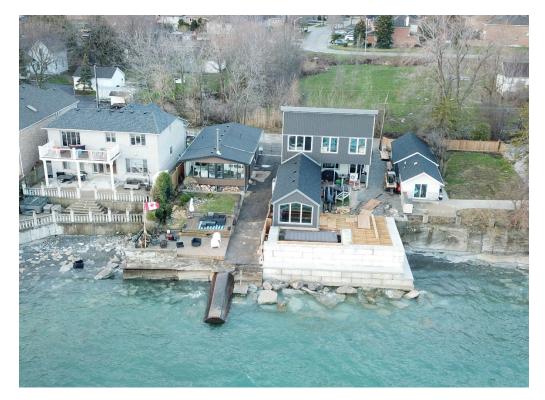
Figure 2. Oblique view of shoreline at 10 Lakeside Dr

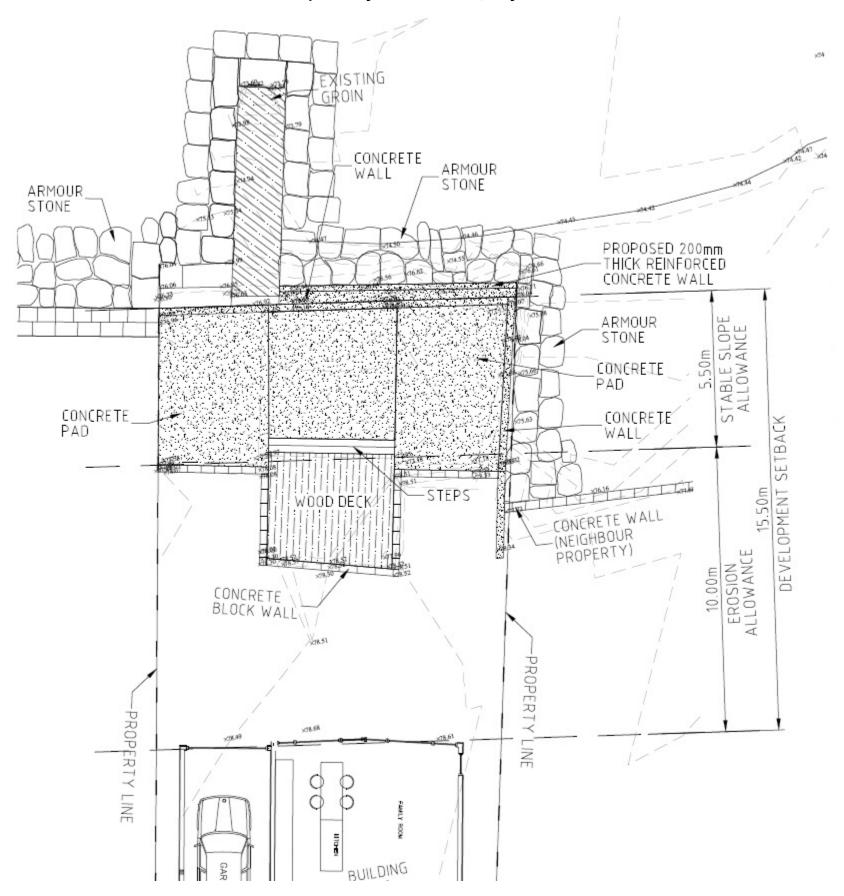
Figure 3. Erosion hazard associated with Lake Ontario. The 10.00 m erosion allowance presumes a recession rate of 0.2 m/yr.

The erosion hazard was more specifically reviewed in erosion hazard assessments prepared by Ahydtech. The erosion hazard setback assumes that the property will be protected with a structure having a design life of 50 years (Attachment B). HCA staff have reviewed a proposed shore wall design prepared by Ahydtech (Attachment E), and are satisfied that the design is satisfies HCA polices and technical requirements, and accept the professional engineer's opinion that the shore protection will have a 50-year design life.

The report prepared by Ahydtech identifies the erosion hazard extending 10 m from the stable top of lake bank (Attachment B). The coastal assessment indicates that a 0.2 m/yr recession rate may be applied to the property. Generally, HCA applies a recession rate of 0.3 m/yr to the Lake Ontario shoreline. If a 0.3 m/yr recession rate is assumed,

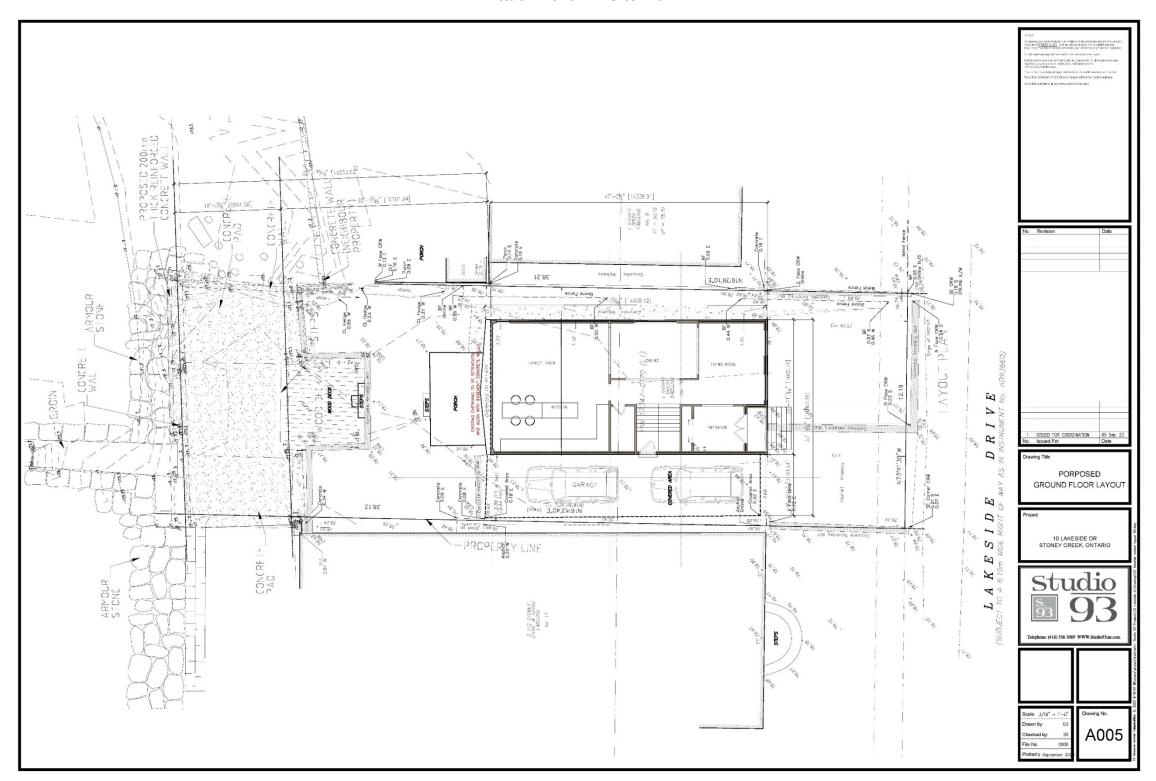
Figure 4. Proposed site plan.

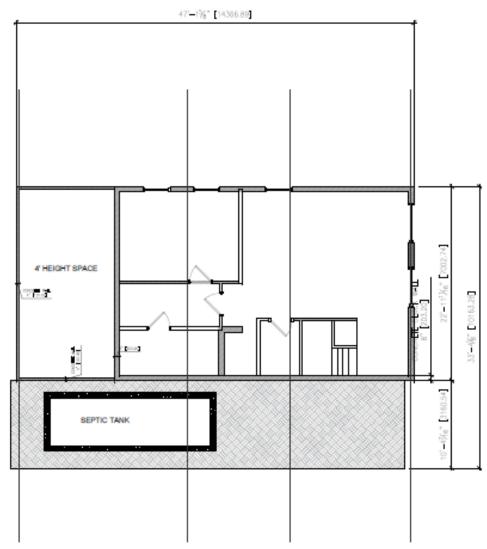
Figure 5. Existing basement.

Figure 6. Proposed basement

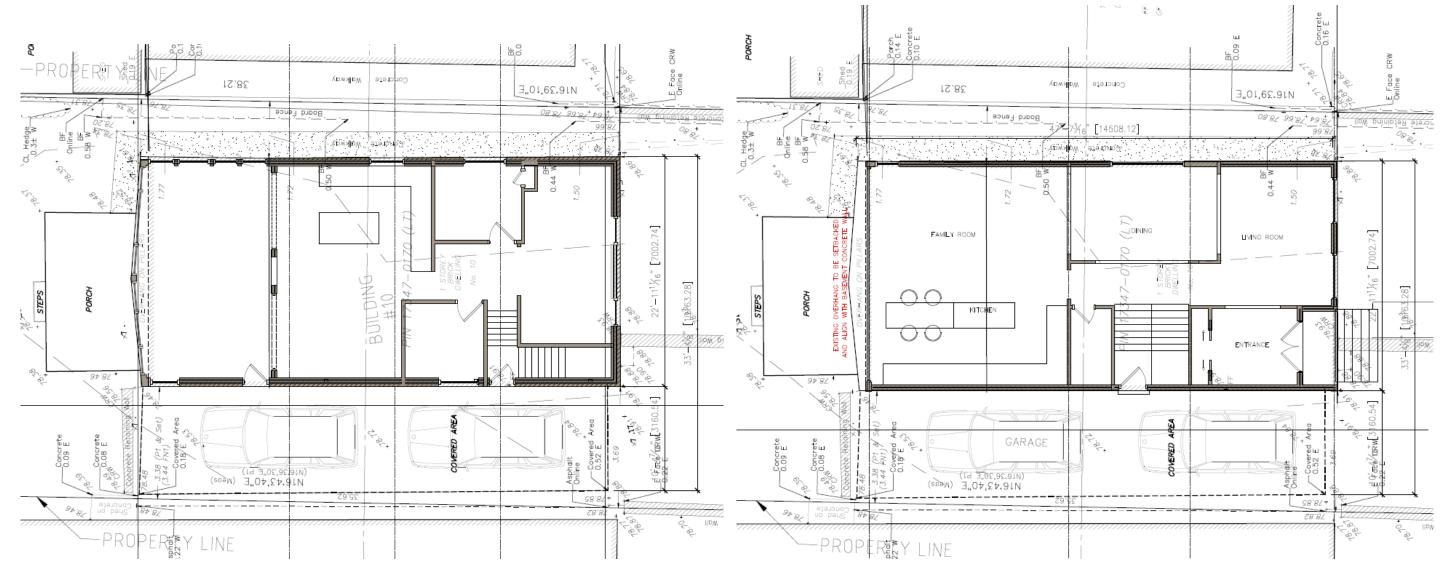
Figure 7. Existing main floor.

Figure 8. Proposed main floor.

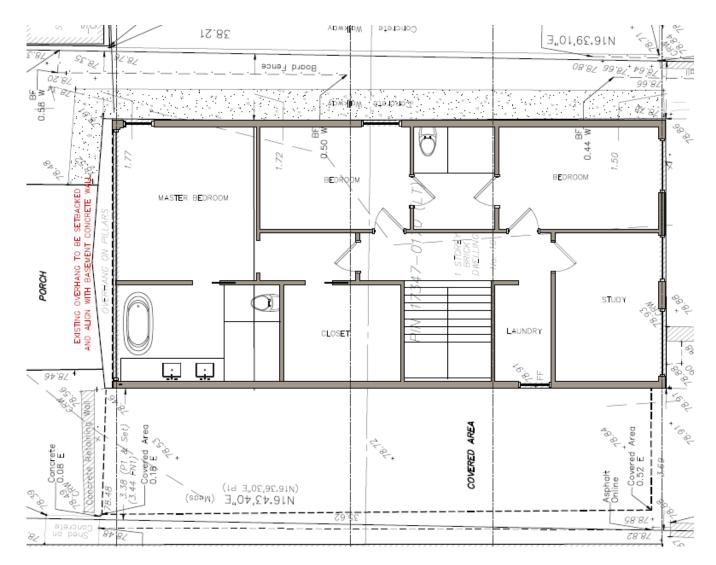
Figure 9. Proposed new second floor.

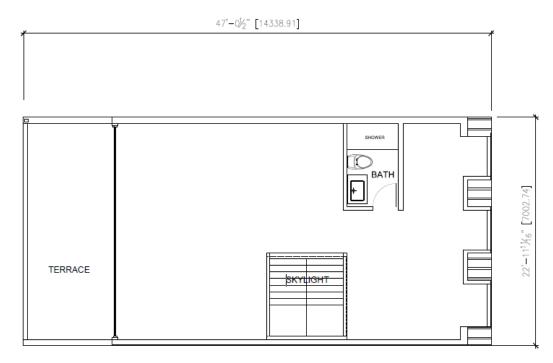
Figure 10. Proposed new attic level.

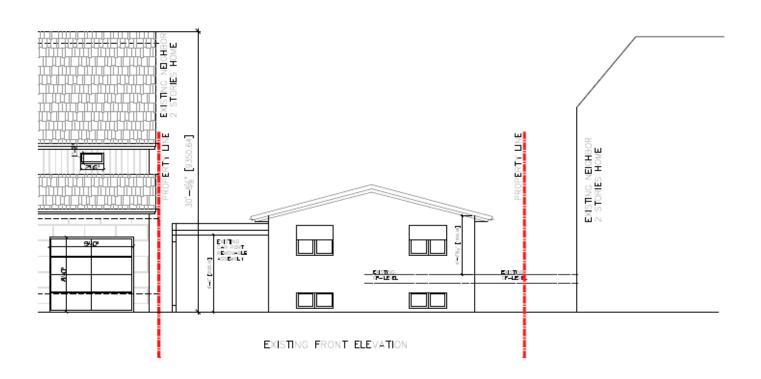
PROPOSED FRONT ELEVATION

Figure 11. Existing and proposed elevations.

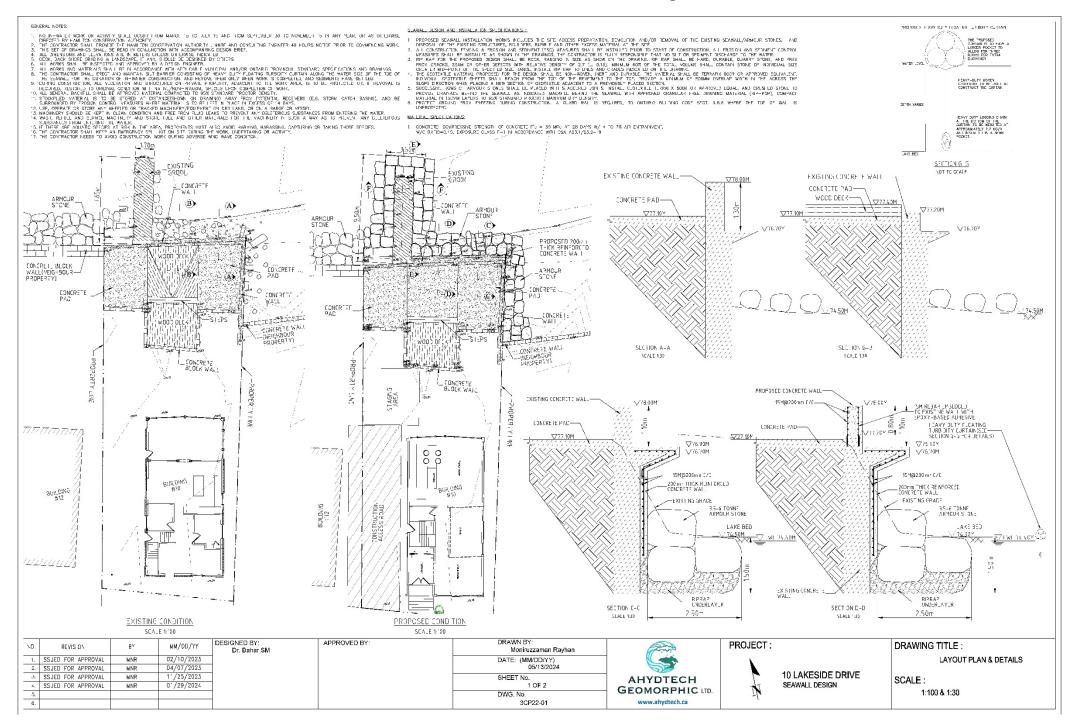
Figure 12. Proposed shorewall design.

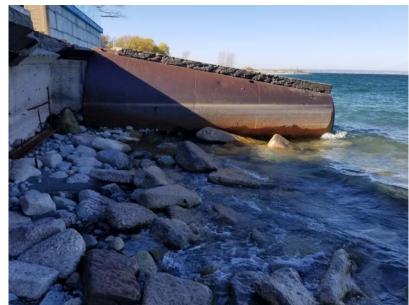
Condition of Existing Steel Barrel Groin in front of 10 Lakeside Drive Property

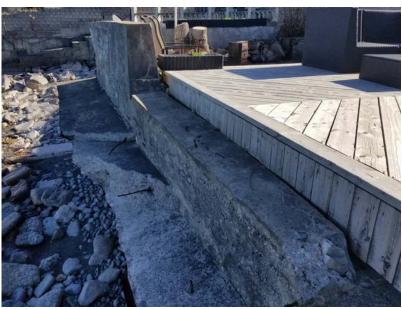
Condition of Existing Concrete Seawall in front of 10 Lakeside Drive Property

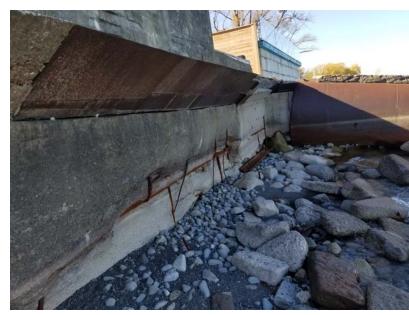
Evidence of Exposed Reinforcements and Scour at Toe

Exposed Reinforcements Scour at Toe Fails preventing flood water from overtopping

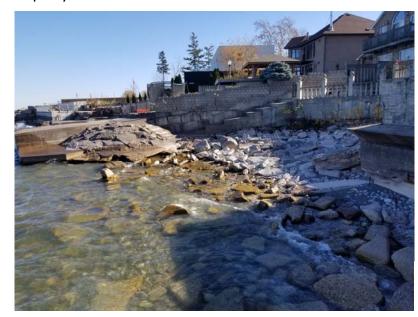
Condition of Neighbouring Shore with an Existing Shoreline Structure at 8 Lakeside Drive

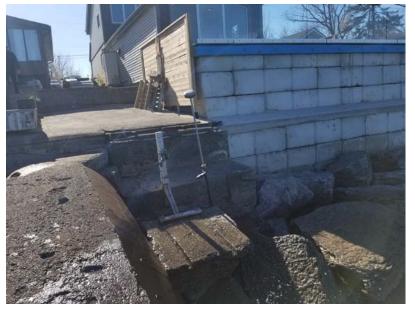
Condition of Neighbouring Seawall at 12 Lakeside Drive

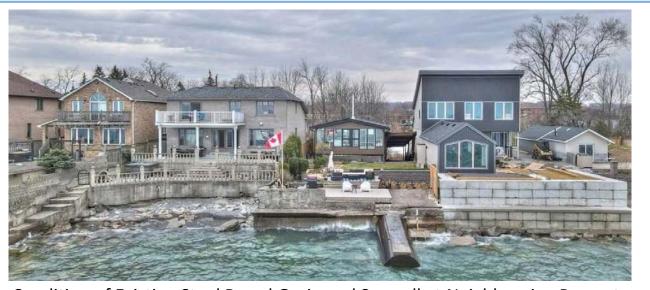
Condition of Existing Steel Barrel Groin and Seawall at Neighbouring Property

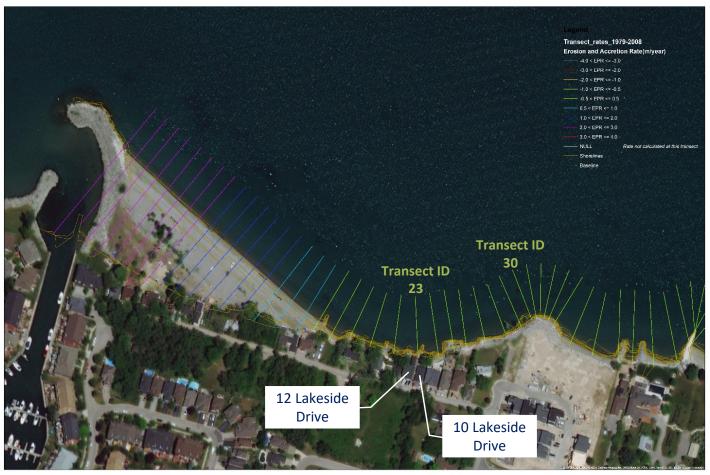
Erosion hazard analysis was performed using the *Digital Shoreline Analysis System (DSAS)* in ArcGIS over a 40-year period.

Transect ID	Recession/Accretion Rate (1979-2019)		
23	0 04		
24	0 02		
25	0 21		
26	0 01		
27	0 02		
28	0		
29	0 05		
30	-0.09 (Maximum Recession)		
31	0 02

The Maximum Recession Rate observed along the 2 km shoreline was **0.09 m/year.**

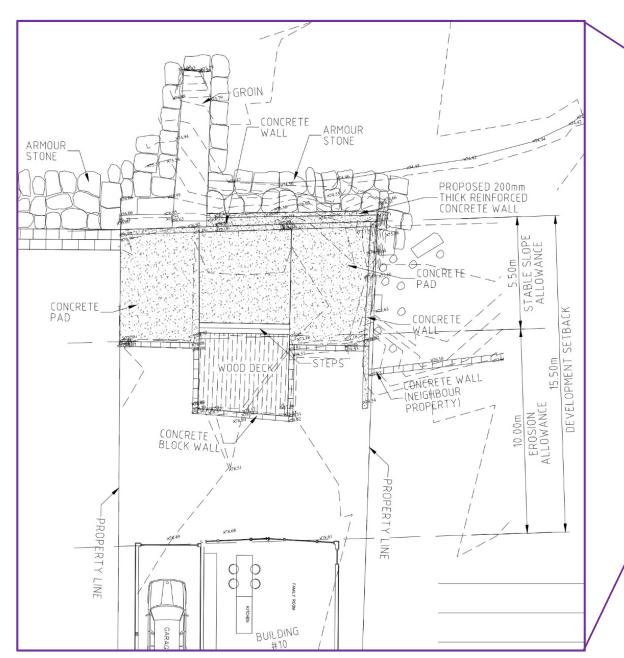
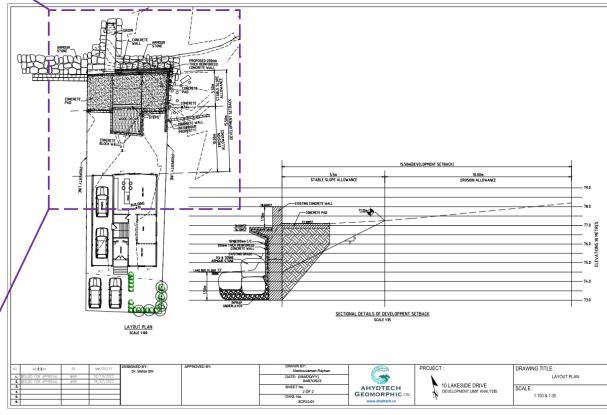
Layout Plan and Section Details of Erosion Hazard Limit/Development Setback at 10 Lakeside Drive Property (Annex – V, Sheet 2)

Extent of Erosion Hazard Limit in the 10 Lakeside Drive Property

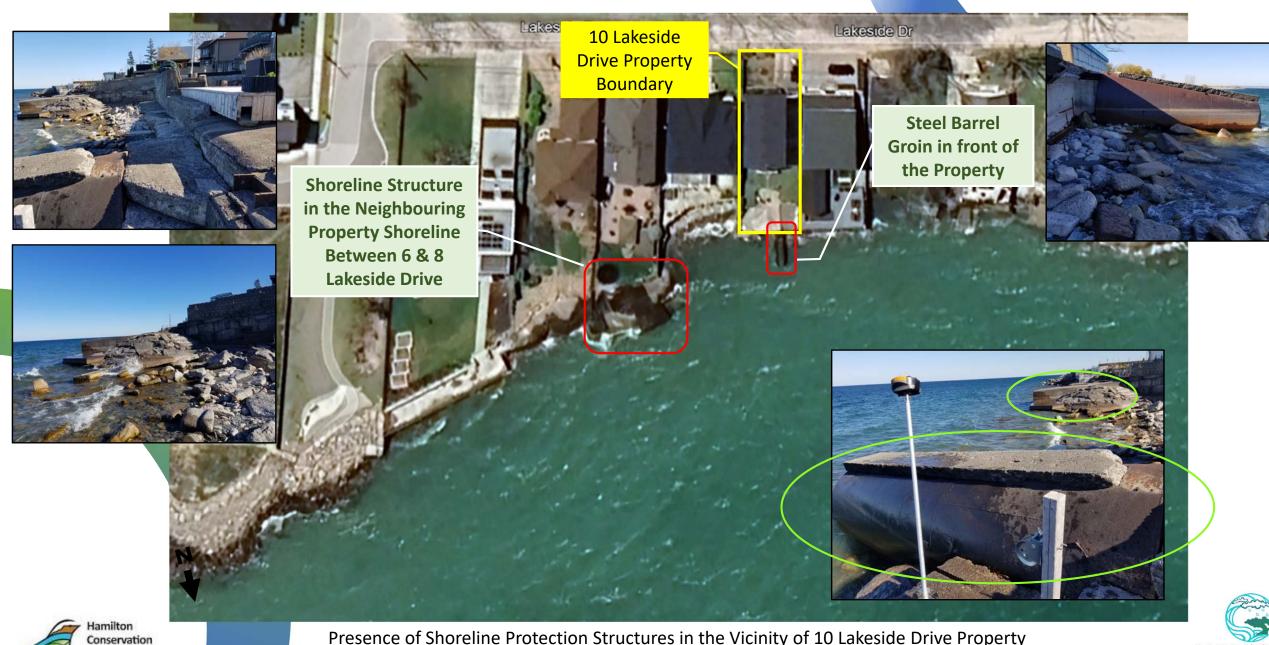
Presence of Shoreline Protection Structures in the Vicinity of 10 Lakeside Drive Property (Google Earth Imagery Date: 04/25/2024)

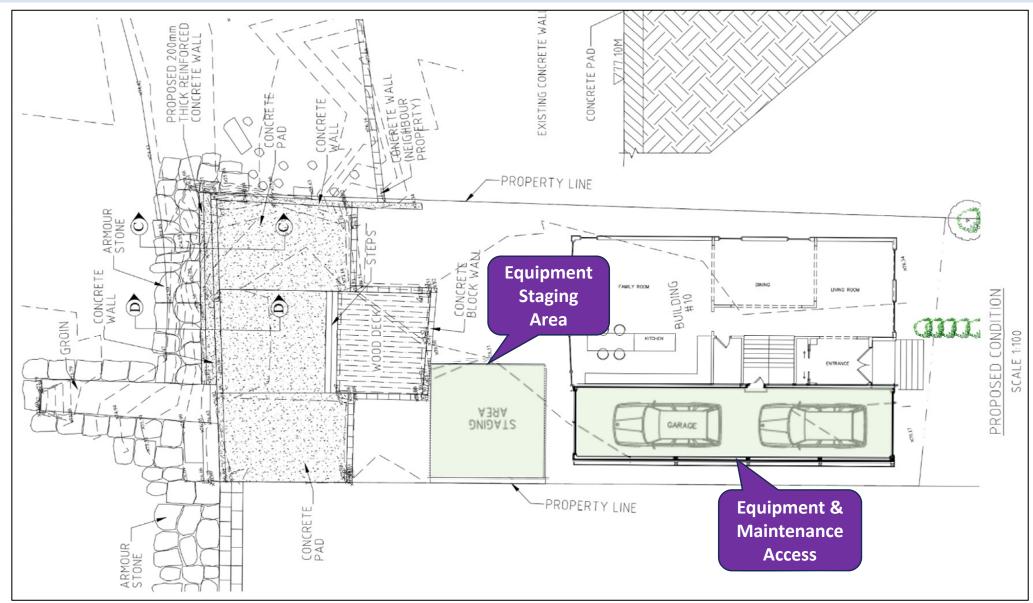
Layout Plan & Details Drawing of Seawall Design for 10 Lakeside Drive Property (Annex – V, Sheet 1)

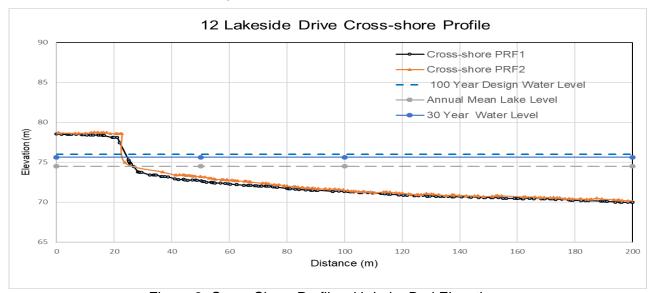
During the field investigation, a single point water surface elevation was measured using the RTK/GPS close to the shoreline. The measured lake water surface elevation was compared and corrected with the Burlington Station water level above 74.2m IGLD chart datum. The Lake Ontario Water Level at the Burlington station on June 12, 2019 was 75.8945m. Using the single point water surface elevation as the reference point, the sounding depths were subtracted to get the elevation of the lake bed at the associated points.[Reference: 18 Lakeside Project] Figure-3 illustrates the 2 cross shore profiles for a total length of about 200m from offshore to the onshore seawall.

Figure 3: Cross-Shore Profile with Lake Bed Elevations

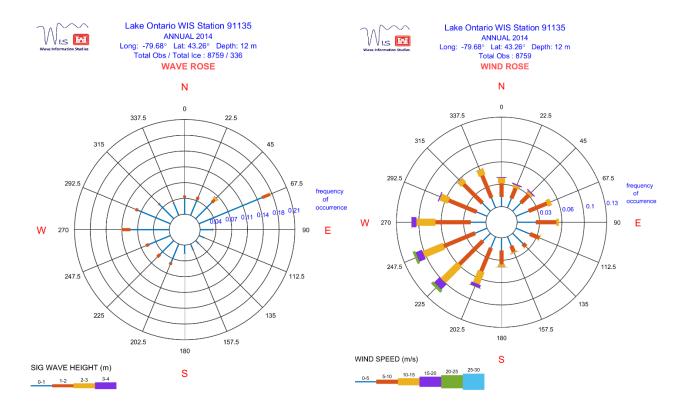
Figure 6: Wave Rose Graph for Significant Wave Height (US ACE, 2014)

Figure 7: Wind Rose Graph for Wind Speed (US ACE, 2014)

The Wave Information Studies (WIS) data collected by the United States Army Corps of Engineers (USACE) were used for the wind and wave frequency analysis at the project site. The project site is located on the shore north of Hwy QEW and Waterford Park in Stoney Creek. The site is closed to Lake Ontario WIS station 91135 (shown in Figure 2). Therefore, the data with record period from 1979 to 2014 of this station were used for this project. Figure 7 illustrates the wave rose graph generated by the USACE WIS for the significant wave height from all directions. It is observed from Figure 7 that the majority of the waves are coming from the west, northwest and northeast directions and a minority of waves come from all the other directions. As mentioned earlier, the shoreline at the project site is facing northeast. Figure 8 shows the wind speed from all the directions at the WIS station. The majority of winds and higher wind speed are coming from the west, southwest, and northwest directions. Any wind-wave coming from the northeast direction will have the greatest influence on the property shoreline.

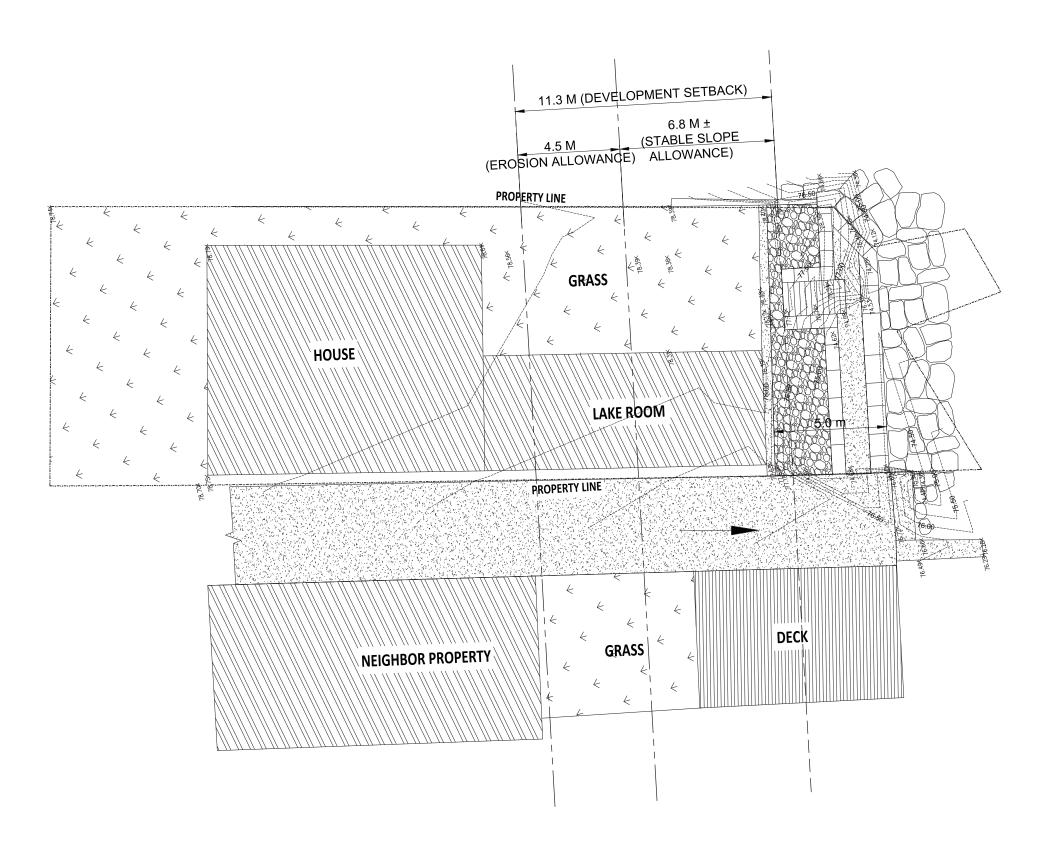
### 12 LAKESIDE DRIVE SHORELINE HAZARD ASSESSMENT SCALE-1:75
